Facility Assessment of Chardon Schools Board of Education Facility

Located at: 428 North Street Chardon, Ohio 44024

May 2024

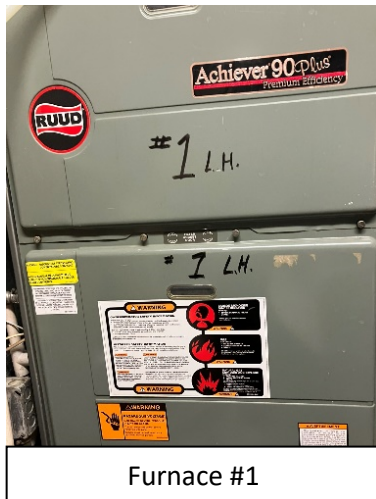
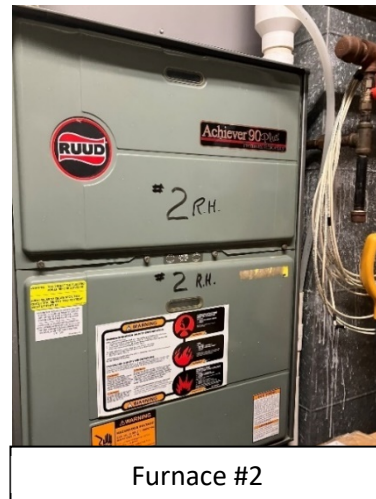
The Board of Education Facility was built in 1985. The existing furnace system for the Board of Education Facility consists of two gas-fired, forced-air furnace systems. Each furnace system is 80,000 BTUS. The heating occurs from Rudd Achiever Plus Premium Efficiency units. The exact date of installation is unknown but assumed to be between 13 and 20 years old. All the temperature controls are electronic. The forced air heating system is in good condition and has no active performance issues reported.

Although the existing furnaces are in good working condition, the typical life span of a furnace unit of this type is 20 years, therefore the recommendation is to anticipate a furnace replacement in the next 3 to 5 years.

Due to the age of the furnace systems, it is recommended to replace the units due to the life cycle.

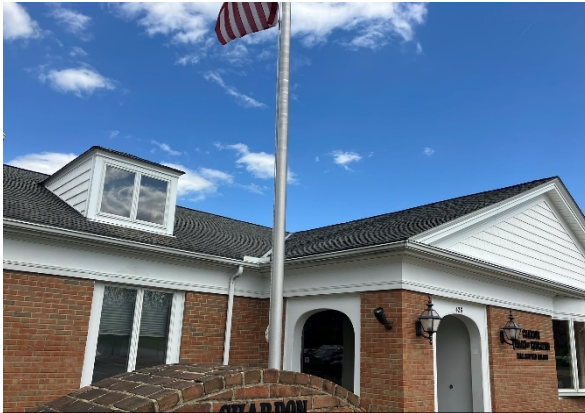
The roof over the overall facility is an asphalt shingle system, installation date is unknown but appears to be in good condition. There are no District reports of leaking. No signs of leaking were visually observed during the physical assessment. Access to the roof was unavailable.

Roof View from Front Elevation

Since the age of the roof is unknown, the recommendation would be to anticipate a roof replacement within 3 to 5 years. The average life of an asphalt shingle roof is 15 to 30 years.

Due to the age of the roof, it is recommended to anticipate replacement due to the life cycle.

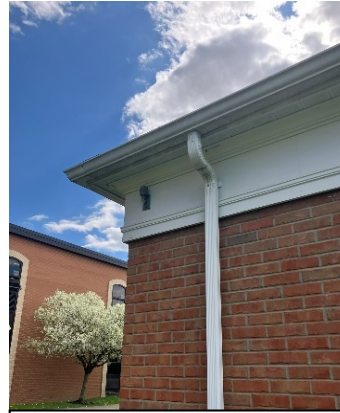
Roof storm drainage is addressed through a system of gutters and downspouts, which are properly located and in good condition. No problems requiring attention were encountered with any roof penetrations. There are not any covered walkways attached to this structure.

Gutter and Downspouts

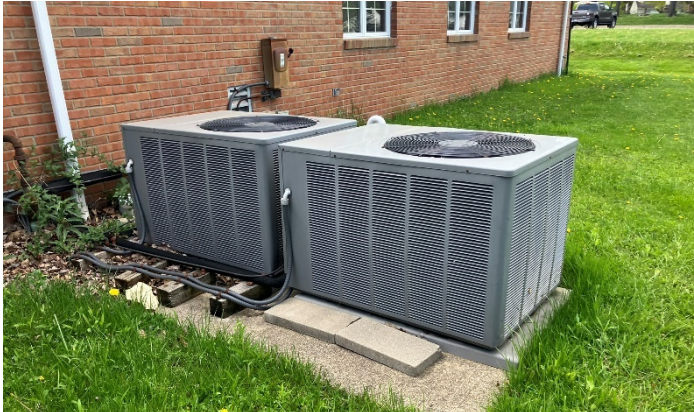
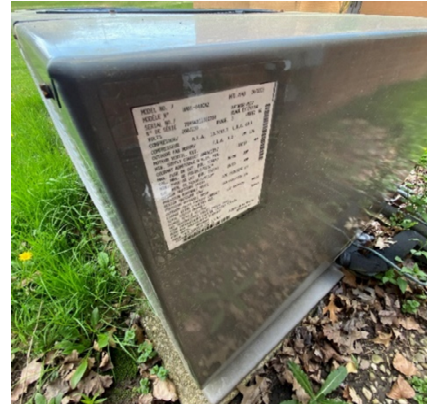
Rudd Condensing Units

The Board of Education facility is cooled by (2) Rudd Achiever Plus condensing units. Each unit is 3 Phase 208/230 volts, 60 hertz. The exact date of installation is unknown; however, it is estimated that the units are 10 years old.

Anticipate replacing both air conditioning condensing units in the next 3 to 5 years.

Due to the age of the air conditioning units, it is recommended to anticipate replacing both units within the next 3-5 years.

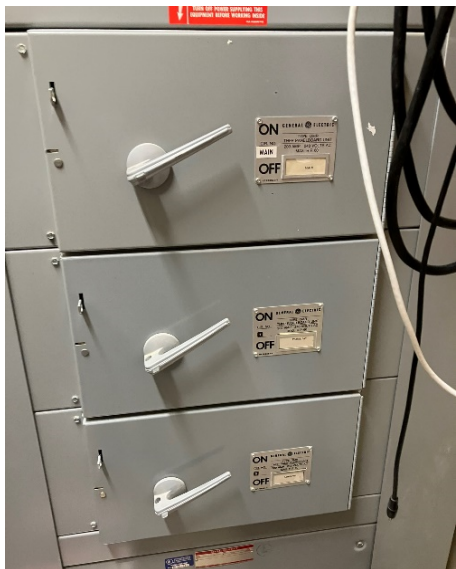
Electrical Panel

The electrical system provided to the overall facility is a 208 Volt, 200 Amp, 3 phase, 4 wire system with the main distribution panel in good condition.

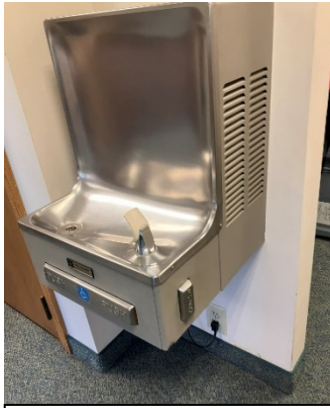
There is an older electric water cooler present in the hallway.

Existing Water Cooler

Upgrade the electric water cooler to an electric bottle filler.

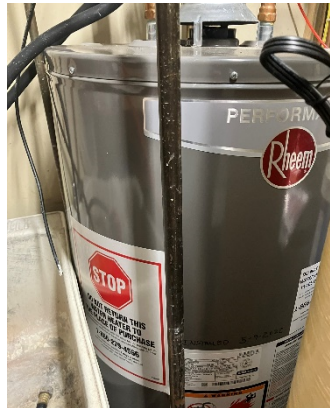
Water Heater

The Board of Education facility is equipped with one Rheem natural gas 40-gallon water heater. The water heater was installed in 2022

Replace hot water tank.

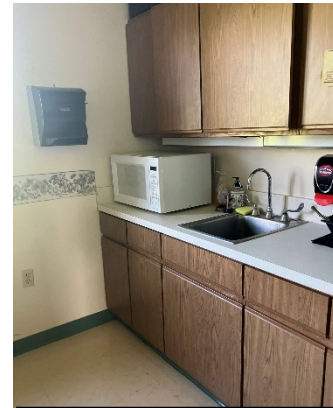
Kitchenette

There is a small kitchenette with one non-ADA compliant sink and a water supply line for a refrigerator.

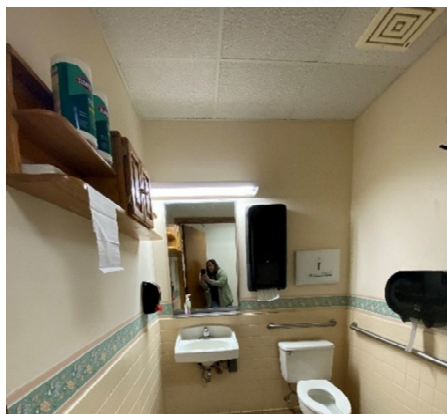
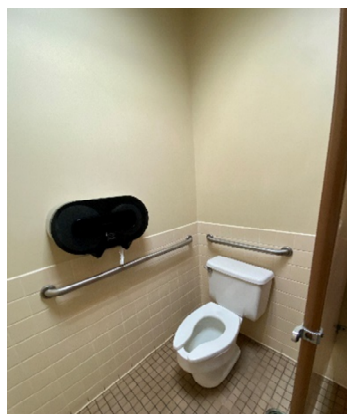
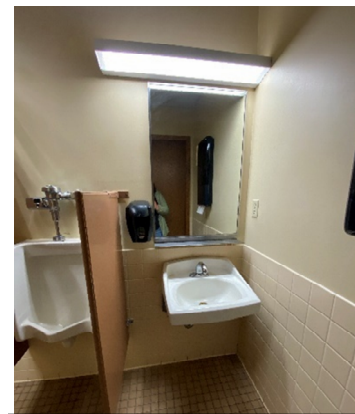
The facility contains one individual men's restroom and one individual women's restroom. The individual men's restroom contains an ADA floor mounted tank toilet with a single flush, one ADA wall-mounted flush valve urinal with wall-mounted urinal screens as well as an ADA wall-mounted lav. The one individual women's restroom contains an ADA floor mounted tank toilet with a single flush and an ADA wall-mounted lav. Neither wall-mounted lavs are properly insulated.

As a Priority 2, replace the flush valves on the existing floor-mounted toilets and upgrade the electric water cooler with an electronic bottle filler. As a Priority 3, replace the hot water tank in 5-10 years due to the life cycle of a domestic water heater.

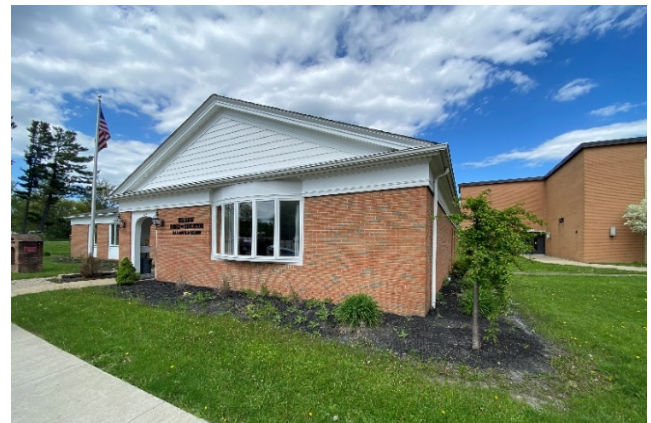
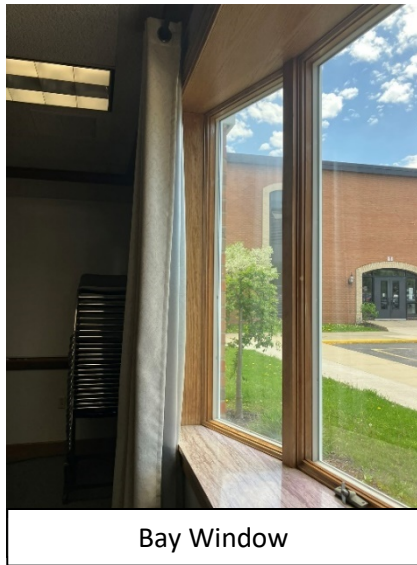
Bay Window

The majority of the windows are double insulated pane casement windows that are original to the building. The window system features both operable and inoperable windows and is not equipped with opening limiters but is equipped with insect screens in good condition. Window system seals are in good condition, and although no active leaks or condensation were present or reported, there was evidence that the window jambs were beginning to rot. Most of the window systems feature surface-mounted blinds which are in good condition. This facility is not equipped with a curtain wall system. This facility does not feature any glass block windows.

Provide for replacement of all original windows.

Provide for replacement of insulated glass panels.

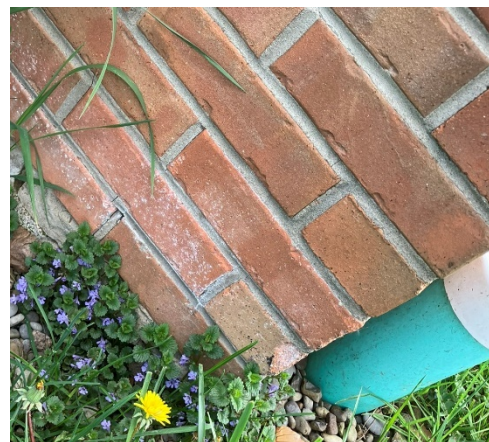
The Board of Education facility has a brick veneer on masonry block walls on the exterior and stud framed walls on the interior. The exterior displayed minimal deterioration and is in good condition. The exterior masonry does not appear to have been cleaned or sealed in recent years and should be done to protect the integrity of the façade. There is evidence of mortar deterioration near grade in some locations. No mold or efflorescence was noted.

Mortar Deterioration and Spalling

As a Priority 1, provide exterior masonry cleaning and sealing to retain the integrity of brick veneer. As a Priority 2, provide tuckpointing as needed to retain the integrity of the brick veneer.

Provide exterior masonry cleaning and sealing of the entire masonry façade.

Provide for tuckpointing.

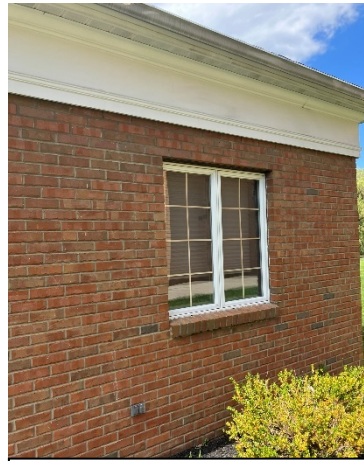
The interior walls are wood-framed partitions with gypsum board and are in good condition. The window sills are a combination of stone and aluminum window systems and are in good condition. The exterior lintels are steel and are in good condition. There are no chimneys. There is a portico over the main entrance which is of a brick veneer and wood construction and is in good condition. The exterior soffits are of vented aluminum construction and are in good condition. The facility does not have a loading dock.

Brick Sill and Lintels

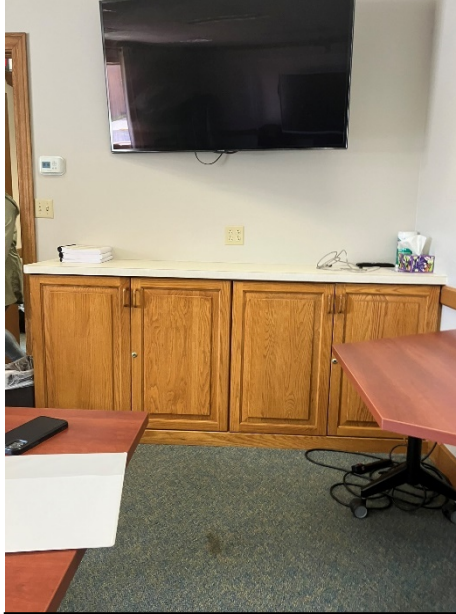
The Board of Education facility features conventionally partitioned offices and meeting spaces with much of the flooring being broadloom carpet, 2x4 and 2x2 acoustic ceiling tile ceilings as well as painted gypsum walls and they are in fair/good condition. The Board of Education facility has restrooms with 2x2 mosaic ceramic tile flooring. The restroom walls are ceramic tile wainscoting with painted drywall and 2x4 and 2x2 acoustic ceiling tile ceilings that are in good condition. Toilet partitions and urinal screens in the men's restroom are metal and are in good condition. The tile in the vestibule is in good condition. The VCT in the kitchenette, mechanical and electrical room are in fair condition.

Conf. Casework/Carpet

Provide complete replacement of carpet and wall base due to the age and condition of the broadloom carpet. Provide a complete replacement of the VCT due to the age and condition.

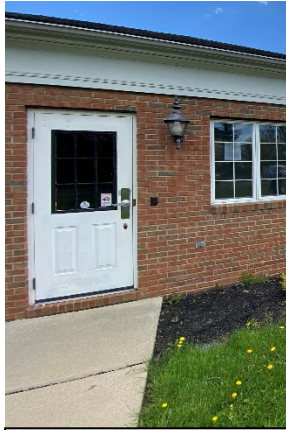
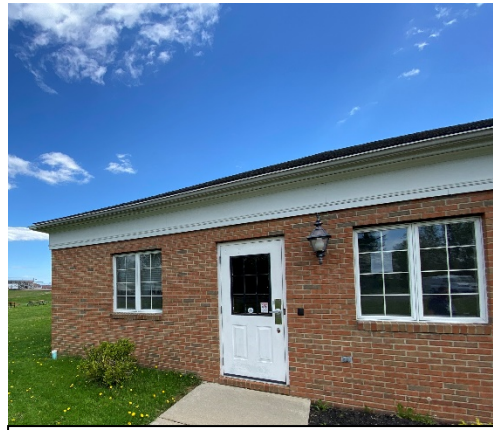
Exterior Door

The exterior doors are mainly comprised of aluminum units with vision lights and hollow metal doors. The exterior doors except for the main entry door are original to the building. The exterior doors are equipped with proper door hardware and the exterior doors at the main entry have panic bars on the inside.

Provide replacements for two exterior doors including the addition of panic hardware on the inside due to being at the end of useful life.

Replace dated exterior doors due to age and condition.
