## Facility Assessment Update of Chardon High School

Located at: 151 Chardon Ave., Chardon, Ohio 44024

May 2024

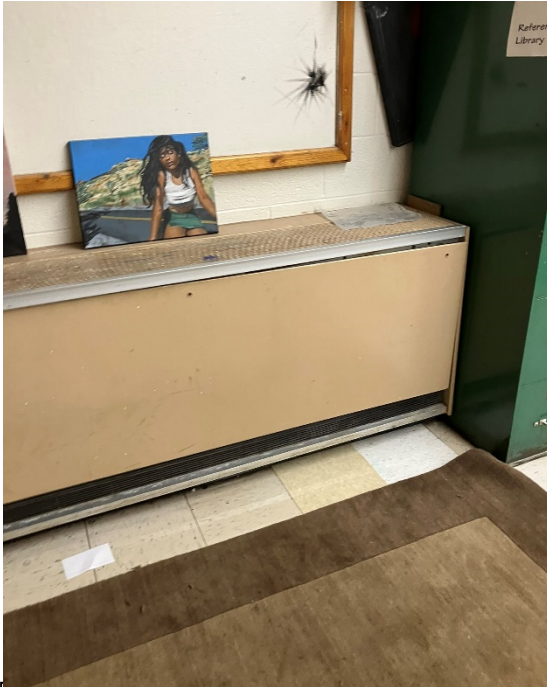
Classroom unit ventilator

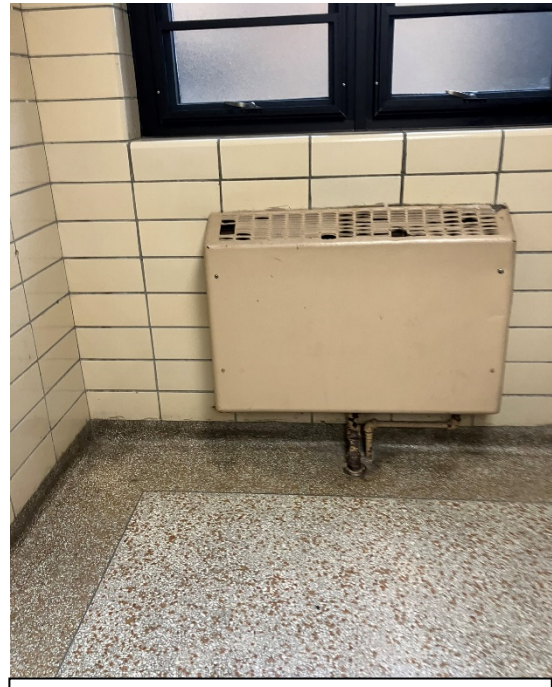
Dated restroom unit

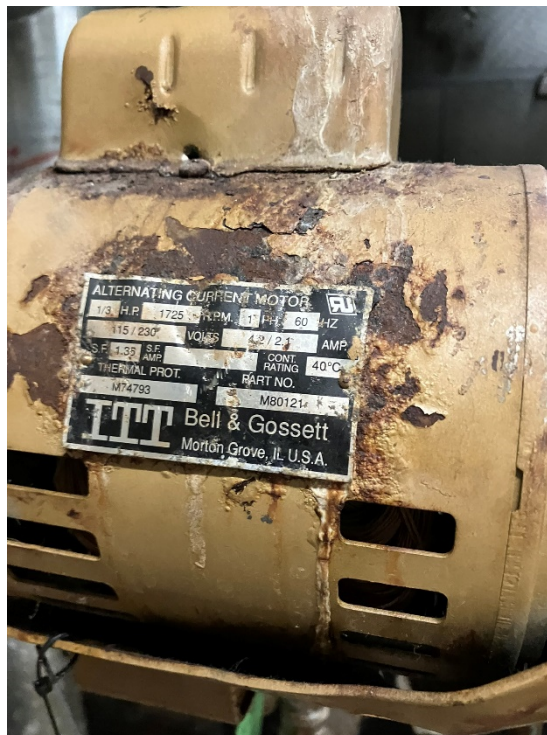
Dated motor

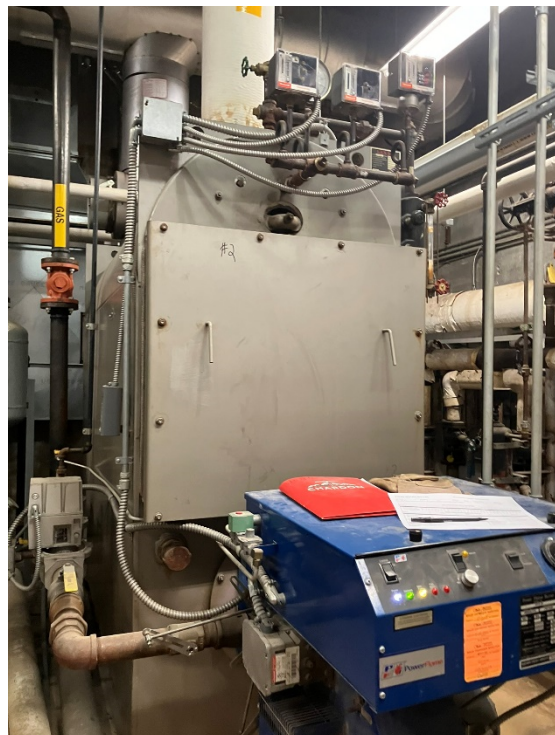
Boiler

Provide a new overall heating, ventilating, and air conditioning system to achieve compliance with OBC and OSDM standards. The heating system has exceeded its expected service life of 35 years. Replace the entire heating system and add air conditioning. The new ducted system will likely require architectural soffits to accommodate the installation of the ductwork.

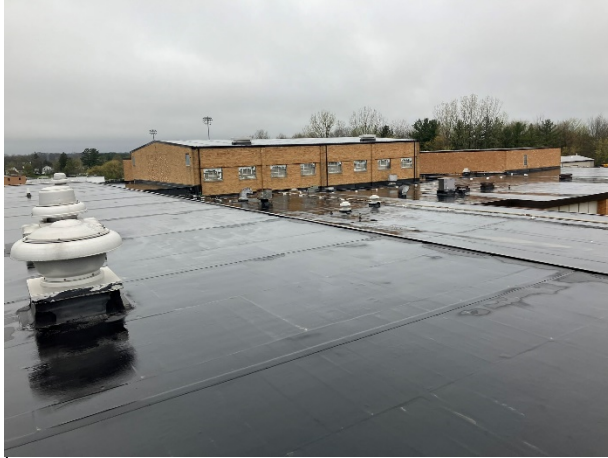
New EPDM roof system

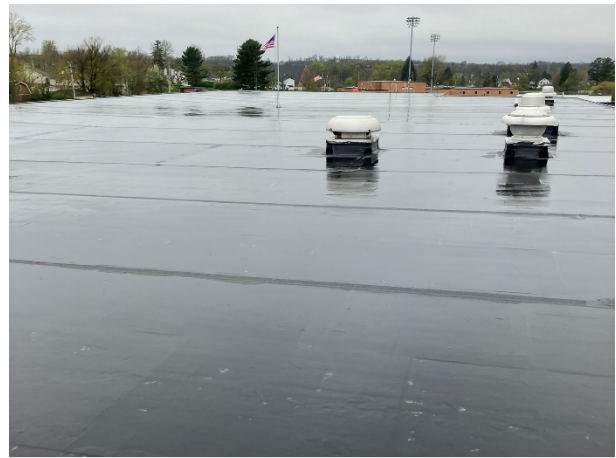
Roof system is in good condition

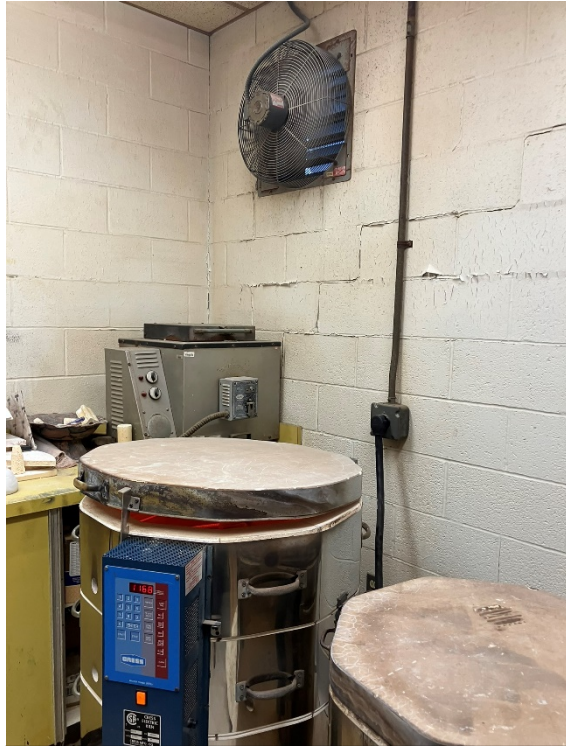
Kiln not properly vented

Provide complete replacement of HVAC system. See Item A for recommendations and pricing.  
Provide kiln exhaust.

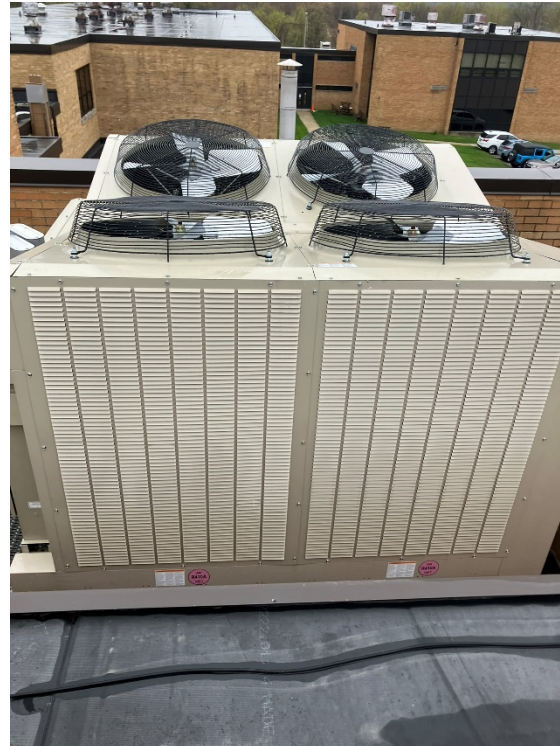
New chiller

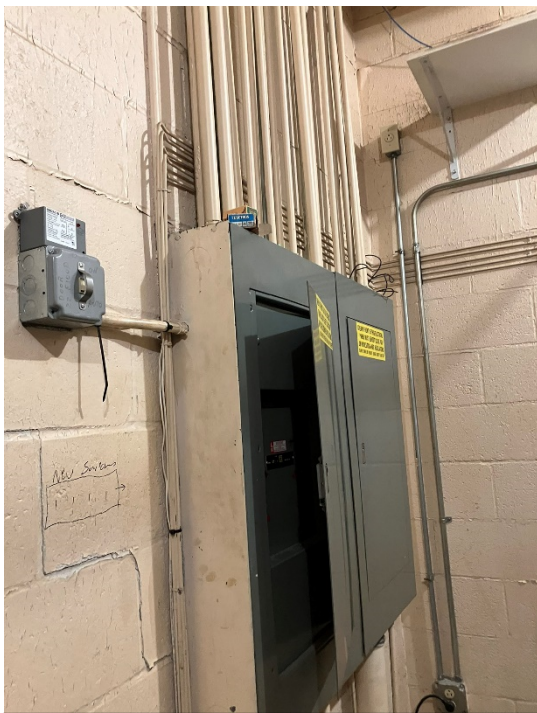
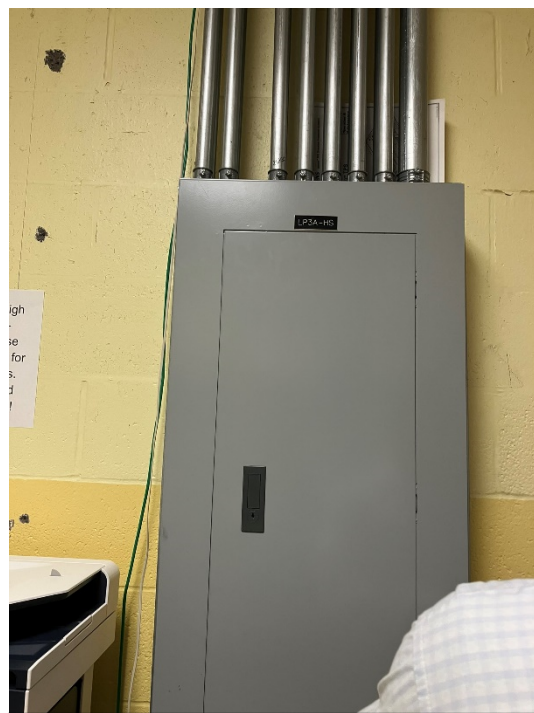
The overall electrical system does not meet OSDM requirements in supporting the current needs of the school and will be inadequate to meet the facility's future needs.

Electrical panel

The entire electrical system requires replacement to meet OSDM guidelines for overall capacity due to age. Work outlined as a Priority 3 is to be coordinated with associated work outlined in Item A and Item U.

Provide for complete electrical system replacement.

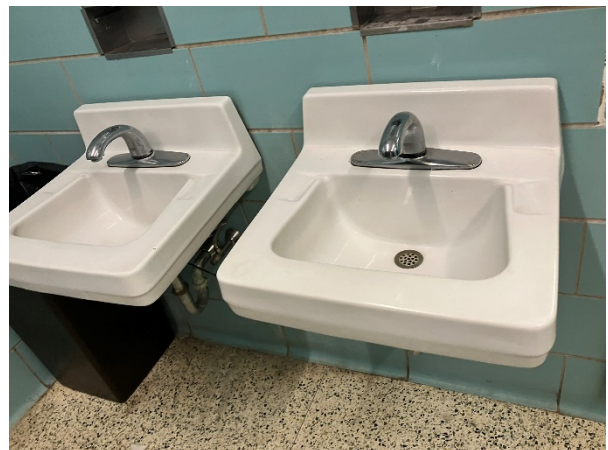
**New touchless faucets**

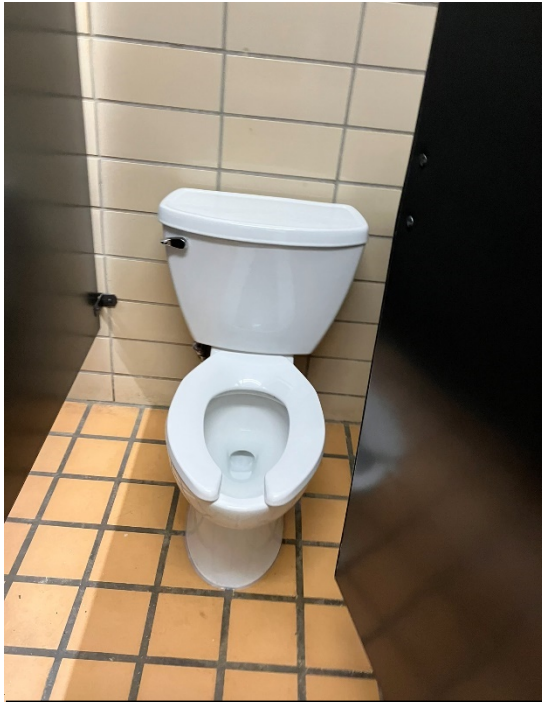
Floor mounted toilet

Provide for replacement of urinals, toilets, and showers to meet low flow requirements for OFCC/LEED (sans units just installed). Note: ADA fixture counts are provided in Item O. Provide 5 electric water coolers/drinking fountains. Replace sanitary and supply piping due to age and condition.

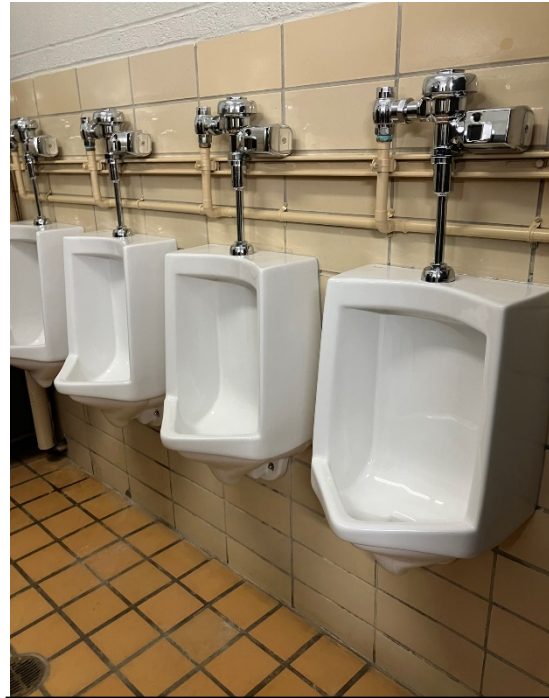
condition, though the fixtures that just received auto-flush valves will not meet OFCC/LEED guidelines for low flow.

New auto flush valves on urinals

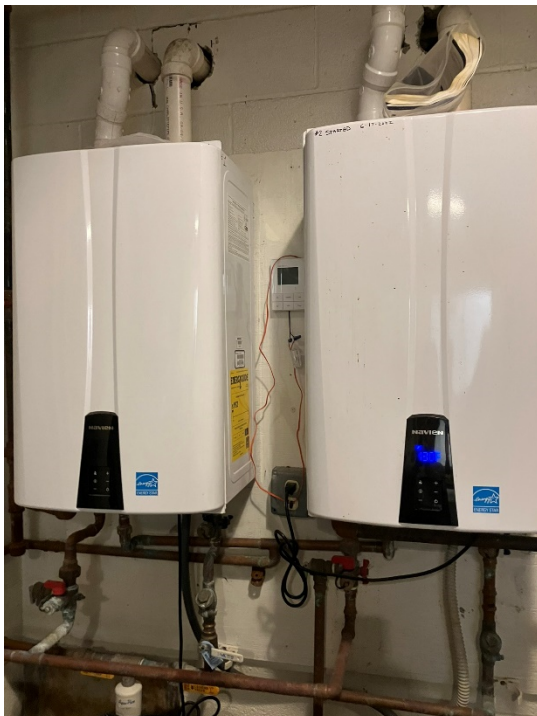
New kitchen tankless water heaters

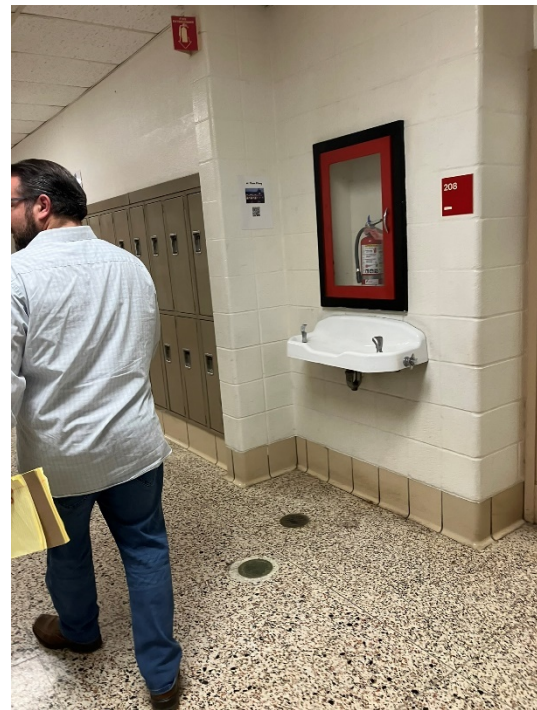
Older drinking fountain

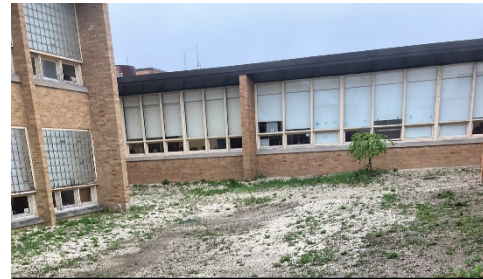
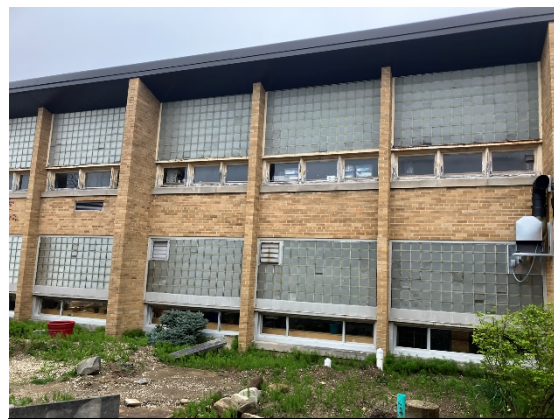
Old single pane windows and glass block

Provide for replacement of all old, single pane window systems due to age and condition. All work is recommended as a Priority 1 to ensure the building is warm, safe, and dry as a priority. Original Assessment calculated 8,481 SF of window area needing replacement. A total of 3,767 SF has been replaced since that time (and slated for replacement this summer), thus leaving 4,714 SF of window area to be replaced.

Provide for replacement of the remaining old single pane window system.

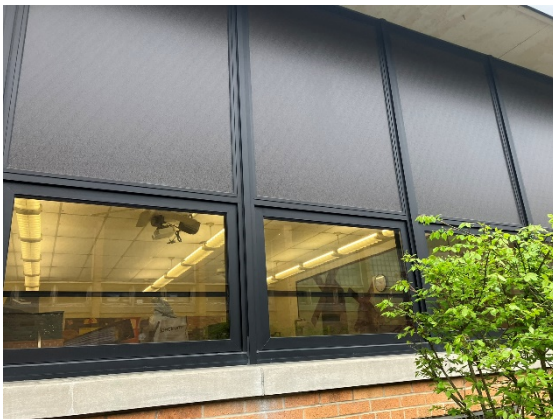
New aluminum window system

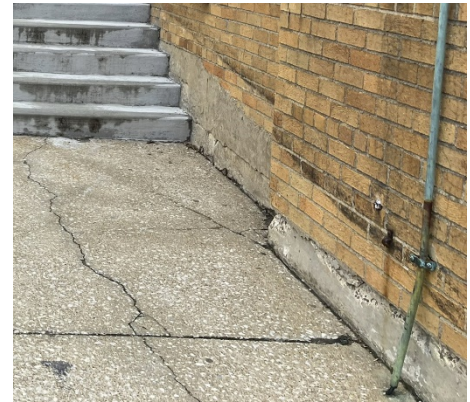
The building is poured concrete slab on grade. Most foundations are not visible. Where it could be observed showed signs of minor spalling. However, seismic activity in 1986 is reported to have damaged other portions of the building's structure. A thorough analysis of the foundation should be performed. The district reported having some issues with water infiltration in the tunnels only, not into any rooms. They have reduced about half of the water infiltration issues by adding a drain tile system. The area in need of additional work is around the courtyard.

**Concrete foundation**

Provide additional drain tile systems and waterproofing of the tunnels near the courtyard. The original assessment recommended professional engineering analysis due to the 1986 earthquake to determine if remedial measures are required for the building's structure.

Provide waterproofing and drain tile system to prevent water infiltration into the tunnels.

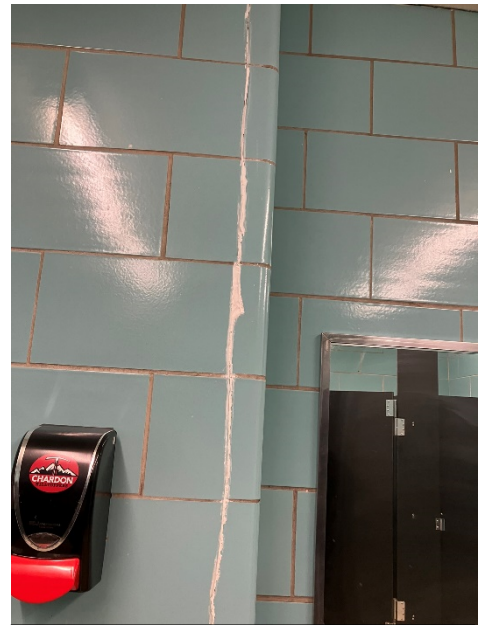
Interior walls are concrete masonry, glazed block units, brick, and drywall, and range condition from poor to good condition. Some interior wall cracking was observed and may be related to

**Interior wall cracks**

the 1986 earthquake. The window sills are mainly stone, and they are in fair condition. One overhang requires replacement, while the remaining should be scraped and painted at window overhangs.

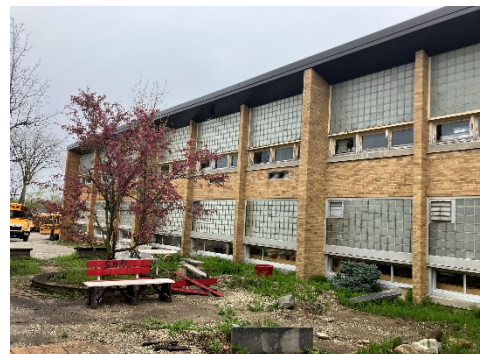
**Exterior facade**

As a Priority 2, provide for replacement of brick as needed, tuckpointing, masonry cleaning, and sealing of the entire masonry façade. Replace overhang in need, and provide scraping and painting to the remaining overhangs over the windows. This work will protect the integrity of the exterior façade. As a Priority 3, provide for the installation of control joints to relieve masonry walls of movement forces and infill brick at unit vent openings in coordination with HVAC replacement outlined in Item A.

Provide masonry tuckpointing, replacement where needed, overhang replacement, and scraping/painting, as well as cleaning and sealing of the entire masonry façade.

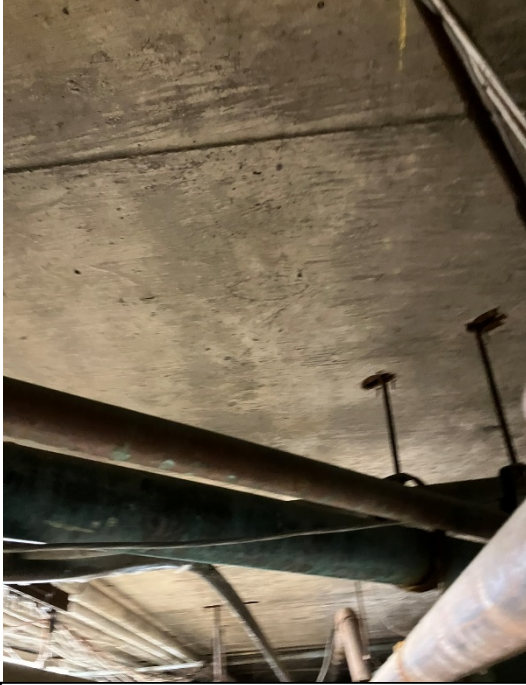
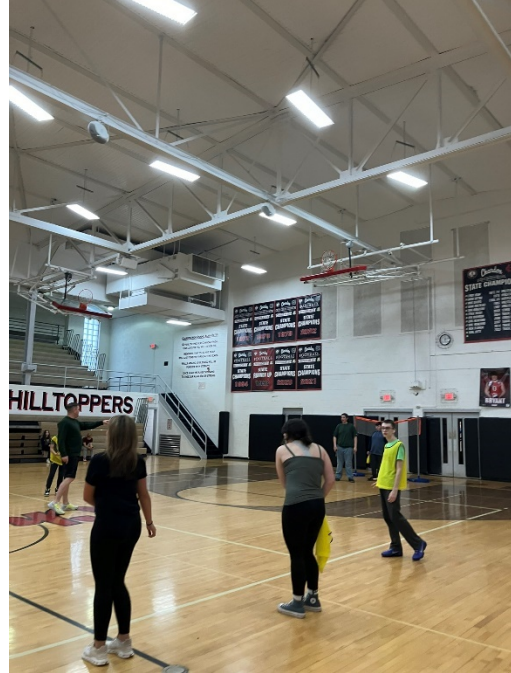
Concrete deck above pipe tunnels

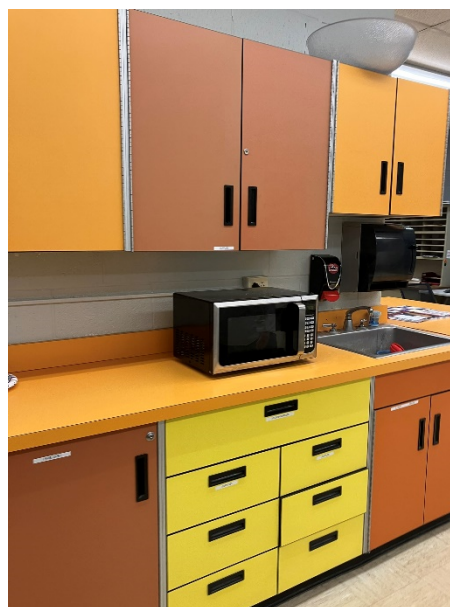
Dated casework

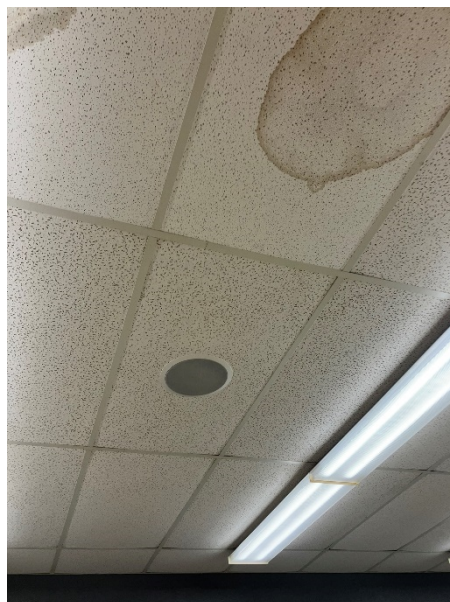
Stained ceiling tiles

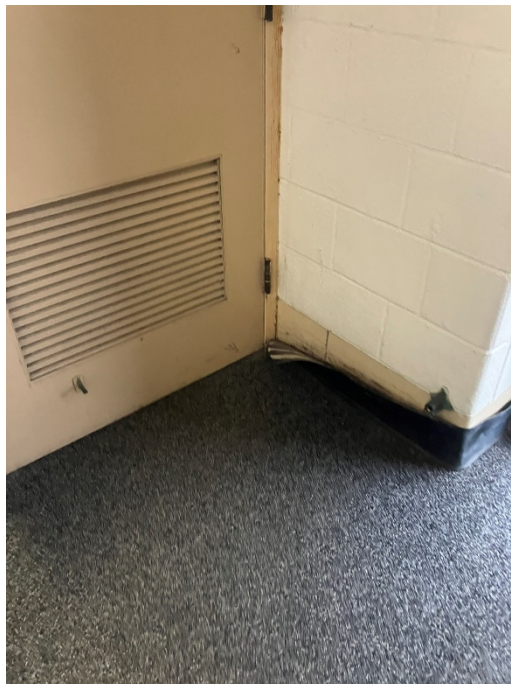
Worn finishes

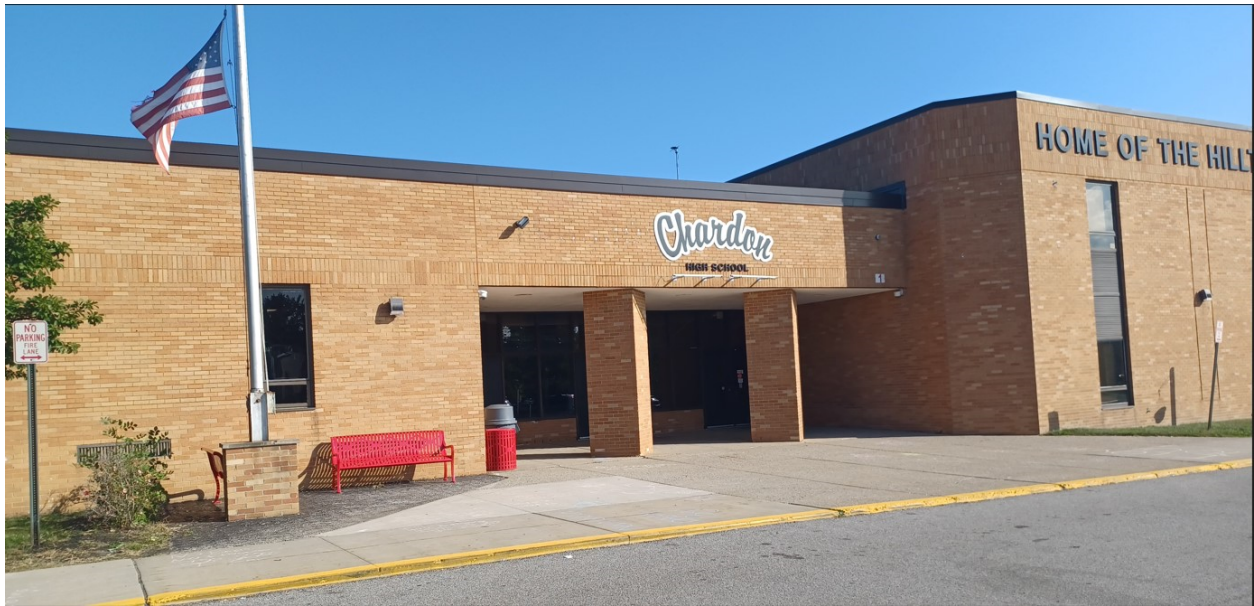
Main entry – a secure vestibule addition is being constructed under canopy

Provide a new security system to meet OFCC design manual standards as a Priority 1 which is focused on warm, safe, and dry. The costs for exterior site lighting have been removed due to updated and adequate exterior lighting conditions.

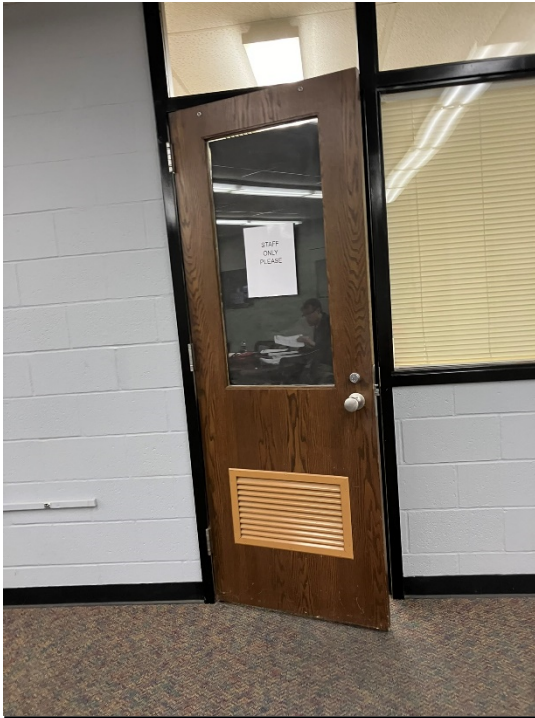
Staff door without ADA hardware

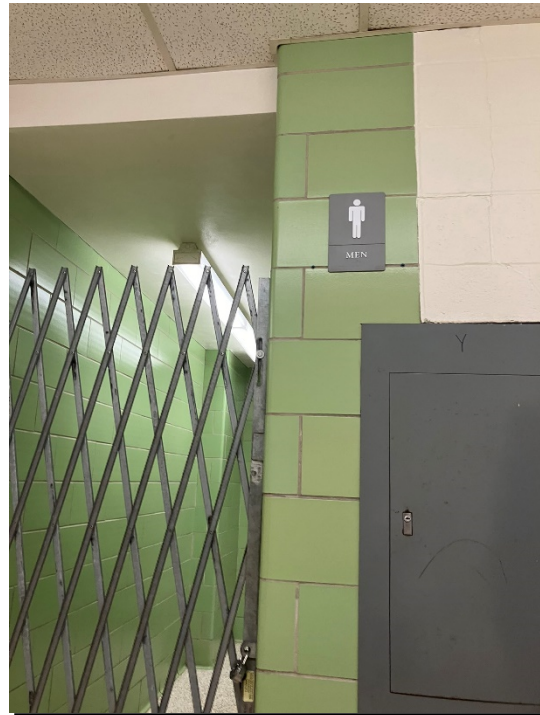
ADA signage mounted too high

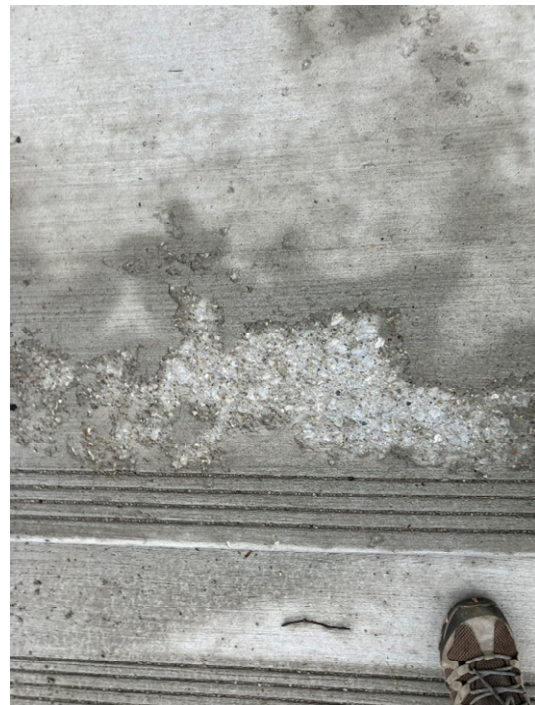
Spalling concrete

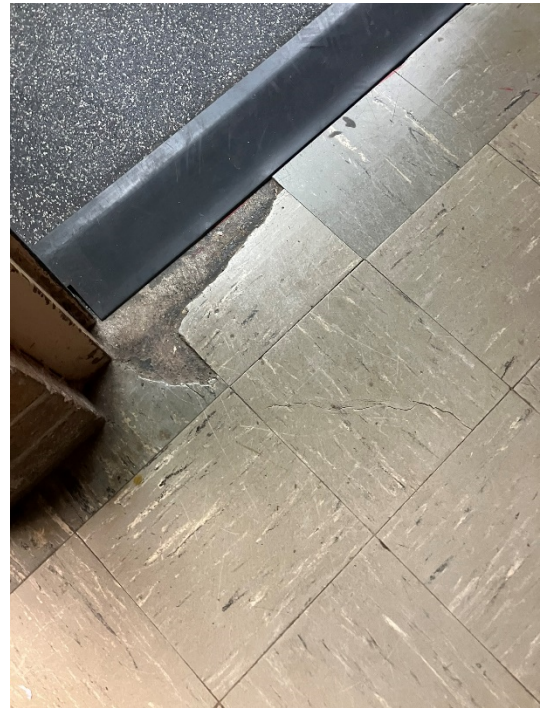
VAT flooring in clinic

Remove asbestos and hazardous material-containing materials.

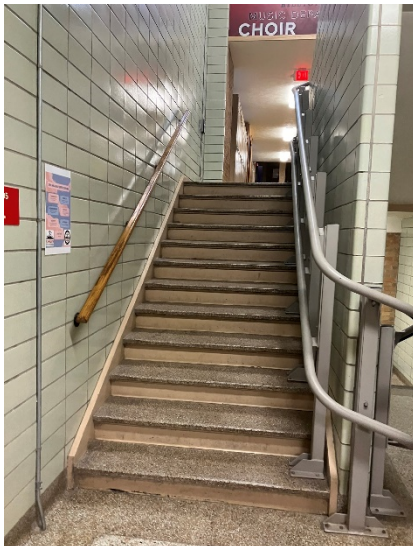
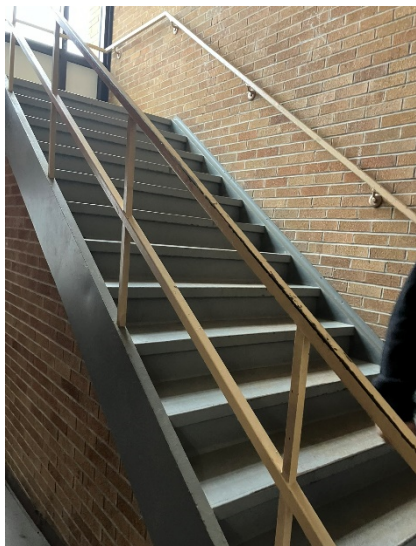
Stair handrail not compliant with current code

Provide a complete sprinkler system that includes a new dedicated fire water line. Provide new handrails/guardrails as needed. Provide fire extinguisher cabinets throughout the building. An emergency generator is provided via complete electrical system replacement in Item D.

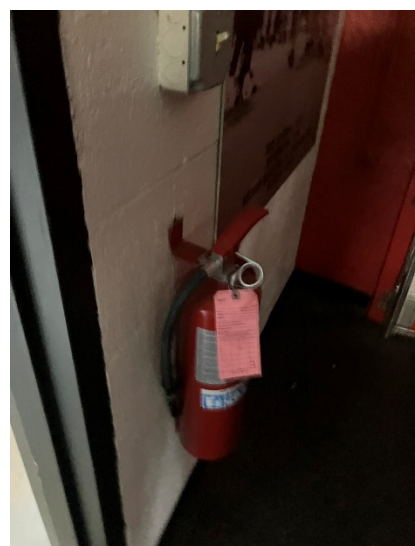
Fire extinguisher – not in wall cabinet
