Facility Assessment of Chardon Middle School

Located at: 424 North Street Chardon, Ohio 44024

May 2024

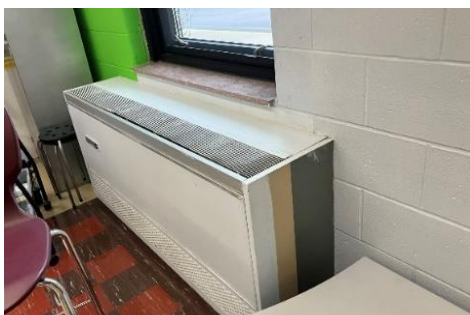
The existing system for the overall facility consists of a 1964 and a 1998 Kewanee water boilers in fair condition. Unit ventilators are used to provide heat and ventilation in a majority of the classrooms. The equipment in the building does not provide the required outside air delivery to meet the OBC mechanical code. The system temperature controls pneumatic type thermostats with DDC controls in fair condition. The structure is not equipped with air conditioning for the overall facility and the ductwork and air handlers do not have the capacity to supply air conditioning to the classrooms. The two-pipe system does not provide a capacity for simultaneous heating and cooling operation which is not compliant with the OSDM requirements. According to school officials, the site does not contain underground fuel tanks.

Unit Vent

Provide a new overall heating ventilating and air conditioning system to achieve compliance with OBC and OSDM standards, the 1998 boiler is to remain. The new ducted system will likely require architectural soffits to accommodate the installation of the ductwork.

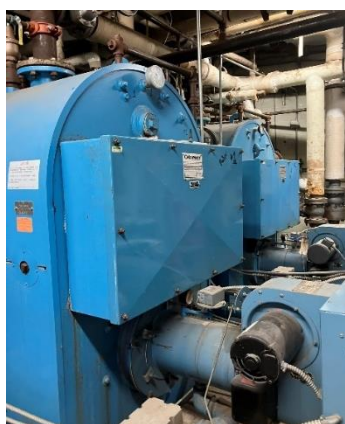
Boilers #1 and #2

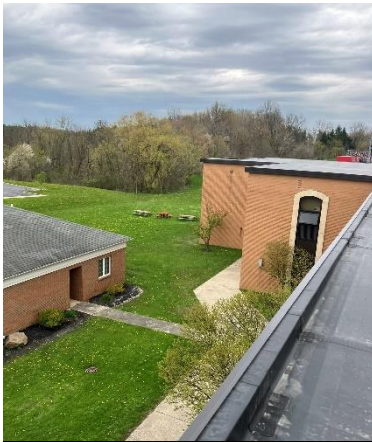
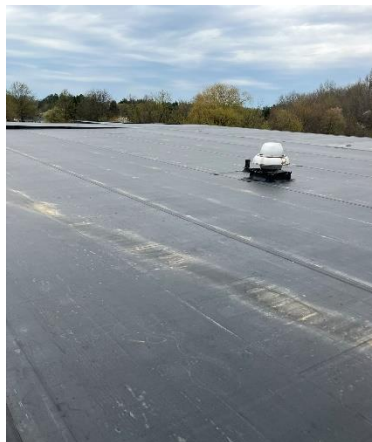
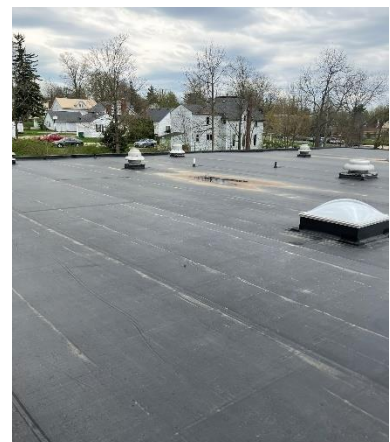
The roof over the Chardon Middle School is a newer EPDM system that was installed in 2022 and is in good condition. There are no District reports of current leaking. Access to the roof was gained by access hatch and ladder that are in good condition.

EPDM Roof

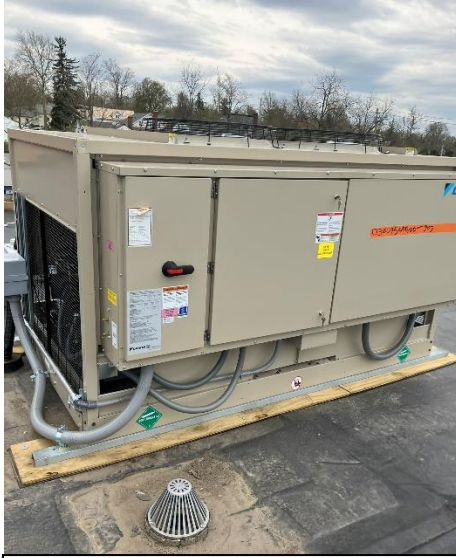
There is no central ducted air conditioning system for the Middle School. A new large air conditioning unit serves 6 classrooms and a large instructional room. The exact date of installation is unknown but was within recent years. A new chiller serves 8 classrooms. The exact date of installation is unknown but was within recent years. A mini split was installed 8 -9 years ago to serve the media center.

Rooftop Condensing Unit

Provide an air condition system to meet OBC and OSDM requirements. Cost included in A. Heating System section.

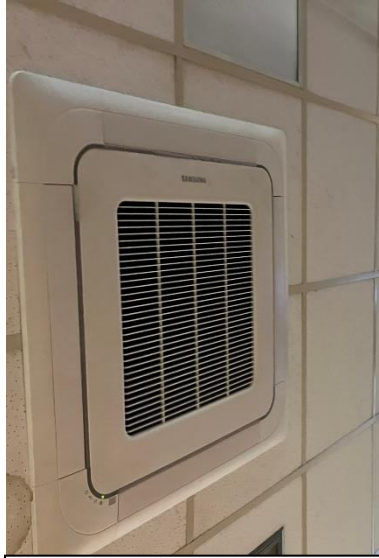
Mini-Split

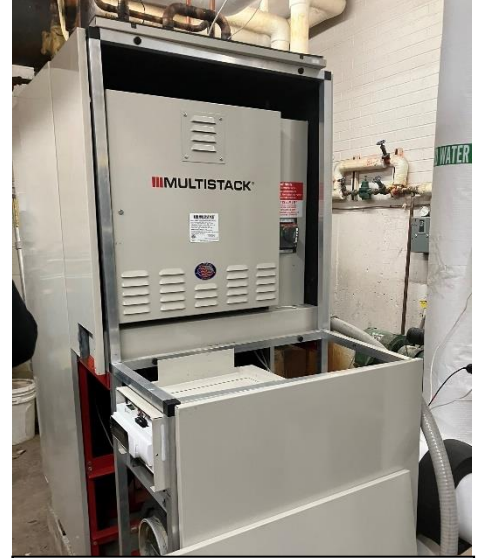
New Chiller

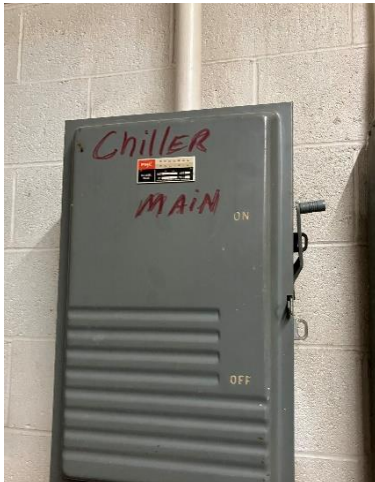
The existing system is not capable of supporting the new HVAC system. The overall electrical system does not meet OSDM requirements in supporting the needs of the school.

Dedicated Chiller Line

The entire electrical system requires replacement to meet OSDM guidelines for overall capacity due to age. Work outlined as a Priority 3 is to be coordinated with associated outlined in Item A and Item U. Upgrade service to 1200 amp, 208/120, 3 phase 4 wire minimum per OSDM guidelines.

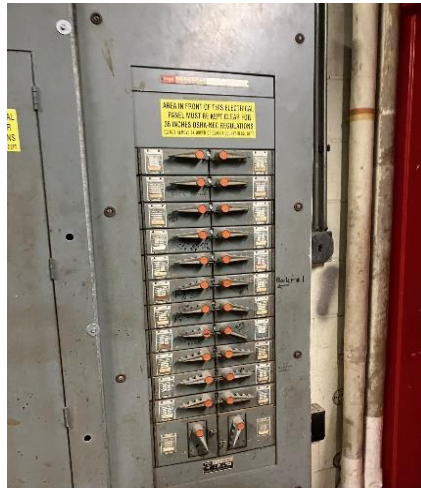
The electrical system in the overall facility is a 240/120 volt, 3-phase 4-wire electric service. The electrical system was installed in 1965 (800 amp) and in 1978 (1200 amp) was added with a total capacity of 2000 amp, an upgrade in 1999 to support the new computers at the school with no increase to the electric service. A new dedicated line was installed to support the new chiller system only. Power is provided to the school by a single utility owned pad mounted transformer. Adequate lightning protection safeguards are not provided. The existing facility is not equipped with a stage.

Electrical Panel

Provide complete electrical system replacement.

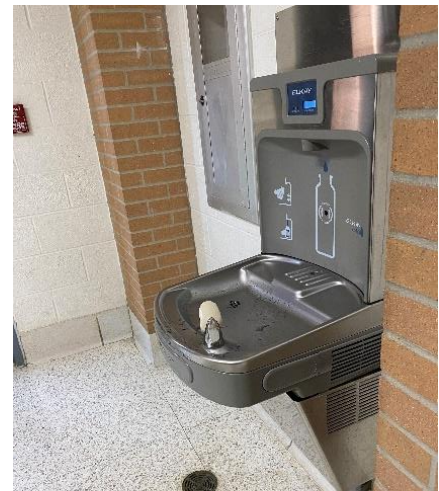
Upgraded Bottle Filler

Provide for replacement of urinals and toilets to meet low flow requirements for OFCC's LEED requirements for water usage. Notes: ADA fixture counts are provided in Item O. Provide 4 electric water coolers with bottle fillers. Replace sanitary and supply piping due to age and condition.

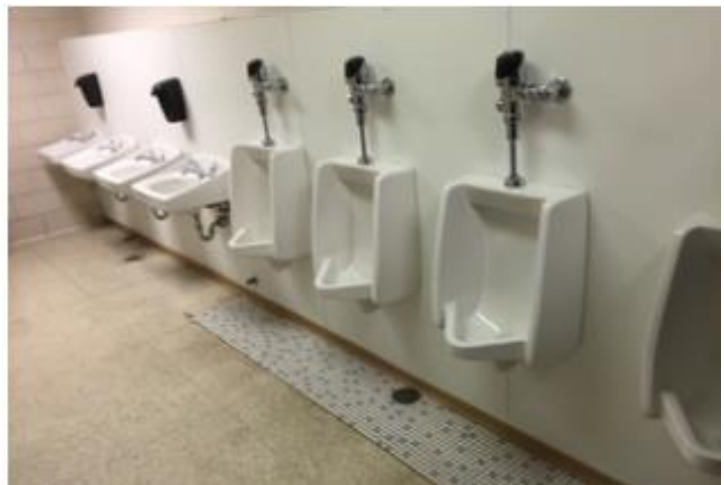
Men's Restroom Fixtures

All toilets and urinals should be replaced to meet LEED low flush requirements in order to achieve water efficiency prerequisites. Some fixtures (sinks, toilets, urinals) are in fairly poor condition and require replacement due to condition and age. Floor mounted urinals are worn and maintenance staff reported difficulty finding replacement parts. The existing water heater has exceeded its useful life and requires replacement.

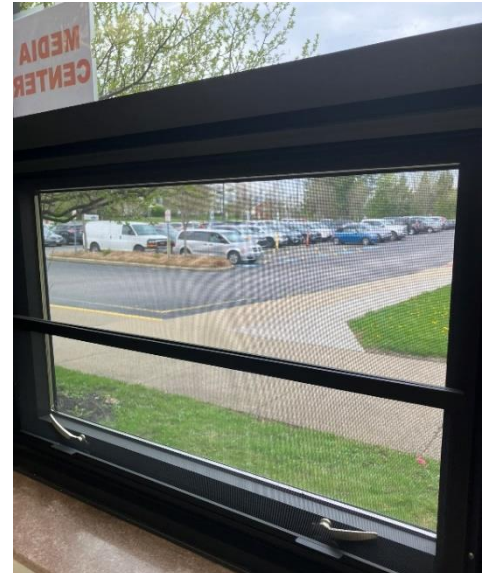
The facility has aluminum frame windows with a double-glazed insulating glazing type window system. All windows have been replaced in recent years and are in good condition. The window system features operable windows throughout the building and is equipped with limiters in good condition and insect screens in good condition. Window system seals are in good condition, with no air and water infiltration being experienced. Window system hardware is good condition. The window system does not feature blinds. The majority of the windows are equipped with roller shades which are in good condition. This facility is not equipped with any curtain wall system or glass block windows.

New Windows

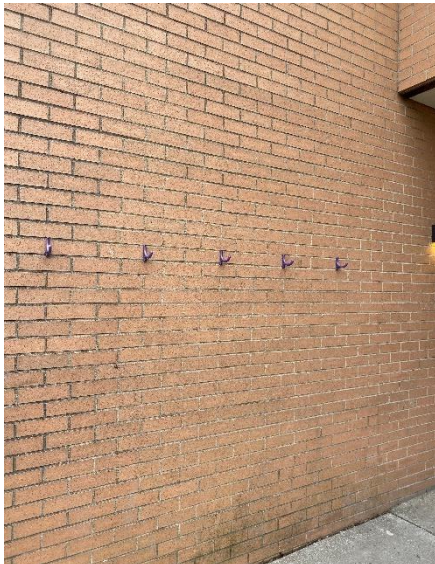
The overall facility has a brick veneer on load bearing masonry wall system, which displayed locations of deterioration, diagonal cracking and in fair condition. Several walls were observed to be damaged by 1986 seismic activity. Engineering analysis should be performed on the building to determine further remedial action beyond the scope of this assessment. They are buckling away from the floors and diagonally cracked as well. A mechanical stack extending from the roof was observed as well. It is missing mortar in several areas. Areas of biological growth and other kinds of staining were observed on the exterior walls. No control joints were observed on the exterior of the building.

Brick Façade

Provide infill of brick @ unit vent voids when HVAC system is replaced.

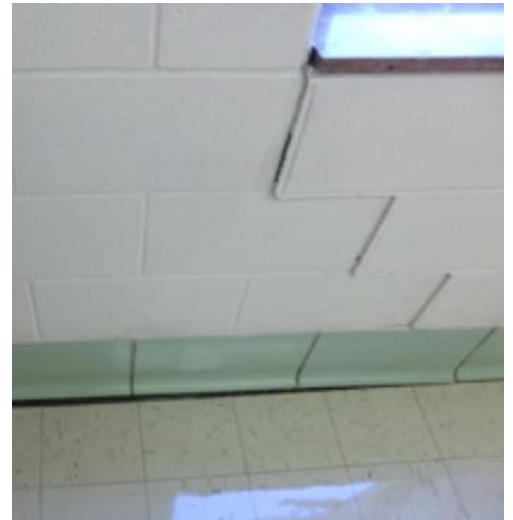
Interior walls are glazed block and concrete masonry units and range condition from poor to fair, showing damage from the 1986 seismic activity.

Diagonal Cracking/Separation
between Floor and wall

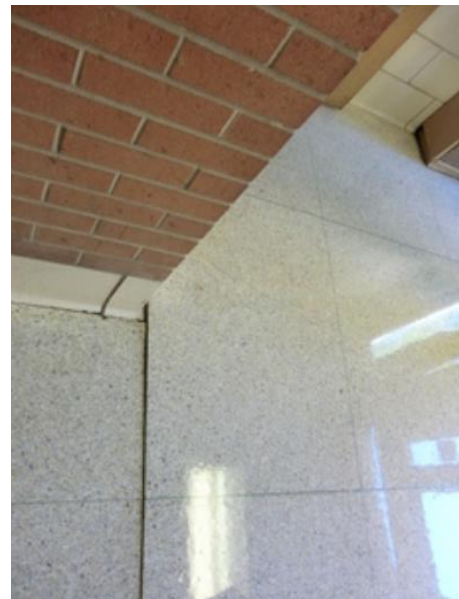
The floor construction of the base floor of the overall facility is a poured concrete slab on grade and is in poor condition. Separation appears to be occurring between construction joints in the poured concrete slab on grade. The floor construction of the intermediate floors are framed with concrete structural flooring systems.

Separation at Floor Slab

Provide expansion joints in the floor as necessary to prevent damage from future movements of floor slabs.

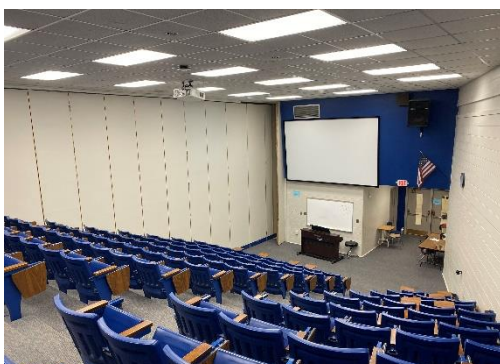
When the facility was assessed in 2016, it contained primarily recessed, fluorescent-type lighting. The lighting in classrooms was T-12 and T-8 fluorescent 2x4 fixtures with electronic ballast. The lighting levels were as follows: classrooms 65 FC, media center 55 FC, cafeteria 60 FC, kitchen 80 FC, gym 45 FC, science 65 FC, offices 77 FC, restrooms 50 FC, art 65 FC, band 50 FC, lecture hall 70 FC, corridor 70 FC. The district recently cut out all of the ballasts and put in LED lamps. The lighting levels are much improved in all of the spaces.

Updated Instruction Space Lighting

Although all new LED lighting is provided, complete replacement of lighting system in areas with dropped ceilings will be required due to the installation of mechanical systems and fire suppression systems outlined in Items A & U.

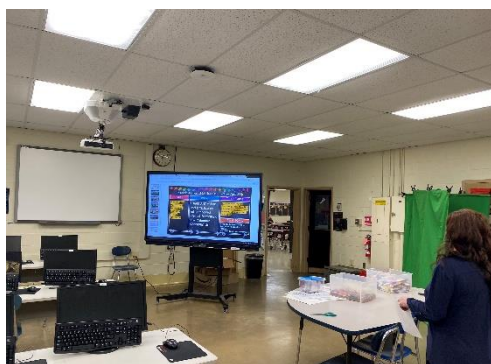
Updated Classroom Lighting

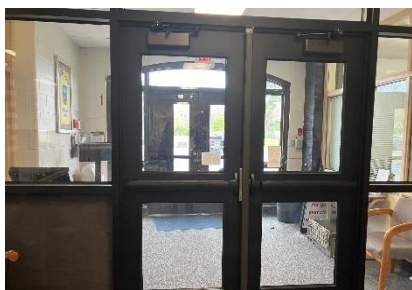
Since the 2016 assessment, the district added a new secure vestibule equipped with a driver's license swipe system. They also upgraded all exterior cameras. The overall facility contains a 1992 Fire Burglary system maintained by Vector Security. Motion detectors are provided in main entries, central gathering areas, offices, main corridors, and spaces where 6 or more computers are located. Exterior doors are equipped with door contacts. An automatic visitor control system is provided. Compliant CCTV Cameras are provided at main entry areas, parking lots, central gathering areas, and main corridors. CCTV is monitored in the administrative area. The system is equipped with card readers at a majority of the doors. Exterior doors do not have position switches. There is not adequate exterior building-mounted security lighting.

New Secure Vestibule

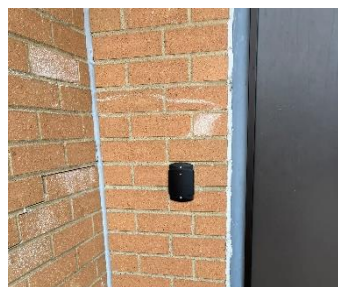
Card Reader

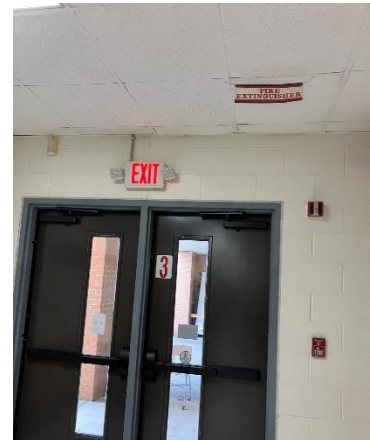
The overall facility is equipped with an emergency egress lighting system consisting of red-lettered illuminated signs which are in fair condition. The facility is equipped with emergency egress floodlighting and the system is in good condition. The system is provided with a battery backup. Since the 2016 assessment, the district has been replacing lighting as it reaches the end of its life.

Exit Signs and Strobes

Provide a complete replacement of emergency egress lighting due to lack of compliance with OSDM and due to the installation of systems outlined in this report. A new generator is included as part of item D.

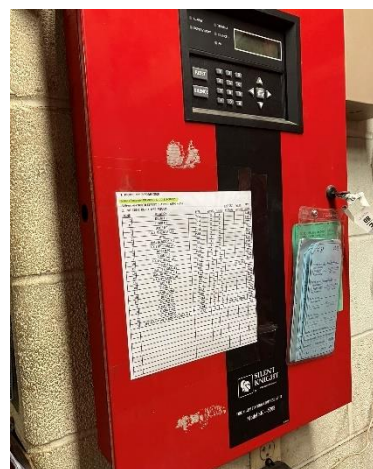
The overall facility is equipped with a 1992 Silent Knight zoned type system and is annually tested and remotely monitored by Vector Security. There is not an adequate number of horn and strobe-indicating devices. The existing system does not have enough capacity to add additional horns and strobe indicating devices or duct fire suppression system detectors for shutdown of air handling equipment to meet NFPA and OFCC standards. It is not likely that the current system would accommodate the addition of a fire suppression system.

Fire Alarm System

Replacement of the system will be required due to lack of compliance with NFPA and OFCC standards and when the work in A and C – upgrading the ventilation and air conditioning is completed.

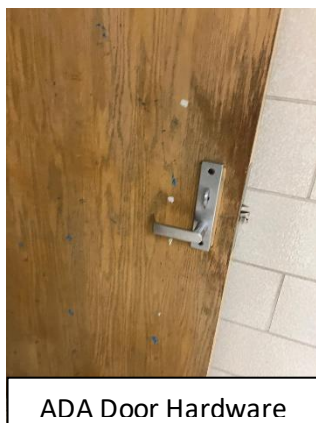
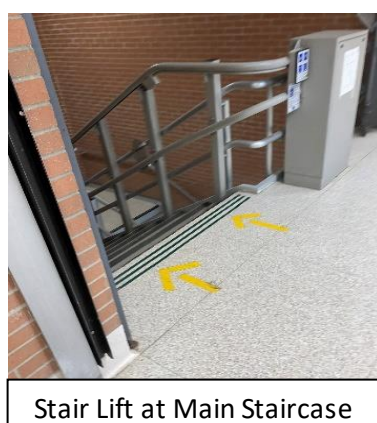
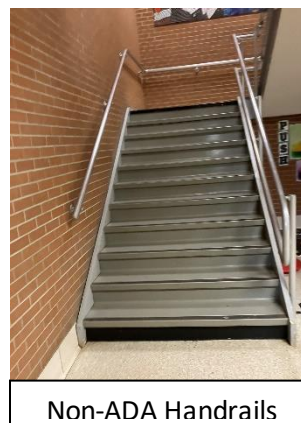
Interior doors are not recessed and mostly provide adequate clearances and are retrofit with ADA-compliant hardware.

ADA-compliant restroom fixtures are required in the large group restrooms, including toilet partitions.

A power assist door set is required at the main entrance. Interior doors are retrofitted at ADA hardware but the doors are dated and in worn condition requiring replacement. ADA compliant restroom fixtures are required in the large group restrooms, including toilet partitions. A two-stop elevator is required in the facility for ADA compliance. The Music/Band room is accessed from the second floor, with stairs leading down to the floor which is actually on ground level. There is no ADA access to this room. A lift is required. There is a grade change in the academic corridor that has no ADA access and will require a lift. The stage in the gymnasium has no ADA access and will require a lift.

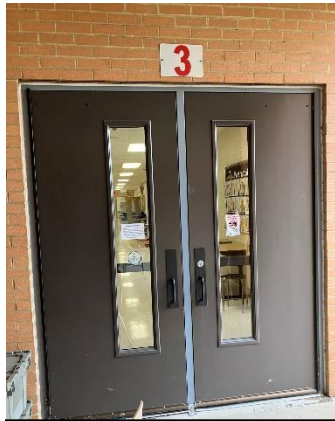
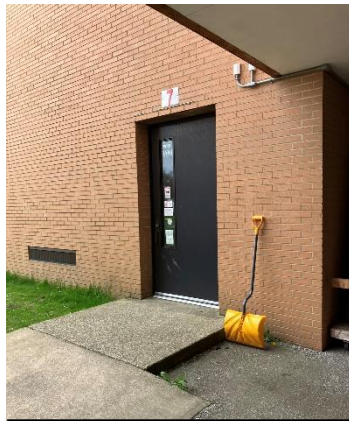
Only partial replacement has occurred of exterior doors in the overall facility. There are several leafs that are dated, worn, and according to the school district, failing in terms of closing and sealing properly. Provide for replacement of worn exterior doors.

Exterior Door

Replace dated and worn door leafs.

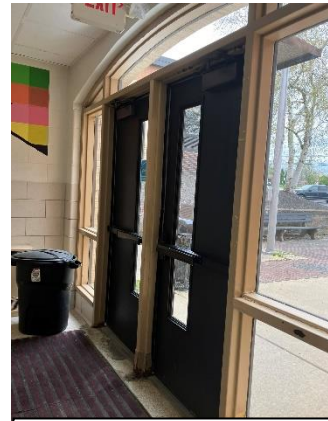
Secure Vestibule Doors

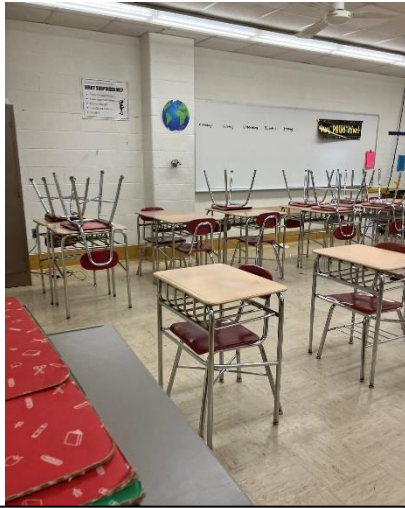
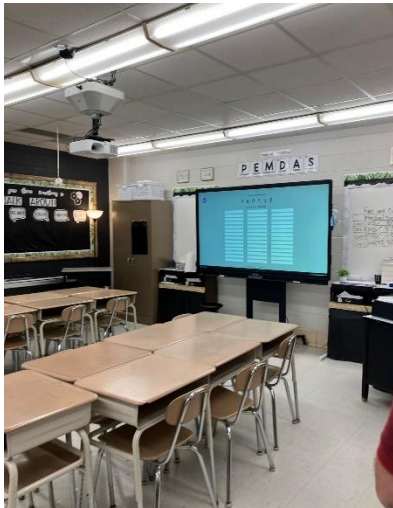
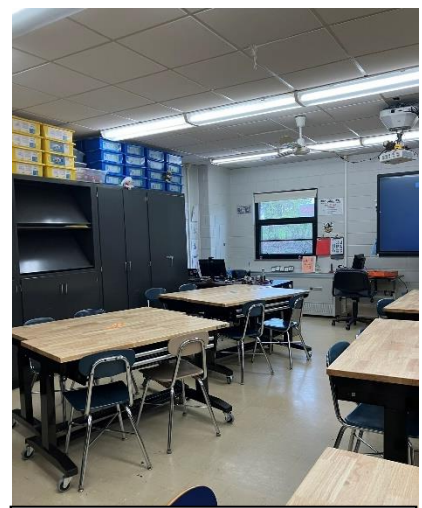
The typical furniture of consistent design, and in generally dated condition consisting of metal frame student desks and chairs, teacher furnishings, filing, free standing bookshelves, reading tables, computer workstations and other typical classroom furniture. Wood tables with chemical resistant work surfaces were observed in the science rooms.

Classroom Furnishings

Replace older, non-uniform, and obsolete furnishings with new items.
