Facility Assessment Update of Hambden School – Operations Building

Located at: 13871 Gar Highway, Chardon, Ohio 44024

May 2024

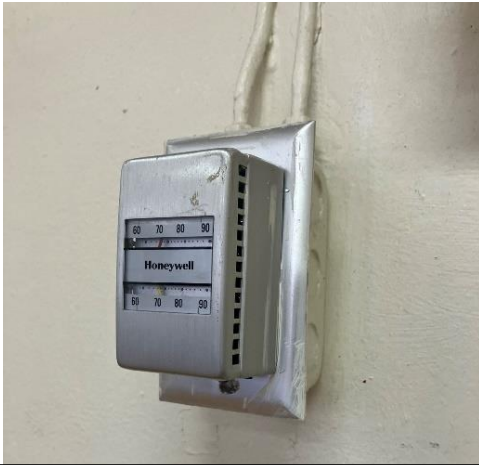
Thermostat

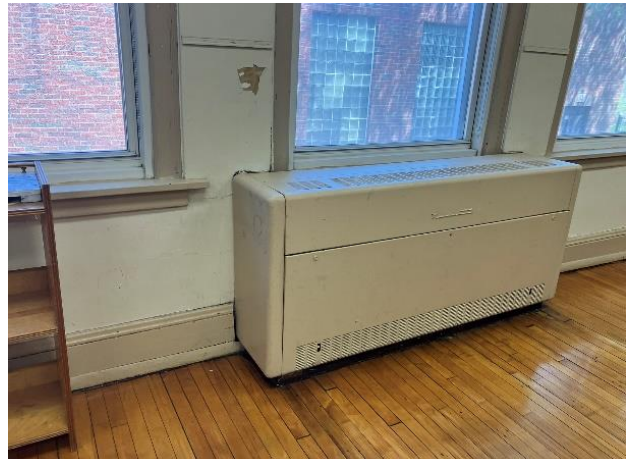
Unit Ventilator

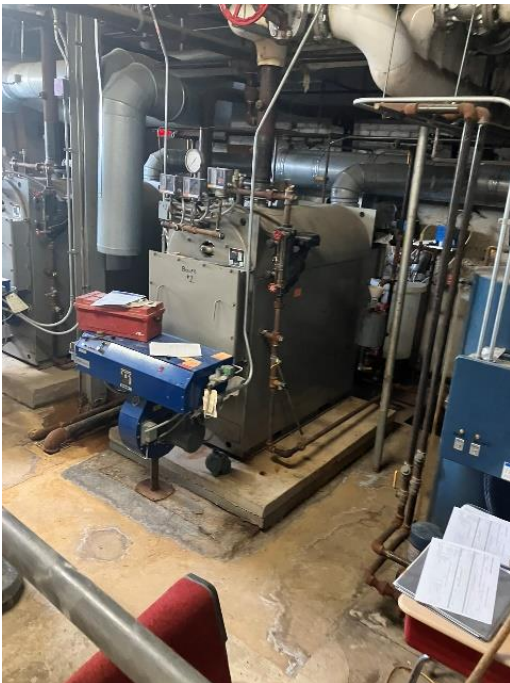
Boiler

Provide a new overall heating, ventilating, and air conditioning system to achieve compliance with OBC and OSDM standards. The heating system has exceeded its expected service life of 35 years. Replace the entire heating system and add air conditioning. The new ducted system will likely require architectural soffits to accommodate the installation of the ductwork.

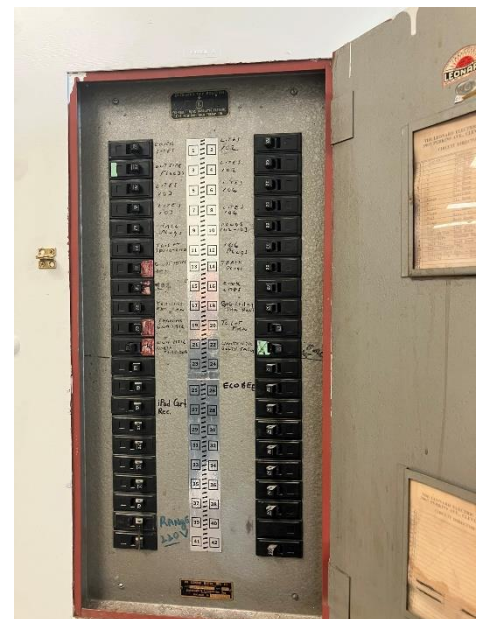
Electrical subpanel

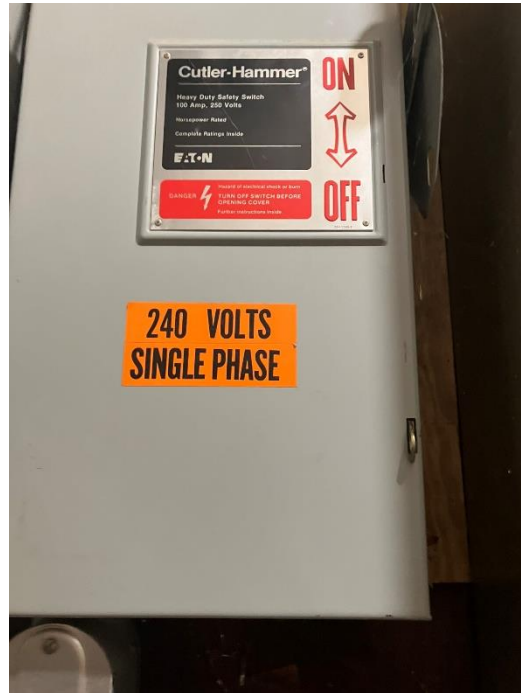
Service is single phase

The entire electrical system requires replacement to meet OSDM guidelines for overall capacity due to age. Work outlined as a Priority 3 is to be coordinated with associated work outlined in Item A and Item U. Upgrade service to 1200 amp, 208/120, 3 phase 4 wire minimum per OSDM guidelines.

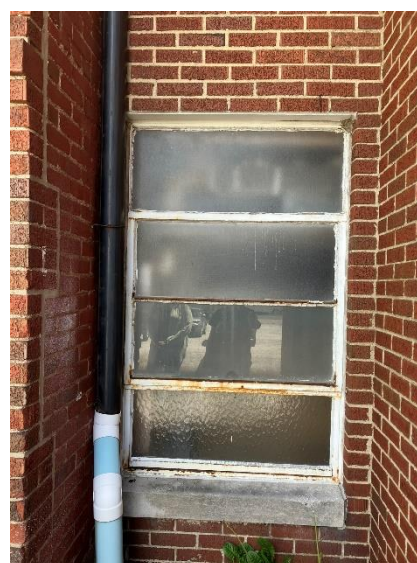
Single pane window

Provide for replacement of the remaining old single pane window system.

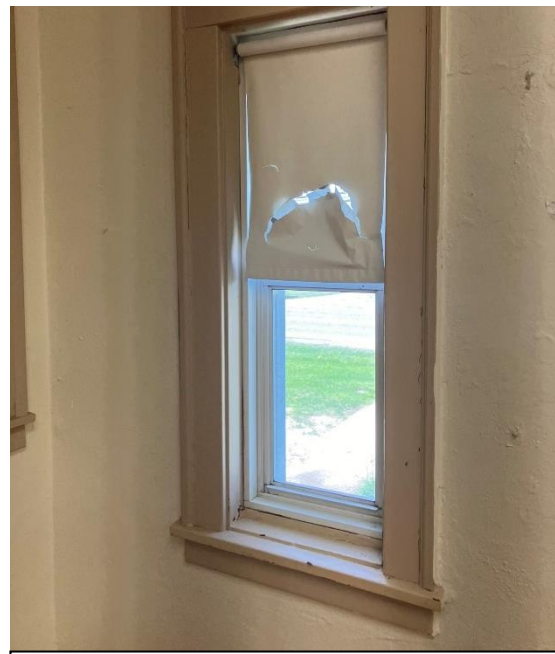
Damaged window blind

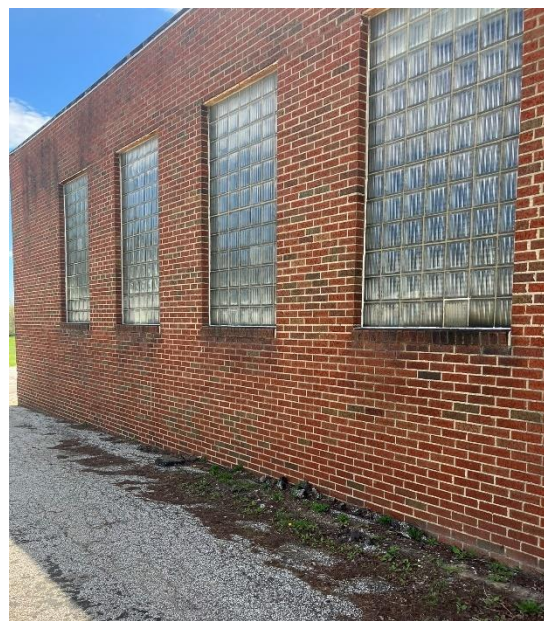
provide a water-tight closure against the frame. Glass block was observed around the gymnasium. Several repairs to seals and mortar were observed around the glass block. The majority of the windows are in poor condition and are a source of energy loss to the building. The windows are provided with surface-mounted shades and blinds, many of which are in poor or damaged condition. No skylights were observed. There is not a greenhouse associated with this facility.

Glass block windows

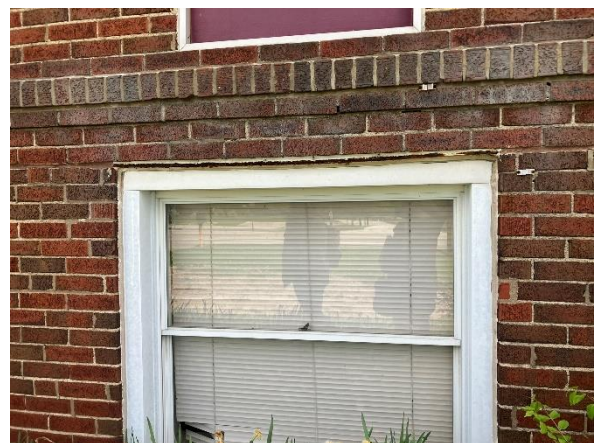
Tuckpointing is required on all building portions. Lintels are rusted and delaminating in some locations. Brick and stone sills require repairs and/or tuckpointing at sill joints in various locations.

Rusted delaminating lintel

Replace stone coping around the original building. Provide new aluminum coping in all other areas in conjunction with roof replacement. Replace delaminated lintels.

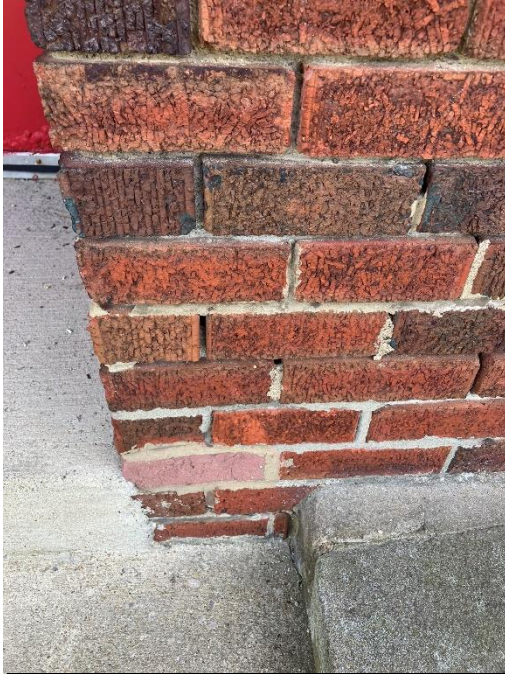
The building is framed throughout with load-bearing masonry with a face-brick exterior. Numerous running cracks were observed around the exterior walls. Potentially, these cracks are likely the result of previous seismic activity in the area. Exterior patch repairs were observed in many of these instances. Engineering analysis should be performed on the building to determine further remedial action beyond the scope of this assessment. Only limited control joints were observed. Stone coping around the original building was observed to be covered with roofing applications and missing joint sealant in many instances. Areas of mortar loss were observed at the parapets of the 1922-era building.

Mortar deterioration

Provide masonry and sill tuckpointing, sill replacement as needed, as well as cleaning and sealing of the entire masonry façade.

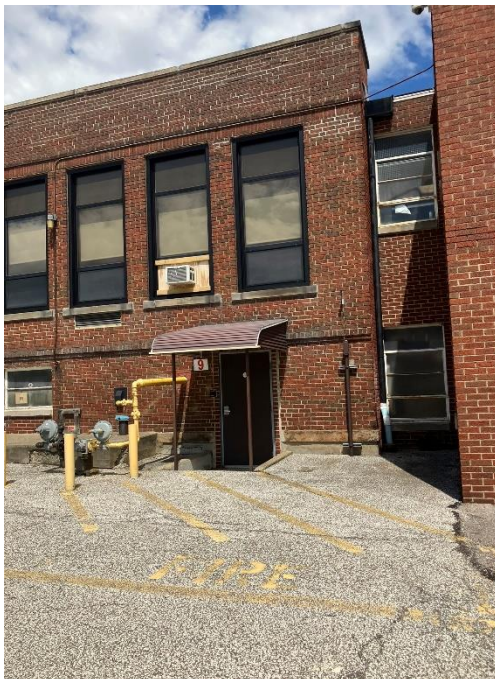
Rusting lintels

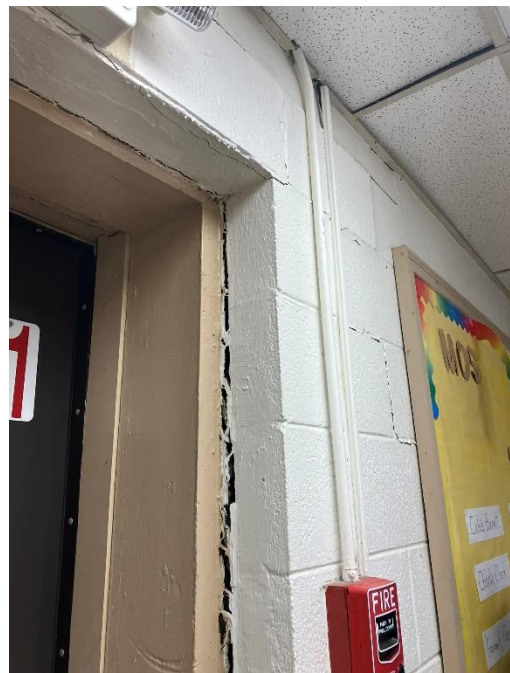
Interior wall cracks

Interior walls are concrete masonry, glazed block units, brick, and plaster, and range in condition from poor to good condition. Some interior wall cracking was observed and may be related to the 1986 earthquake.

Provide infill of brick @ unit vent voids when HVAC system is replaced. Install control joints.

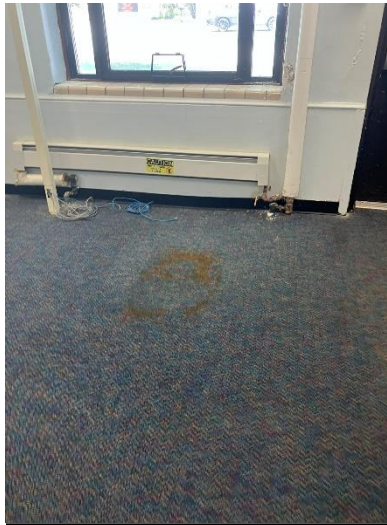
Carpet stain in office area

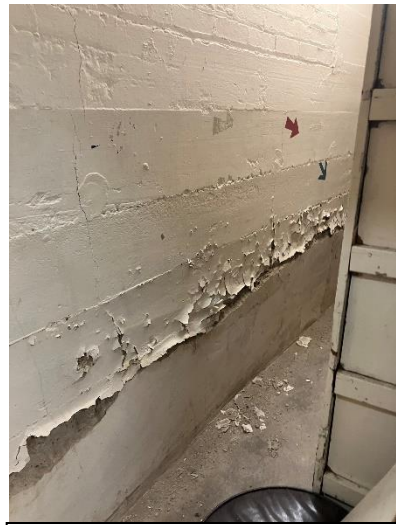
Peeling paint

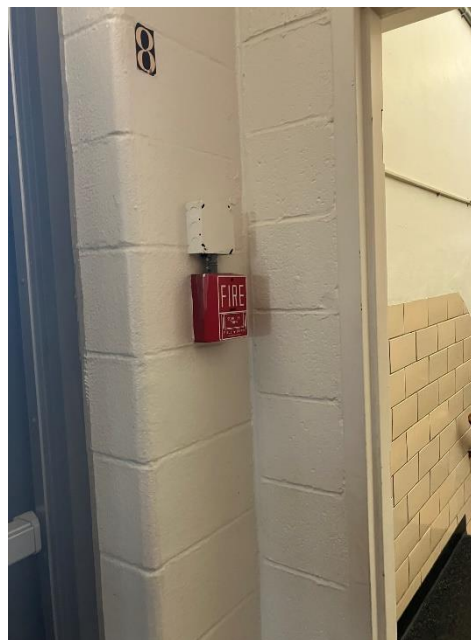
The fire alarm system is a 1992 Silent Night zoned type system and is remotely monitored by Vector Security. There is not an adequate number of horn/strobe units. The existing system does not have enough capacity to add additional horn strobes or duct fire suppression system detectors for the shutdown of air handling equipment to meet NFPA and OFCC standards. It is not likely that the current system would accommodate the addition of an upgraded fire suppression system.

Fire alarm panel

Provide for replacement of fire alarm system.

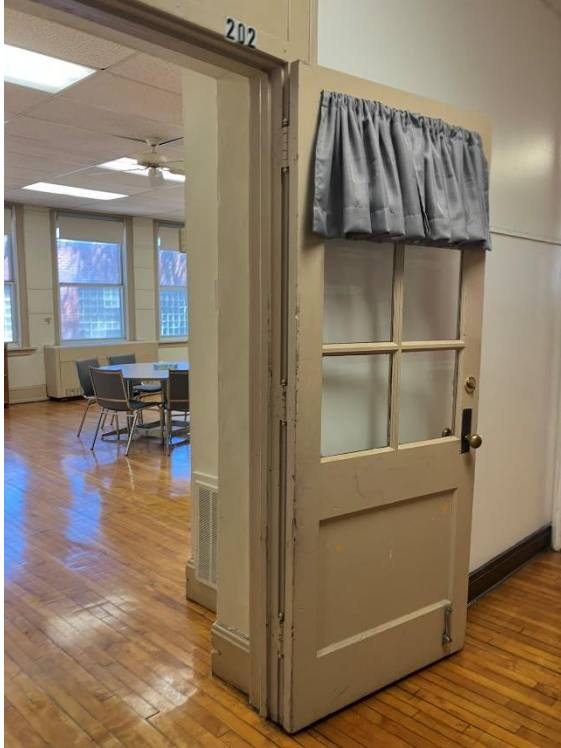
Bldg. lacks ADA door hardware and signage

Provide ADA compliant large group restrooms fixtures. Provide a 2-stop elevator for ADA accessibility, lift at gym, interior door replacement, and ADA signage.

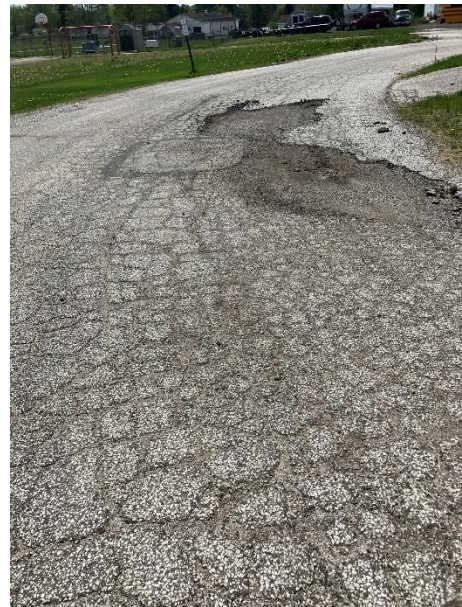
Asphalt in very poor condition

Provide for sidewalk and asphalt replacement throughout the site.

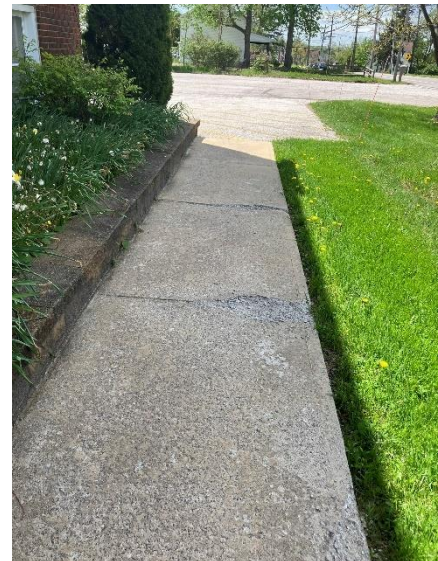
The sidewalks are a mix of ages and conditions from fair to poor. Many areas were observed to have large holes, cracking and/or uneven, which could pose tripping hazards. Sidewalks and asphalt drives are placed logically for pedestrian and vehicular circulation patterns.

Sidewalk in poor condition

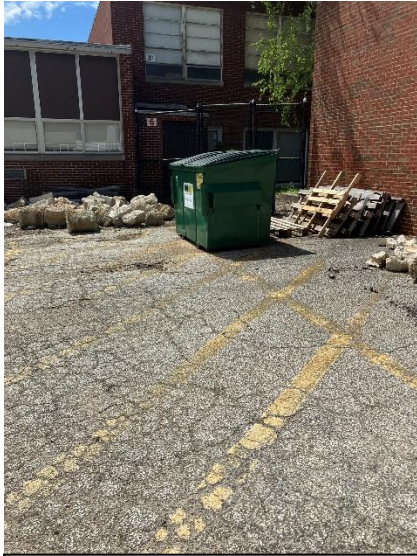
Dumpster on asphalt

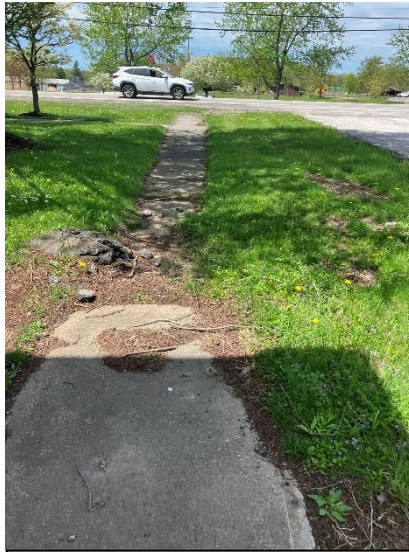
Sidewalk settling

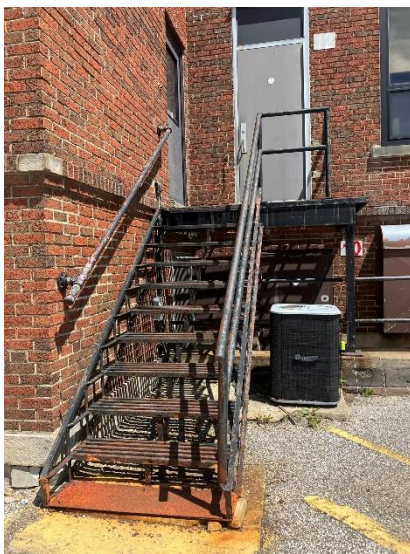
Exterior stair in poor condition

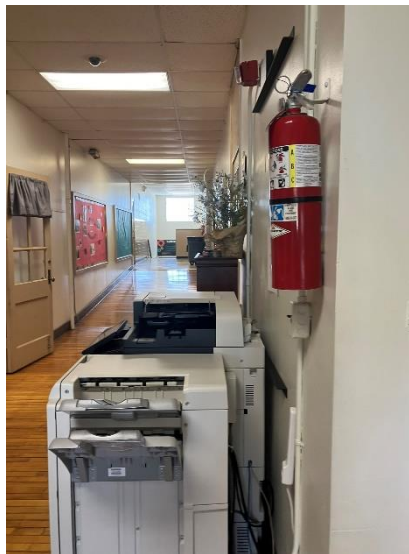
Fire extinguisher mounted too high, obstructed by copier

Provide a complete sprinkler system that includes a new dedicated fire water supply system. Provide new handrails/guardrails as needed. Provide fire extinguisher cabinets throughout the buildings. An emergency generator is provided via complete electrical system replacement in Item D.

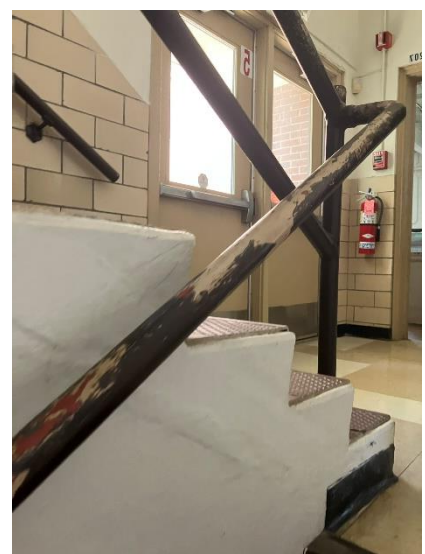
Handrails not compliant with current code
