Facility Assessment Update of Chardon Early Learning Center (formally Maple Elementary School)

Located at: 308 Maple Ave., Chardon, Ohio 44024

May 2024

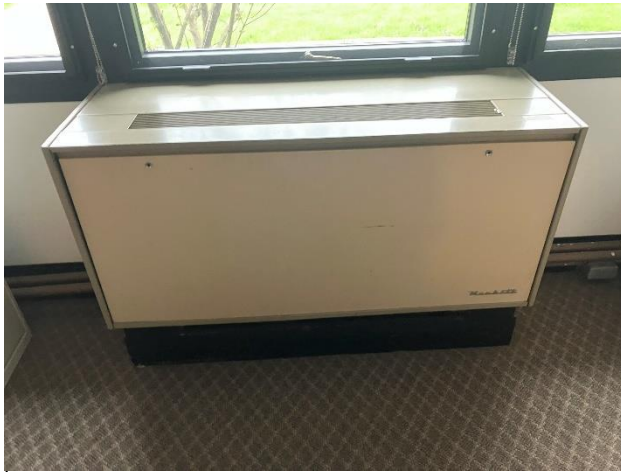
The existing system of the building is comprised of two 1996 Bryan water boilers in fair condition. Unit ventilators are used to provide heat and ventilation in most of the classrooms. The equipment in the building does not provide the required outside air delivery to meet OBC mechanical code. The system temperature controls pneumatic-type thermostats with DDC controls in fair condition. The structure is not equipped with air conditioning for the overall facility. The two-pipe system does not provide a capacity for simultaneous heating and cooling operation which is not compliant with the OSDM requirements. According to school officials, the site does contain an underground abandoned fuel tank that has been filled with sand.

Unit ventilator

Provide a new overall heating ventilating and air conditioning system to achieve compliance with OBC and OSDM standards. The new ducted system will likely require architectural soffits to accommodate the installation of the ductwork. This work is outlined as Priority 3.

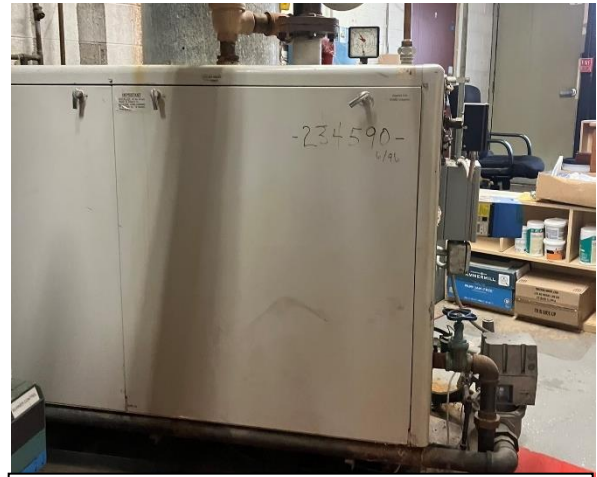
Mechanical equipment

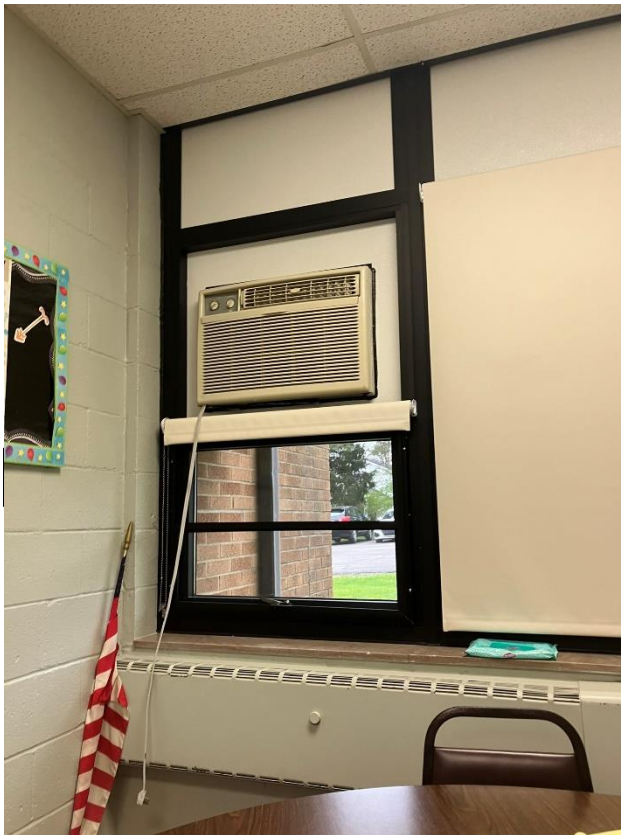
Window A/C unit in administration room

There is no central ducted air conditioning system for this building. Limited air conditioning is provided by indoor units and window units for the office area, with window units for the library and teacher's lounge. The overall system is not compliant with OSDM requirements. The general building exhaust systems located in the restrooms and gym are functional and in satisfactory condition. Since the school converted to an Early Learning Center for grades PK-K, the kiln has been removed and is no longer present (formally had one without proper exhaust). Also due to the current grade configuration, no considerations are needed for paint hoods, science chemical hoods, etc.

Existing units have exceeded their expected service life of 15 years. Provide an air conditioning system to meet OBC and OSDM requirements. Cost included in A. Heating System section.

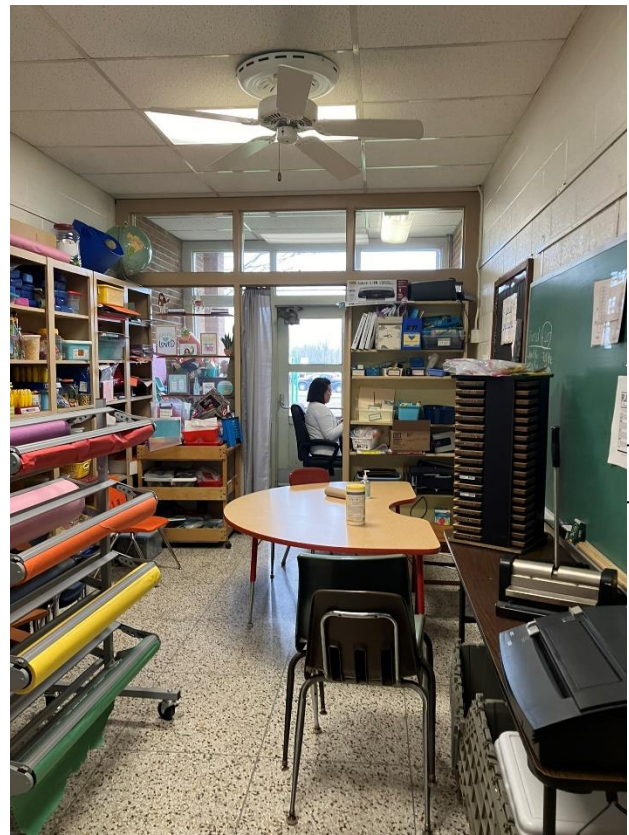
Most rooms have ceiling fans for air movement

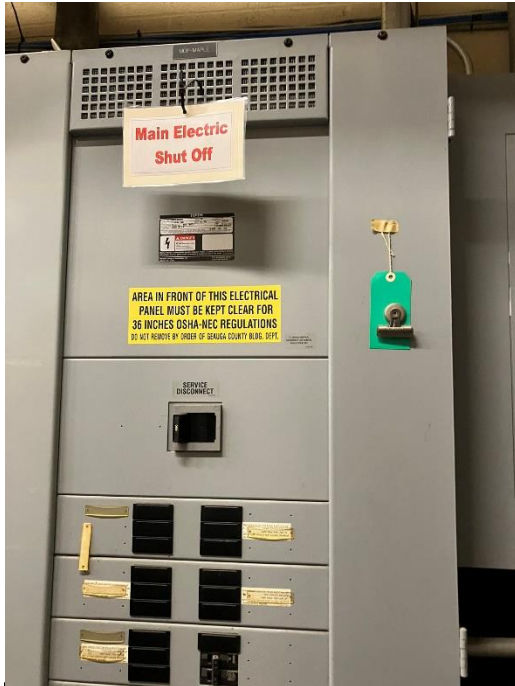
The overall electrical system does not meet OSDM requirements in supporting the needs of the school. The electrical system in the overall facility is a 240/120 volt, 1 phase 3 wire electric service, 400amp was the original in 1955, and with the addition of 600 amp in 1999 to support the new computers at the school, presently a 1000-amp electric service. The existing system is not capable of supporting the new HVAC system. There is no lightning protection. The overall electrical system does not meet OSDM requirements in supporting the needs of the school.

Electrical main panel

The entire electrical system requires replacement to meet OSDM guidelines for overall capacity due to age. Upgrade service to 1200 amps, 208 volt, 3 phase, 4 wire system minimum per OSDM guidelines. Work outlined as a Priority 3 is to be coordinated with associated work outlined in Item A and Item U.

Provide complete electrical system replacement.

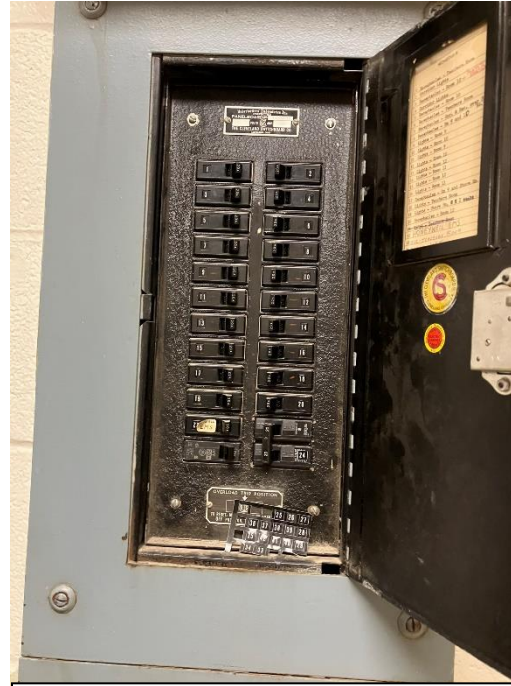
Electrical subpanel

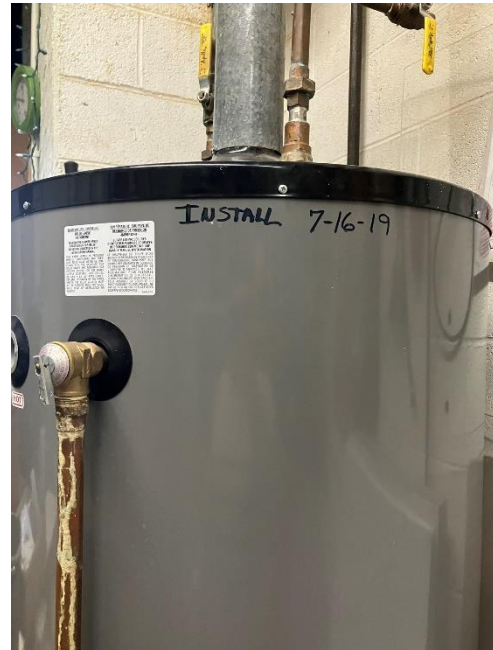
Electric hot water heater

Provide for replacement of urinals and toilets to meet low flow requirements for OFCC/LEED (ADA-required units are outlined in Item O). Replace the electric water cooler. Install a backflow preventer. Replace the hot water heater.

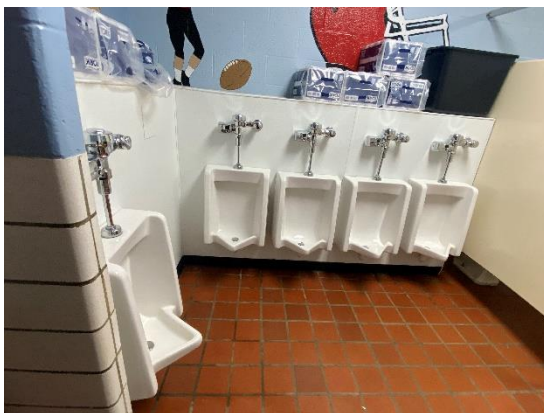
Urinals have new flush valves

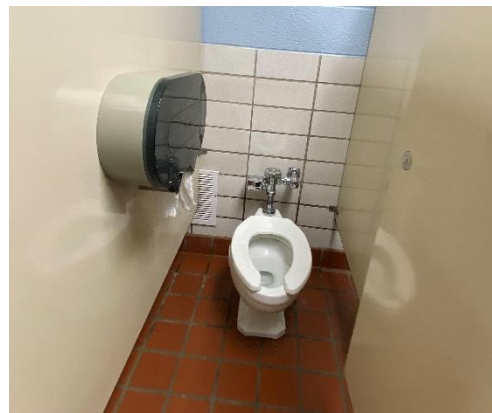
Floor mounted toilet

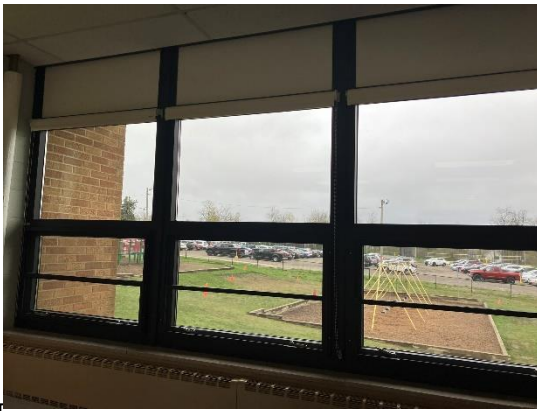
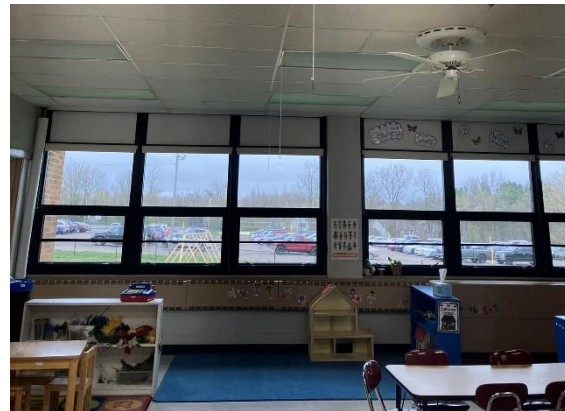
Approximately 2 years ago, the district replaced all the windows in the overall facility. The new windows are an aluminum frame, thermally broken system with double glazing. During the replacement, the district removed the former 2 opaque panels that were part of each 3-ganged window system, restoring the original design intent which brings in an abundance of natural light. The windows are equipped with surface-mounted blinds in good condition. The typical classroom windows are awning-type on the lower panel with insect screens, and the top panels are fixed. Window hardware is in good condition and no problems of operation were reported. There are no skylights in the building. There is not a greenhouse associated with this school.

New windows

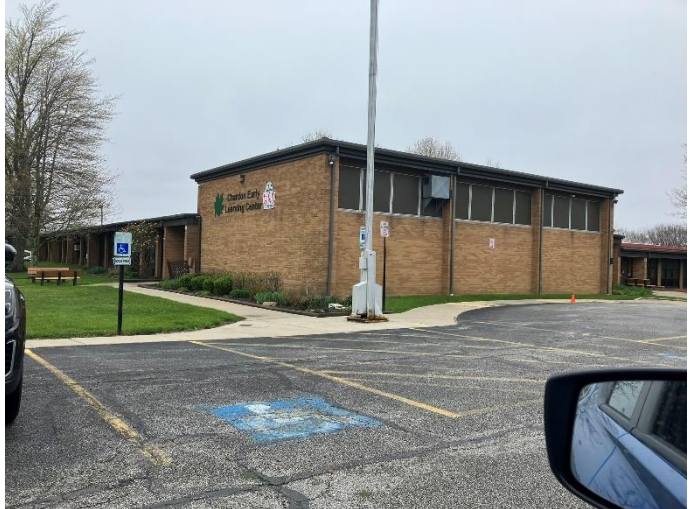
The overall facility has brick veneer on load-bearing wall system which displayed no locations of spalling or deterioration and is generally in good condition. Brick veneer masonry walls are not cavity walls. The exterior masonry shows no evidence of mortar deterioration. It does not appear, however, to have been recently cleaned and sealed and stains were noted in several locations. No areas of efflorescence were observed. There are no major elements of exterior accent materials on the exterior other than metal fascia between the top of the windows and the bottom of the roof line. Installation of the new HVAC systems recommended in Item A will result in the removal of existing unit ventilators, necessitating the exterior masonry infill of associated exterior wall voids. Steel lintels are in fair condition.

Brick needs cleaning & sealing

As a Priority 3, provide masonry cleaning and sealing, as well as infill brick at unit vent openings in coordination with HVAC replacement outlined in Item A.

Provide infill of brick @ unit vent voids when the HVAC system is replaced. Provide masonry cleaning and sealing.

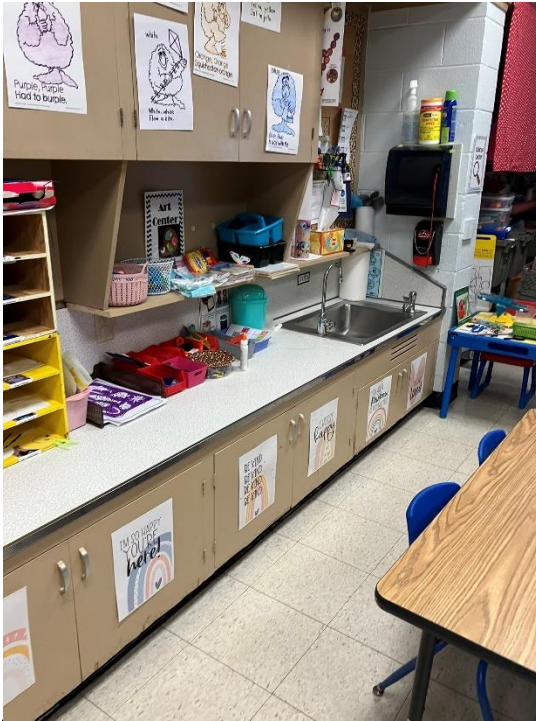
Classroom casework

Provide complete replacement of finishes and casework, basketball backboard replacement, additional wall insulation, and replacement of warming kitchen equipment. See Item O for ADA requirements for interior door replacement.

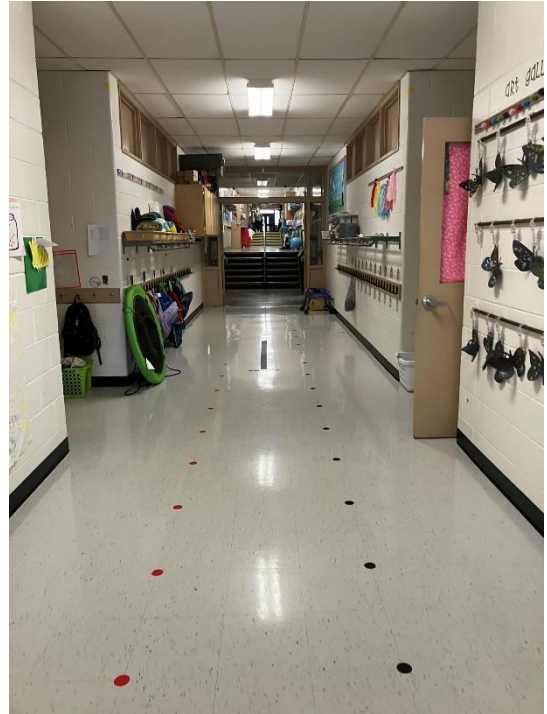
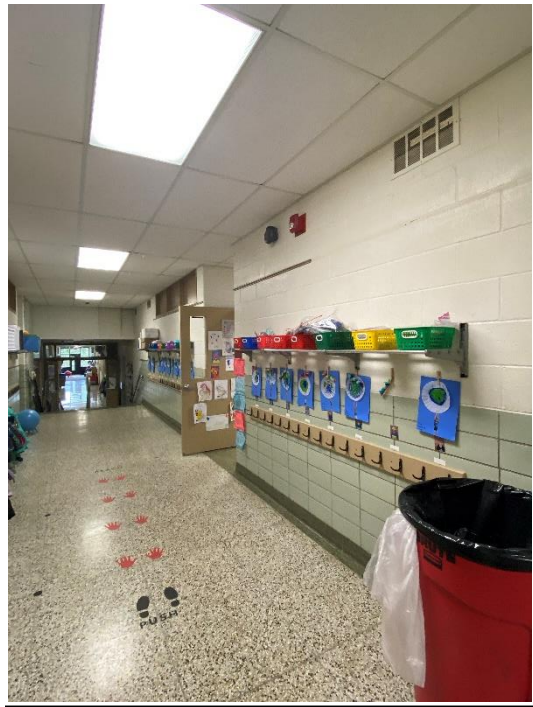
The corridors feature both terrazzo and VCT flooring, painted & glazed block walls, and 2' x 4 lay-in ceiling tiles which are in fair/good condition. The terrazzo has evidence of water wicking up through the floor as mentioned in Item G. Coat hooks with a shelf above are provided in the corridors for storage of students' outdoor clothing materials and bookbags/lunchboxes. The classroom doors are the original metal doors, are a combination of non-recessed and recessed depending on which building portion you are in and have been retrofitted with ADA-compliant door hardware. The doors are in dated condition.

Corridor finishes

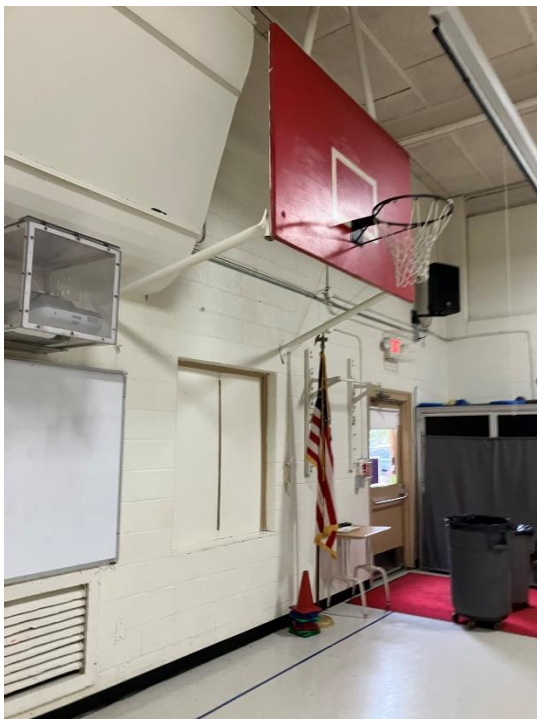
Gym basketball backboard/hoop

The school has a combined gymnasium/student dining space that is equipped with VCT flooring, painted block walls, and an exposed tectum ceiling structure. There is no stage provided. There are 2 dated basketball backboards/hoops that should be replaced.

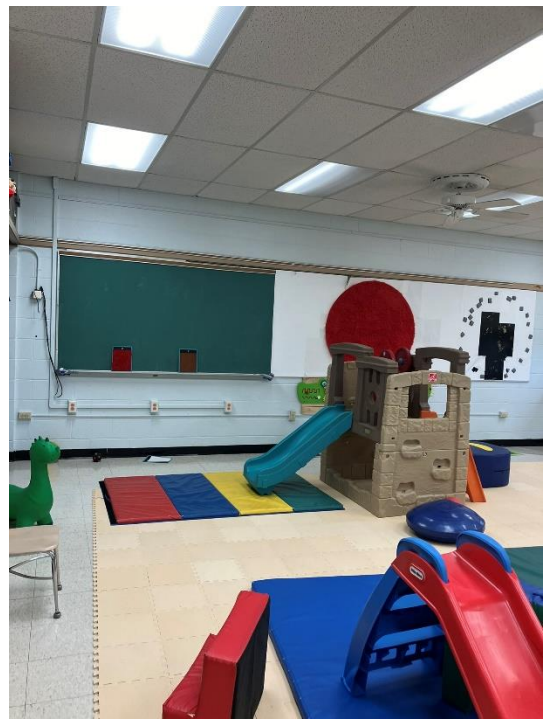
Classroom finishes

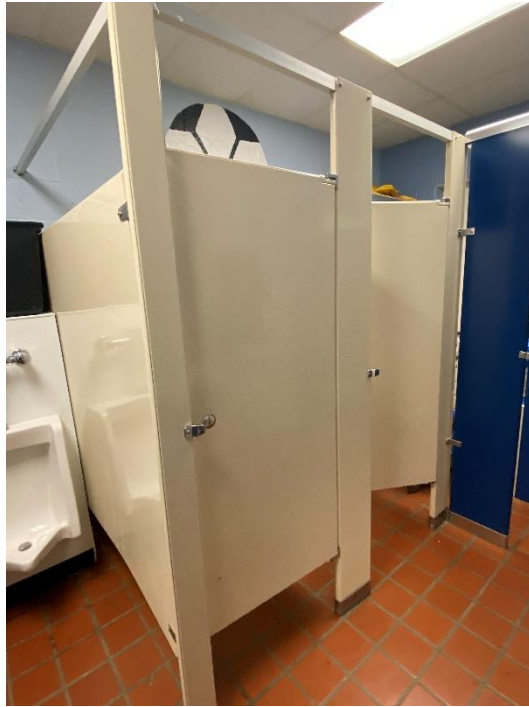
Large group restroom finishes

The restrooms feature quarry tile flooring, glazed and painted block walls, and 2' x 4' lay-in acoustical ceiling tiles that range in condition. The toilet partitions are metal and in fair condition.

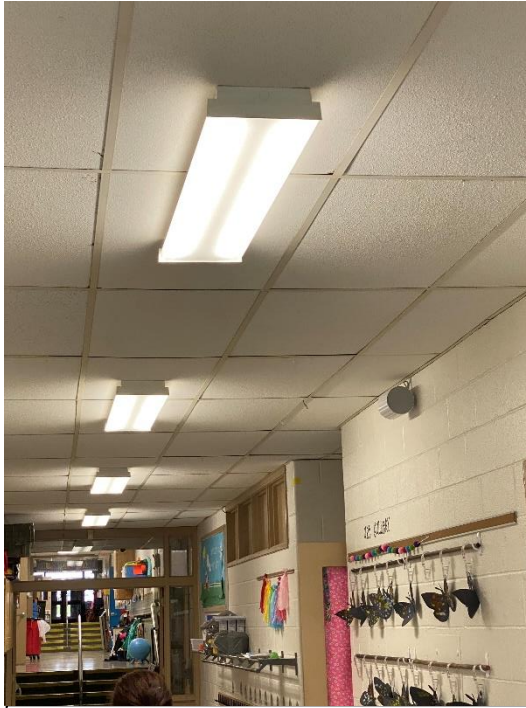
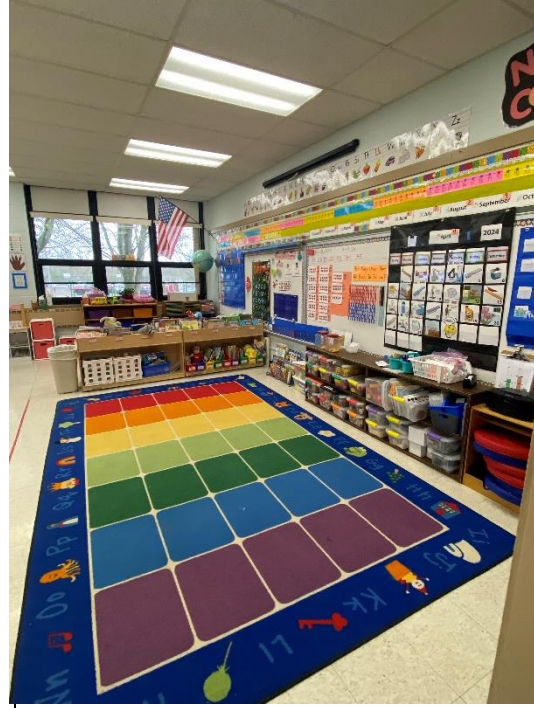
Corridor – New LED lighting

New LED lighting

Although all new LED lighting is provided, complete replacement of lighting systems in areas in which they are recessed into the dropped ceilings will be required due to the installation of mechanical systems and fire suppression systems outlined in Items A & U.

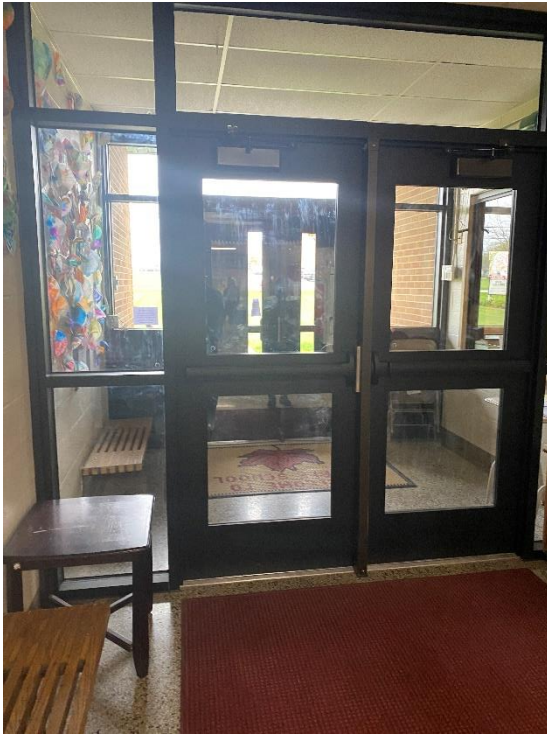
The district has recently installed a secure vestibule at the main entrance for proper security clearance checks on visitors.

Secure Vestibule

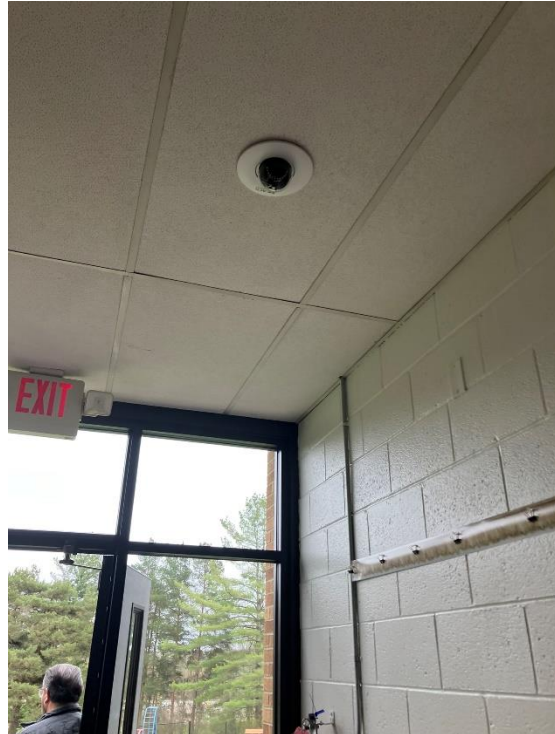
The security system is a 1992 Fire Burglary system maintained by Vector Security. It includes cameras located inside (18) and outside of buildings (11). All school district cameras are connected to the high school recording equipment with 2 weeks of storage. There is a card reader located at the main entrance of the classroom building with 2-way communication and a door release for visitors. Exterior doors do not have position switches.

Security camera

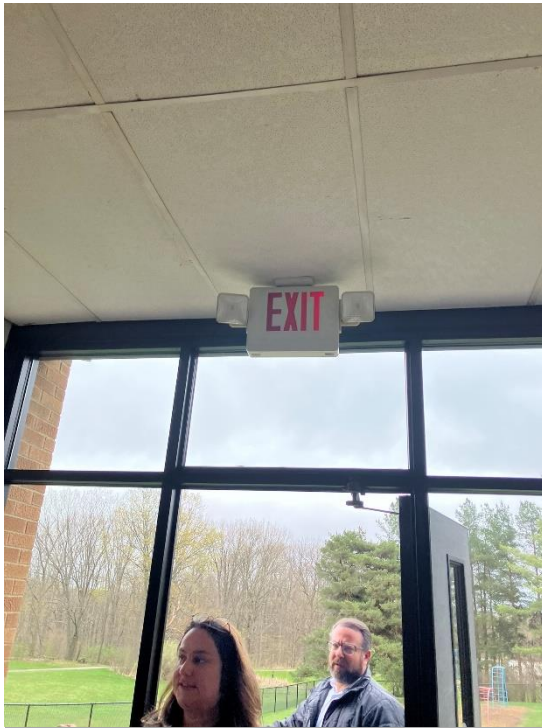
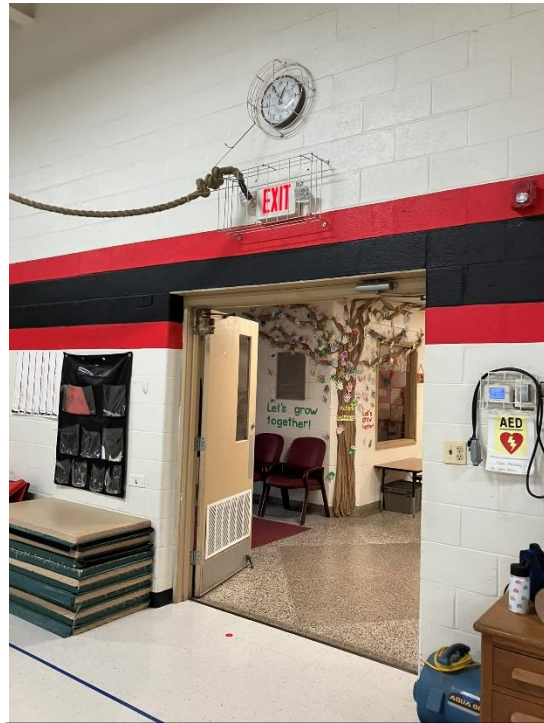
The overall facility is equipped with an emergency egress lighting system consisting of compact fluorescent and LED exit signs, and emergency lighting with battery packs. The system is not adequately provided throughout and is not compliant with OFCC design manual guidelines. There is no emergency generator.

Exit sign/Emergency lighting

Provide a complete replacement of emergency egress lighting due to lack of compliance with OSDM and due to the installation of systems outlined in this report. A new generator is included as part of Item D. Item is recommended as a priority 3 to be coordinated with other system replacements.

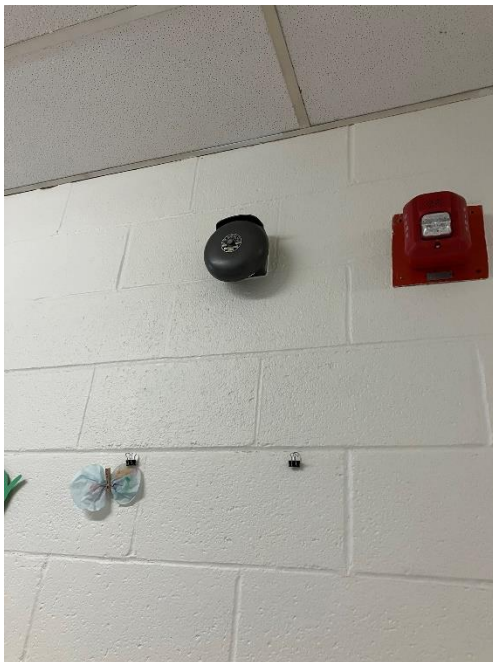
Fire alarm devices

Replacement of the system will be required due to lack of compliance with NFPA and OFCC standards and when the work in A and C- upgrading the ventilation and air conditioning is completed. At that time, the devices would be replaced and added to with addressable devices.

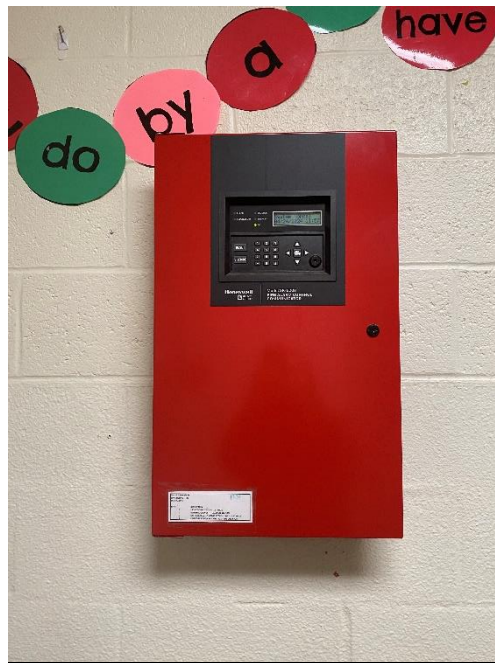
The fire alarm system is a 1992 Silent Night zoned type system (non-addressable) and is annually tested and remotely monitored by Vector Security. The district recently performed upgrades to the main panel, however, there is not an adequate number of horn/strobe units. The existing system does not have enough capacity to add additional horn strobes or duct fire suppression system detectors for the shutdown of air handling equipment to meet NFPA and OFCC standards. It is not likely that the current system would accommodate the addition of a fire suppression system.

Fire alarm control panel

Provide for replacement of fire alarm system.

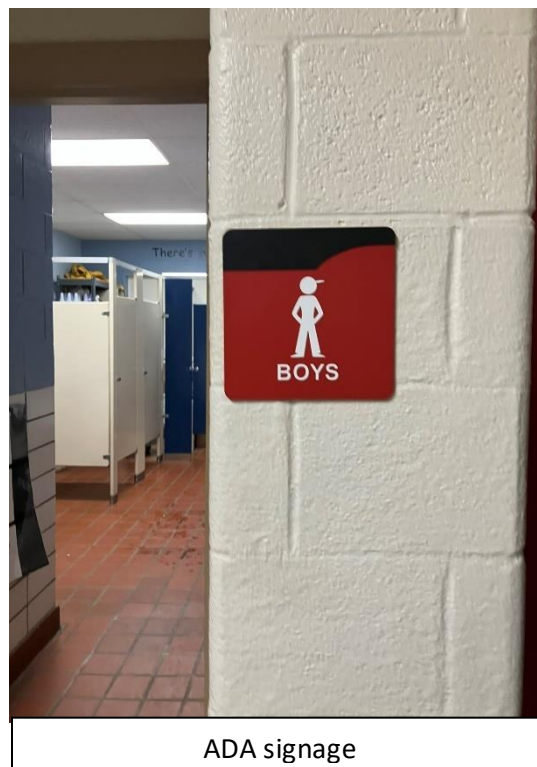
ADA signage

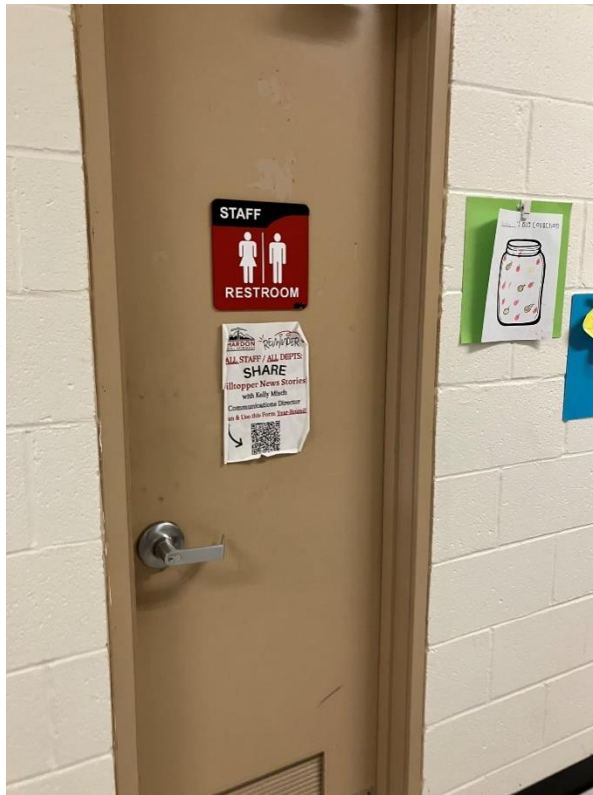
Doors retrofitted with ADA hardware

Provide replacement of restroom fixtures as outlined in Item E. for ADA requirements. Provide an ADA power door assist. Although the building has doors that are retrofitted with ADA hardware, the doors themselves are dated and should be replaced. Additionally, 6 doors require wider openings. Provide ADA signage in the building. Restripe/configure one parking space for ADA purposes (includes sign).

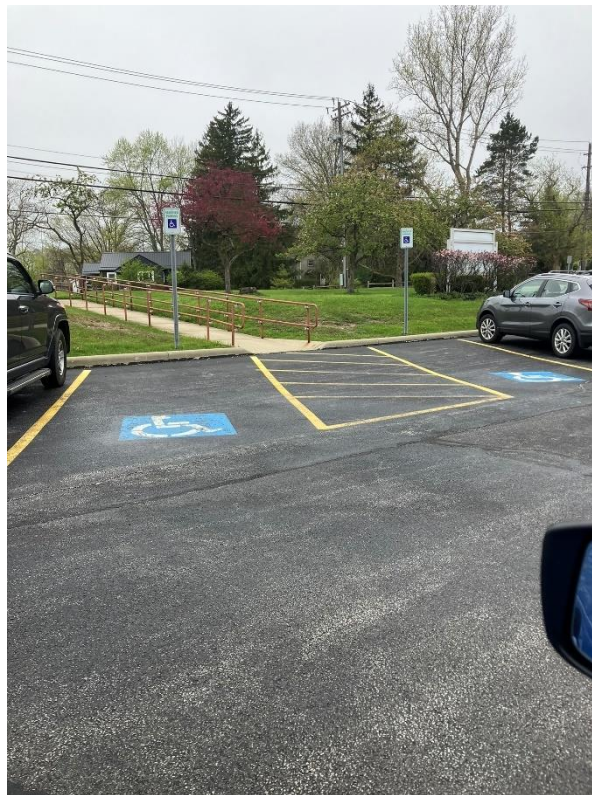
There is no ADA power door assist at the main entrance. In the parking lot, there are 62 regular parking spaces and 2 ADA spaces provided. ADA

requires 3 ADA parking spaces to be provided when there are between 51 and 75 regular parking spaces present.

ADA parking spaces

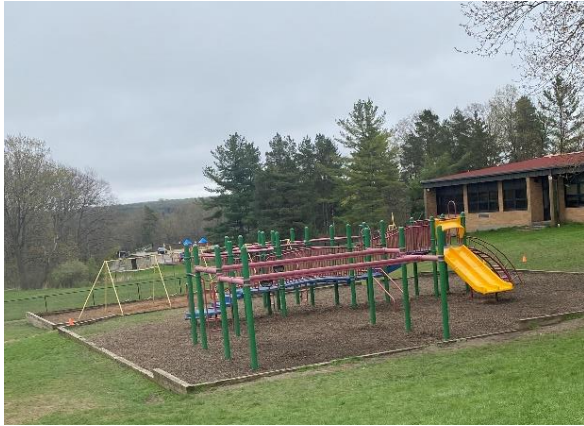
Two main playgrounds are provided, one on the east side of the site and another on the north end of the site. Multiple playground areas are provided on-site. Fencing is provided around the play areas, and it is in good condition. A mix of equipment is present including heavy-duty plastic and older metal pieces. The metal swings were recently provided with a new fall area and mulch. The other play areas, however, need additional mulch, as what is present is not of sufficient depth to meet fall safety guidelines.

Depth/quantity of mulch is insufficient

As a Priority 1, provide for the replacement of the sidewalk adjacent to the cafeteria/gym portion of the school as it is a tripping hazard. Also, as a Priority 1, add additional mulch to sufficient depths in the playgrounds requiring it. As a Priority 2, provide for resurfacing of the asphalt parking lot. As a Priority 3, provide a concrete pad & enclosure for the dumpster, and replace older pieces of playground equipment. Note: OFCC automatically puts in a lump sum for unforeseen circumstances. This allowance remains in this assessment report and is under Priority 3.

Provide adequate depth of wood mulch in the playgrounds and replace cracked sidewalks.

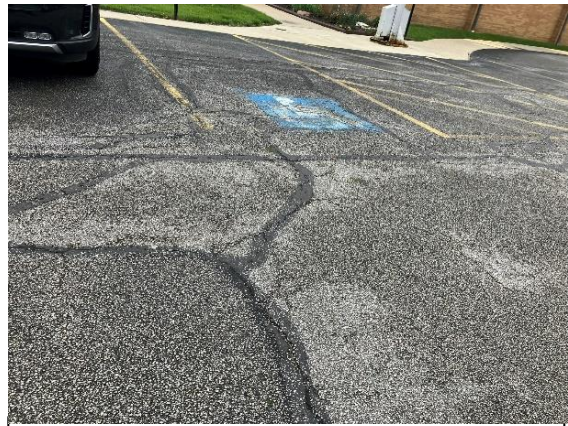
Asphalt in need of resurfacing

Asphalt New Wearing Course: 2,394 SY x \$24.61/SY =	\$58,916.34
---	-------------

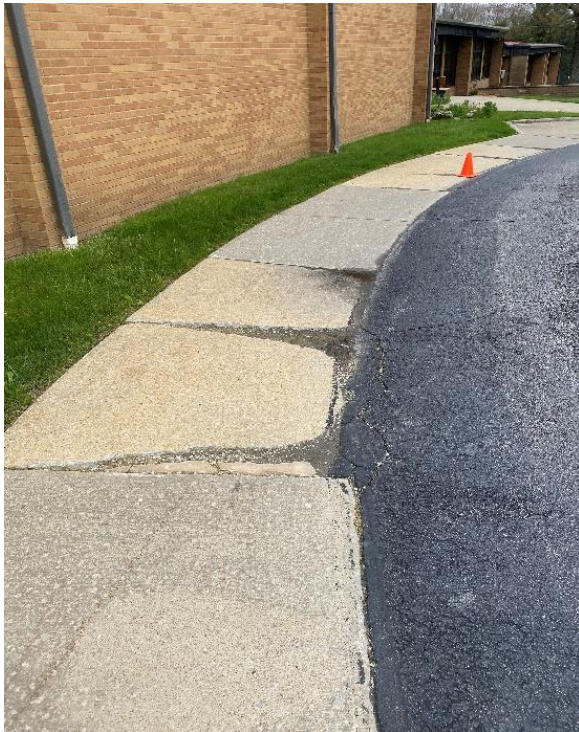
The sidewalks are a mix of ages and conditions from good to poor. The sidewalk area most in need of replacement is the south, curved walk-in front of the cafeteria. This sidewalk has large cracks and could pose tripping hazards.

Sidewalk cracking

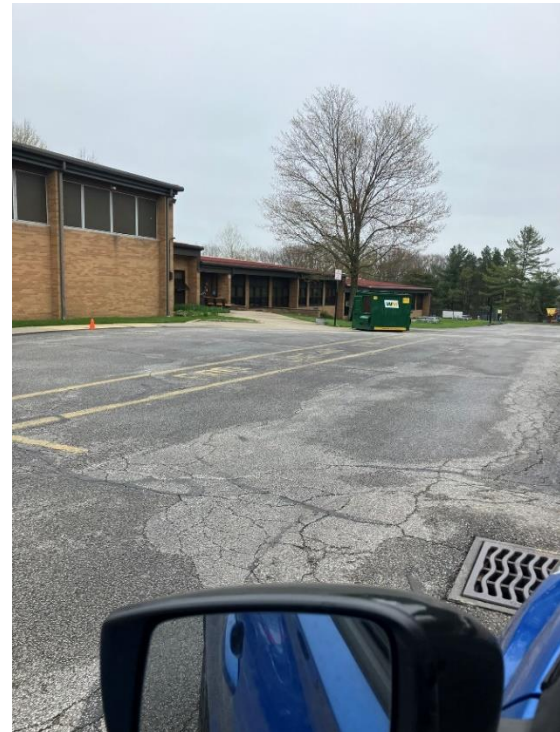
Ample parking is provided on the south side of the building. The asphalt parking lot contains 62 regular spaces and 2 handicapped spaces which is more than the OFCC recommendations for the current grade configuration and enrollment. See Item O for handicapped quantity evaluation and recommendations. The asphalt is becoming worn and in need of resurfacing. Water evacuation is addressed through storm sewers in the parking lot. No issues with parking lot ponding were observed or reported. There is some minor ground erosion at the end of the parking lot. There is no true bus loop at this school, but rather a peel away on Maple St. There is a gravel parking lot to the north of the building, but this is utilized as student parking for the high school across the street. A dumpster is located on the south side of the school near the main entrance. It is not provided on a dedicated concrete pad nor is provided with any enclosure.

Asphalt parking lot on south side of school

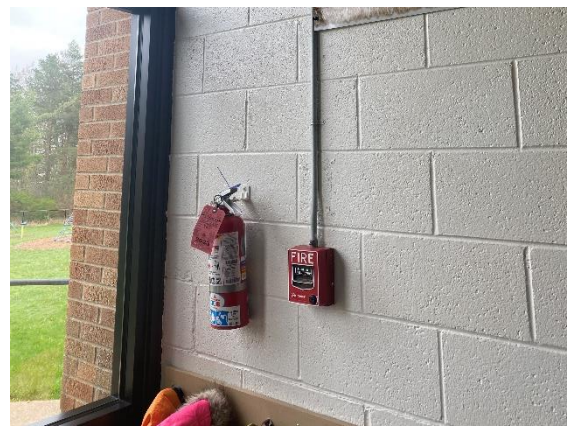
Fire extinguishers are provided throughout the building, though are not provided with ADA-compliant, through-the-wall cabinets. The facility is not equipped with an emergency generator. The existing water supply system cannot support the installation of a sprinkler system. Rooms with a capacity greater than 50 occupants are equipped with adequate egress. The school is not equipped with an emergency generator.

Wall mounted fire extinguisher

Provide a complete sprinkler system and dedicated fire line. Provide through-the-wall fire extinguisher cabinets at ADA heights. An emergency generator is provided through recommendations of complete electrical system replacement outlined in Item D. Note: This work is recommended as a Priority 3 to coordinate the timing of HVAC & electric replacement.

Provide an automatic fire suppression system throughout the facility and a dedicated water line connection. An emergency generator is provided in Item D: electrical system as part of the complete system replacement costs. Provide new fire extinguishers through the wall cabinets at ADA height.

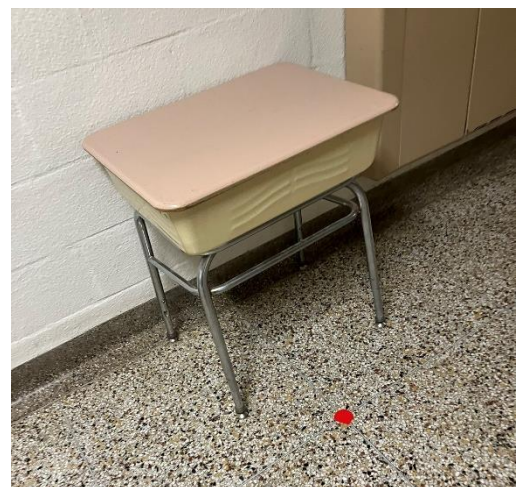
Dated desk

Replace outdated, worn furniture.

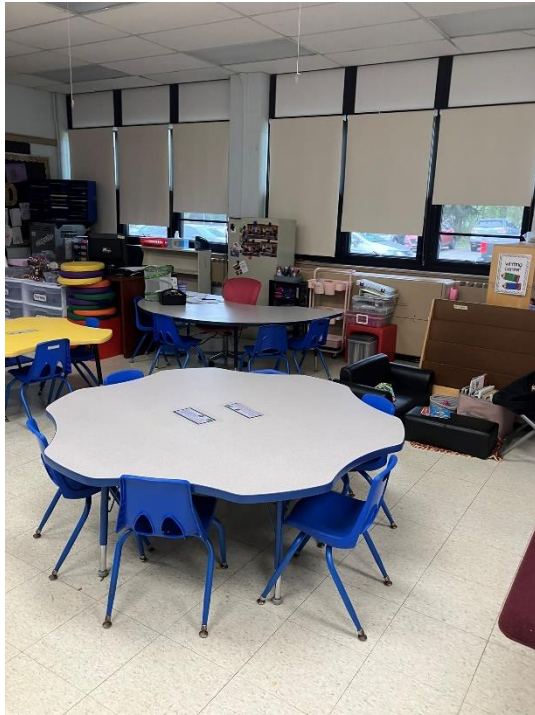
Newer furnishings

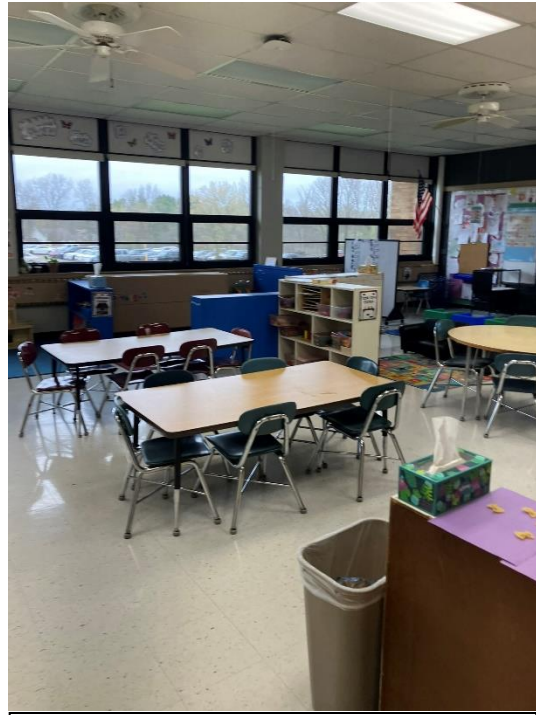
Older pieces

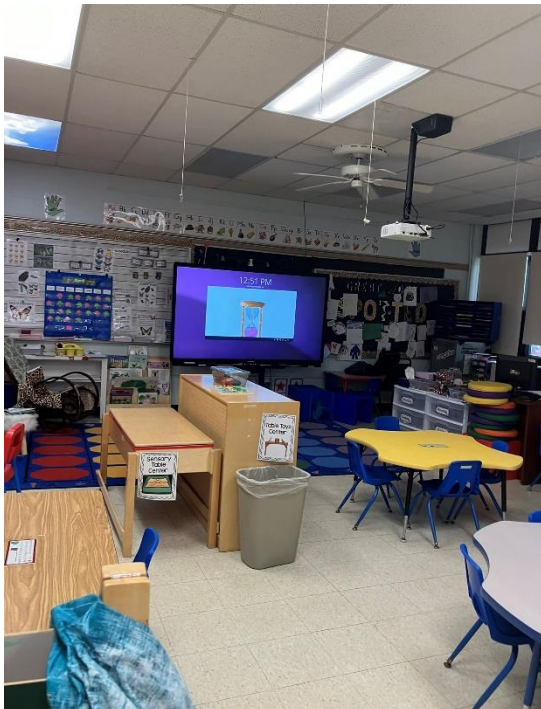
New interactive board in typ. classrooms

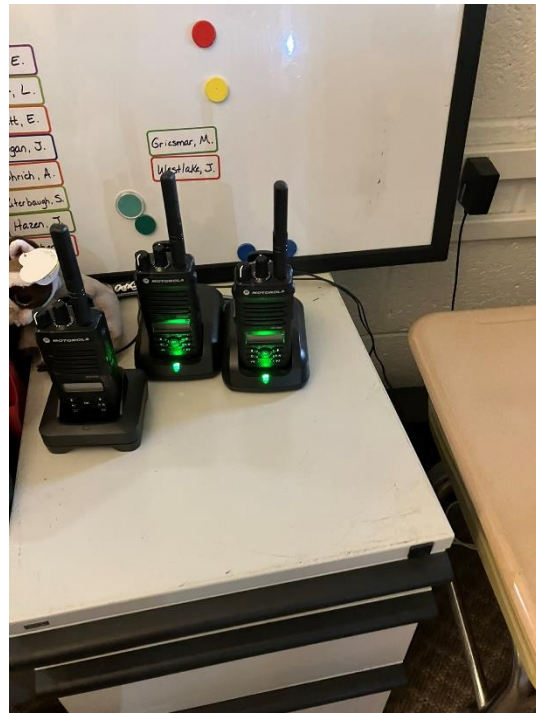
Walkie-Talkies
