Facility Assessment Update of Munson Elementary School

Located at: 12687 Bass Lake Rd. Chardon, Ohio 44024

May 2024

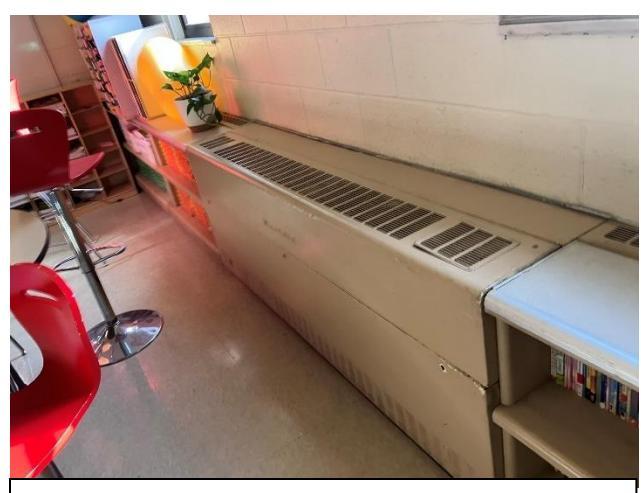
Unit ventilator

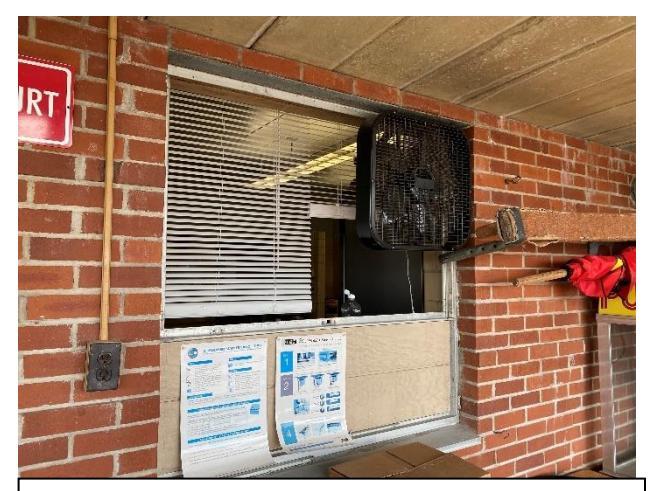
Fan in administration window

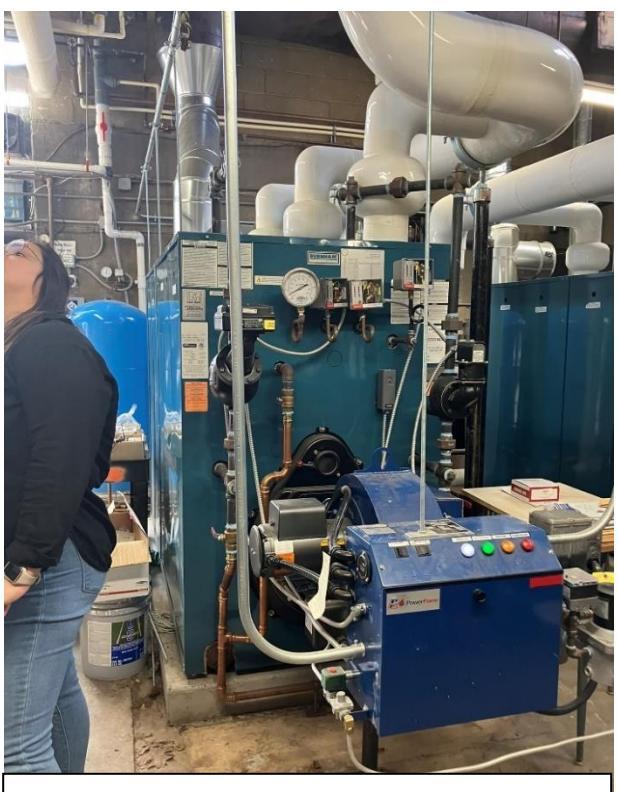
New boilers

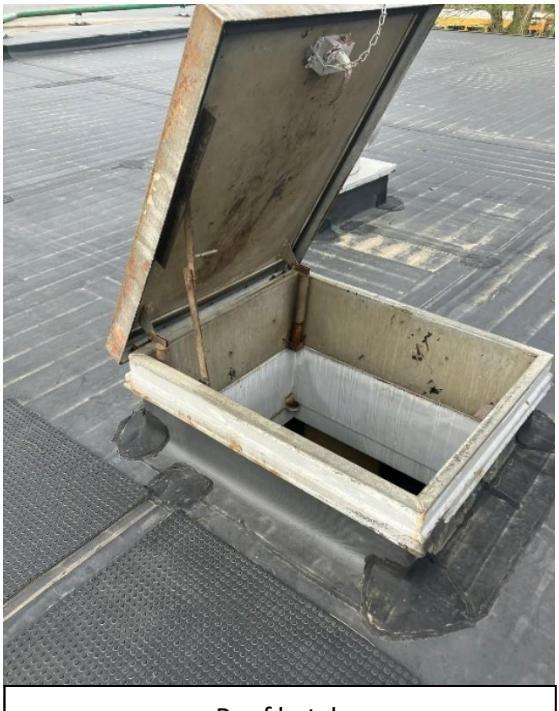
There were no observations of significant areas of standing water on the roof during the physical assessment. There are no overflow drains or scuppers on the roof. Roof access was gained via a roof hatch that is in fair condition and operating properly. Fall safety protection

Roof hatch

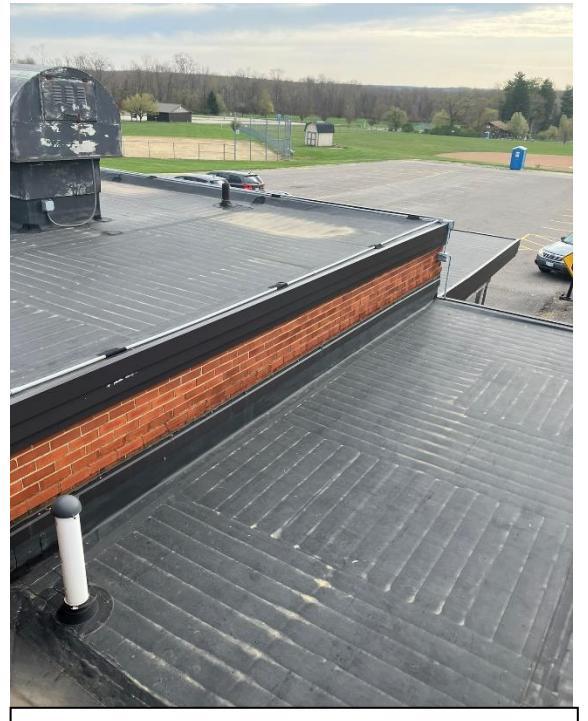
Roof system is in good condition

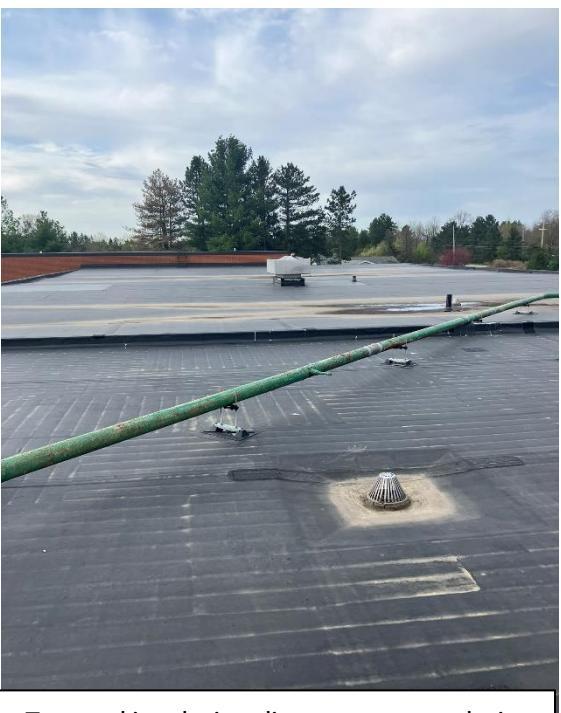
Tapered insulation directs water to drains

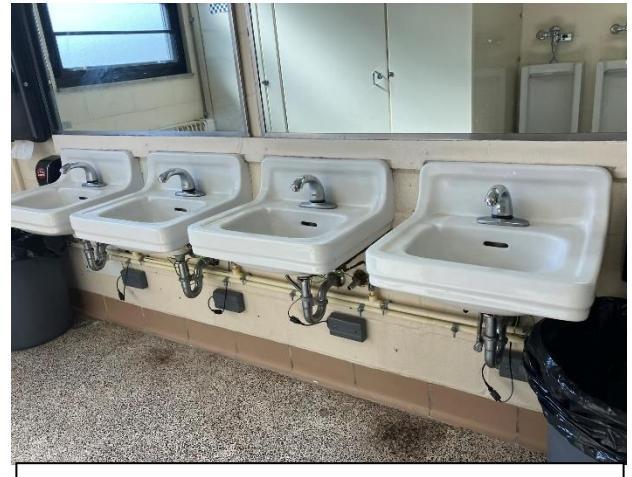
Sinks with new touchless faucets

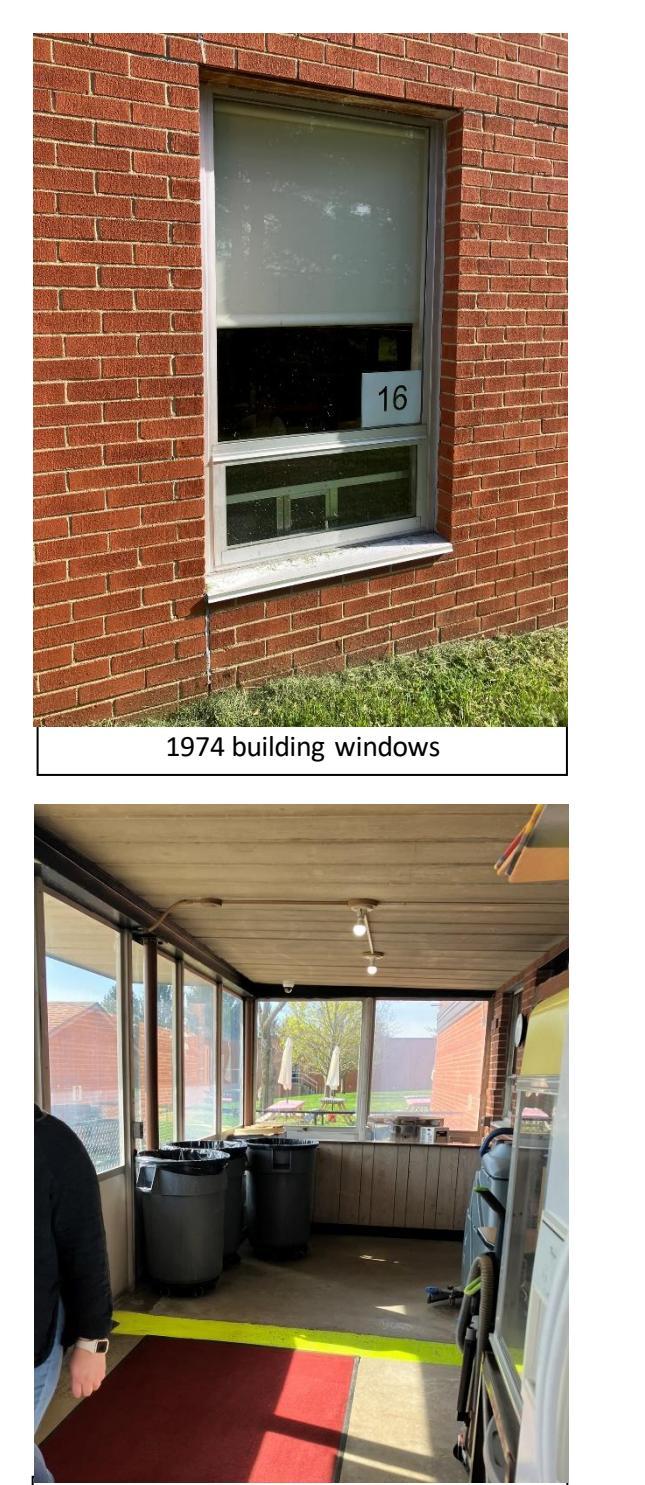
The overall facility is equipped with a variety of window systems for different ages. The classrooms in the 1955 building contain new thermally broken, aluminum frame, awning type windows with double insulated glazing and they are in good condition. Both the lower and clearstory windows in the 4 classrooms were replaced. The windows are equipped with surface-mounted blinds in good condition. There are still some original windows in the 1955 building, however, in the breezeway adjacent to the kitchen and the boiler room. These windows are single pane, aluminum, and steel frame windows and are in poor condition and a source of energy loss to the building.

Old single pane windows in Orig. Bldg.

Provide for replacement of all old, single pane window systems in the Original Building due to age and condition. All work is recommended as a Priority 1 to ensure the building being warm, safe, and dry as a priority.

<u>Priority 1 Recommendation:</u> Provide for replacement of the remaining old single pane window system.

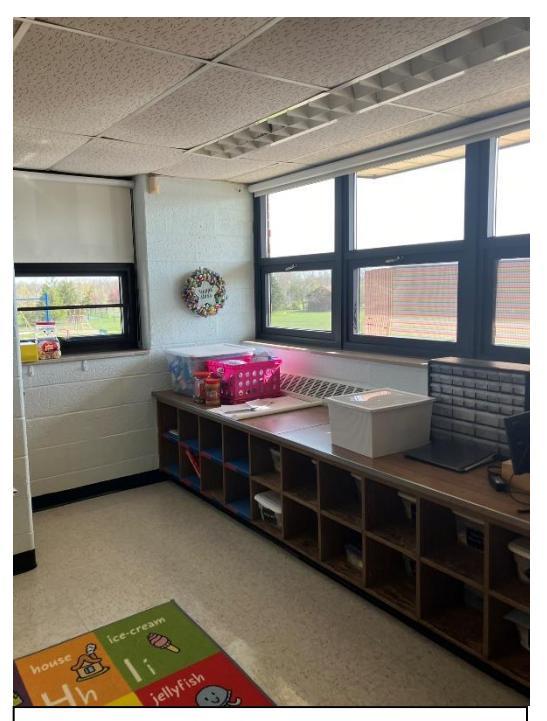
New windows in Original Bldg.

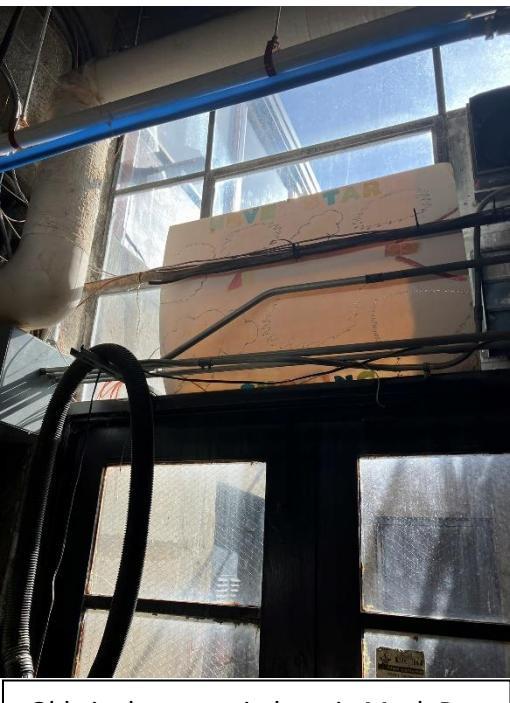
Old single pane windows in Mech Rm.

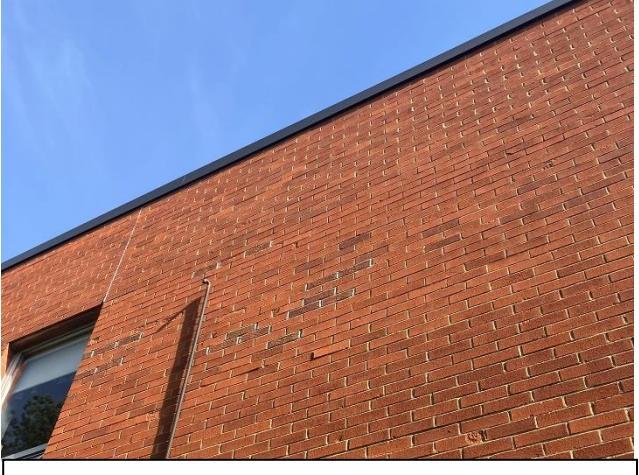
The overall facility has brick veneer on loadbearing wall system which displayed locations of spalling and deterioration, particularly on the west façade of the building near the main entrance and on the south side of the 2-story addition. Cracking was observed in both exterior and interior masonry which has been reported in the past due to the 1986 earthquake.

Brick veneer masonry walls are assumed not to be cavity walls given the construction dates. The exterior masonry shows evidence of some mortar deterioration and needs repair, cleaning, and sealing. Efflorescence was observed in several locations; however, no mold was observed. There are no major elements of exterior accent materials on the exterior. Installation of the new HVAC systems recommended in Item A will result in the removal of existing unit ventilators, necessitating the exterior masonry infill of associated exterior wall voids. The chimney stack is present just outside the mechanical room and needs brick replacement and tuckpointing. Lintels are in fair condition.

Spalling brick & previous repairs

As a Priority 2, provide for replacement of brick as needed, tuckpointing, masonry cleaning, and sealing of the entire masonry façade (including chimney as applicable). This work will protect the integrity of the exterior façade. As a Priority 3, install control joints as needed, and infill brick at unit vent openings in coordination with HVAC replacement outlined in Item A.

Provide masonry tuckpointing, chimney & masonry repairs, cleaning, and sealing of the entire masonry façade.

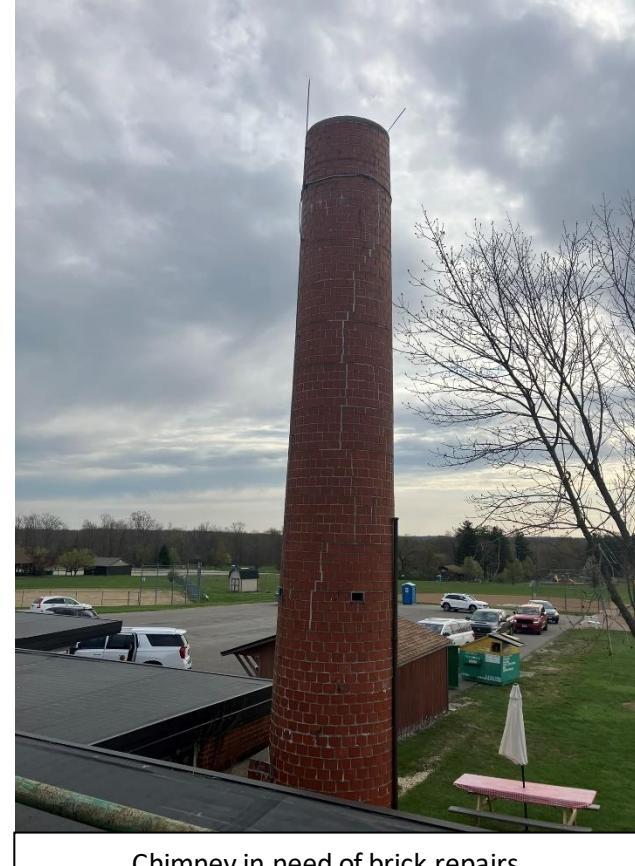
Chimney in need of brick repairs

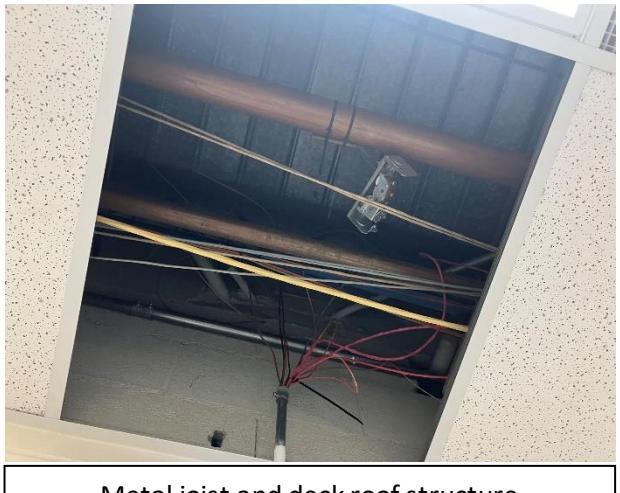
Metal joist and deck roof structure

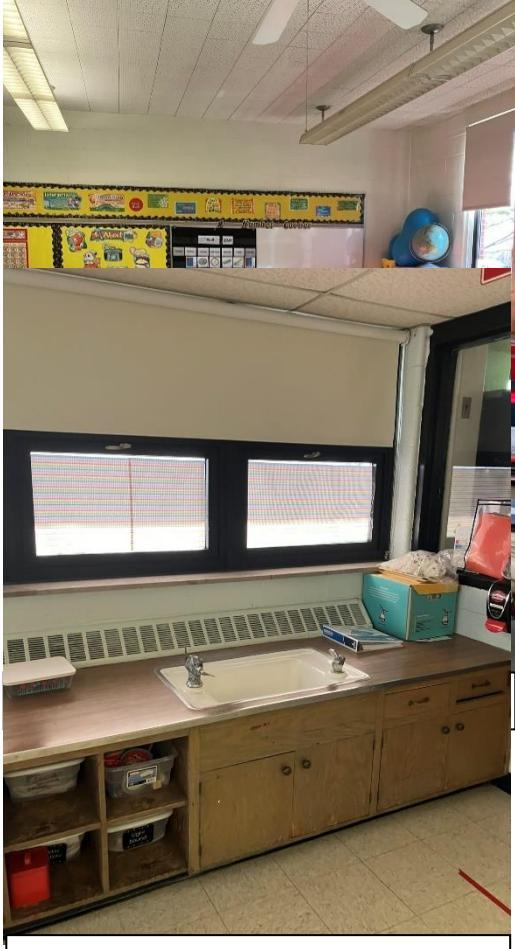
Dated/worn classroom casework

Provide for complete replacement of finishes and casework throughout due to age, condition, lack of compliance with OSDM requirements, and in conjunction with mechanical, electrical, plumbing, and life safety upgrades. Provide new toilet partitions and accessories due to age and condition. Provide for about ½ of the kitchen equipment replacement due to some pieces still being dated and beyond their anticipated useful life span. In the cafeteria/gym space, provide for the replacement of the basketball backboards and the operable partition wall. New interior door replacement is outlined in Item O. The building is not provided with the wall insulation necessary to meet the LEED requirements by OFCC. Additional wall insulation is required to meet this requirement.

Provide complete replacement of finishes and casework, new toilet partitions and accessories, basketball backboard replacement, operable wall replacement, additional wall insulation, and replacement of select kitchen equipment. See Item O for ADA requirements of ADA toilet partitions and interior door replacement.

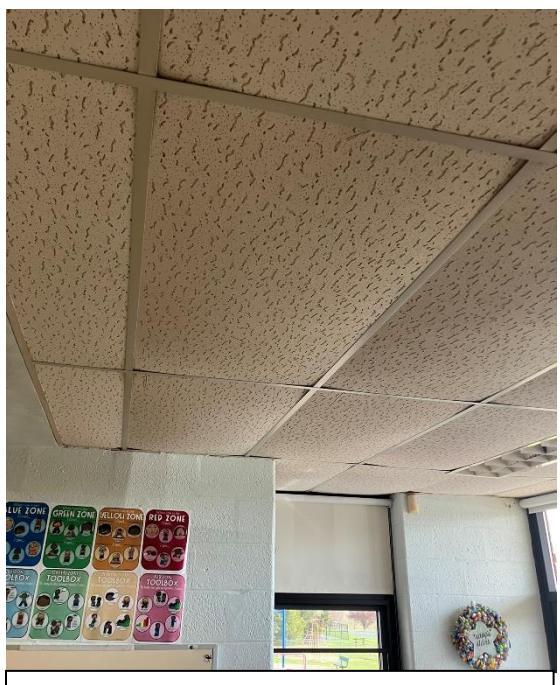
Bowing ceiling tiles

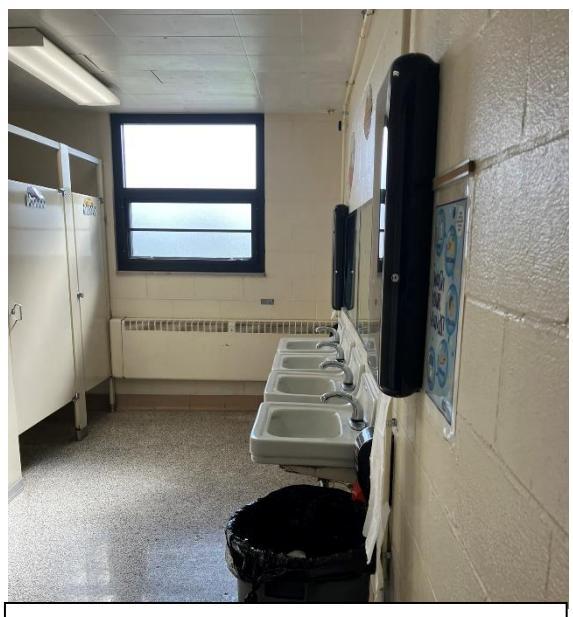
Typical restroom finishes

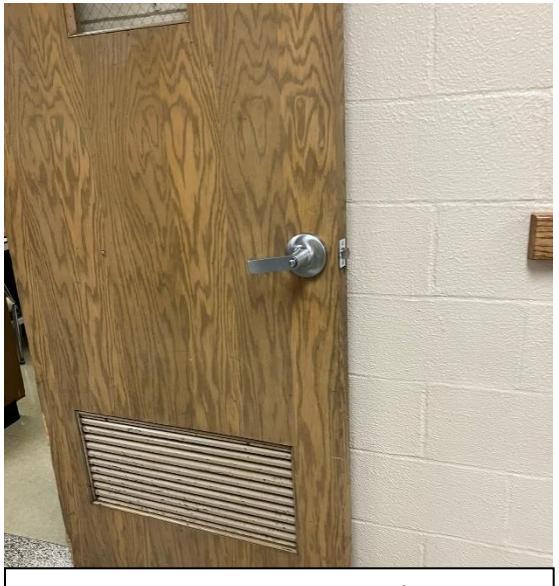
Old wood classroom doors w/new ADA hardware

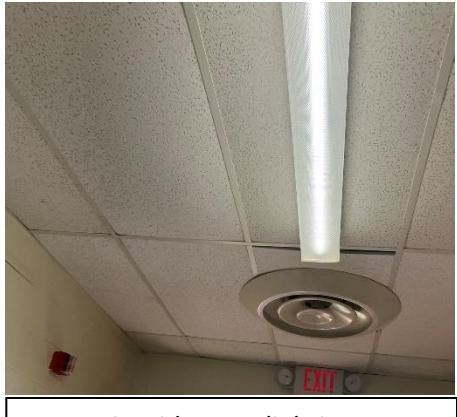
Corridor LED lighting

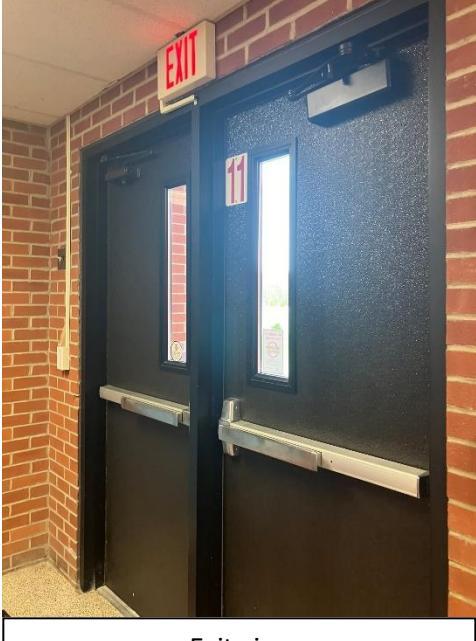
Exit sign

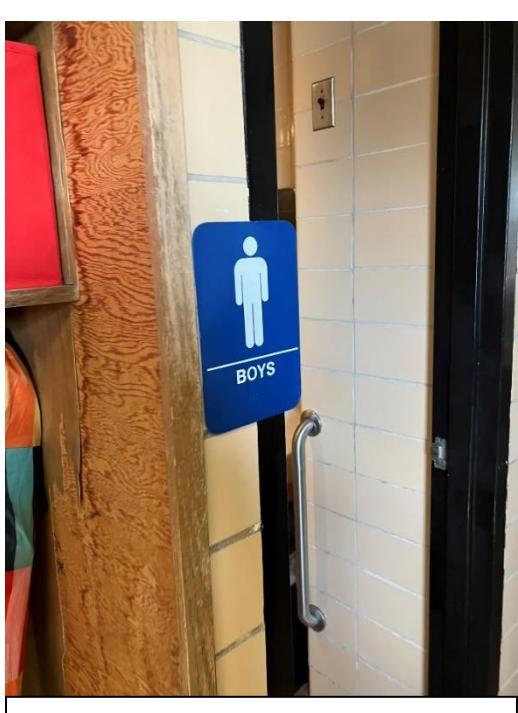
Limited ADA signage

Provide ADA-compliant large group restrooms on each floor of the building. Provide a 2-stop elevator for ADA accessibility, as well as a power door assist on a main entrance point. Provide a lift in the library for direct access to the tiered bookshelf area. Although the building has doors that are retrofitted with ADA hardware, the doors themselves are very dated and should be replaced. Additionally, 2 doors in the original building require wider openings. Provide ADA signage in the building.

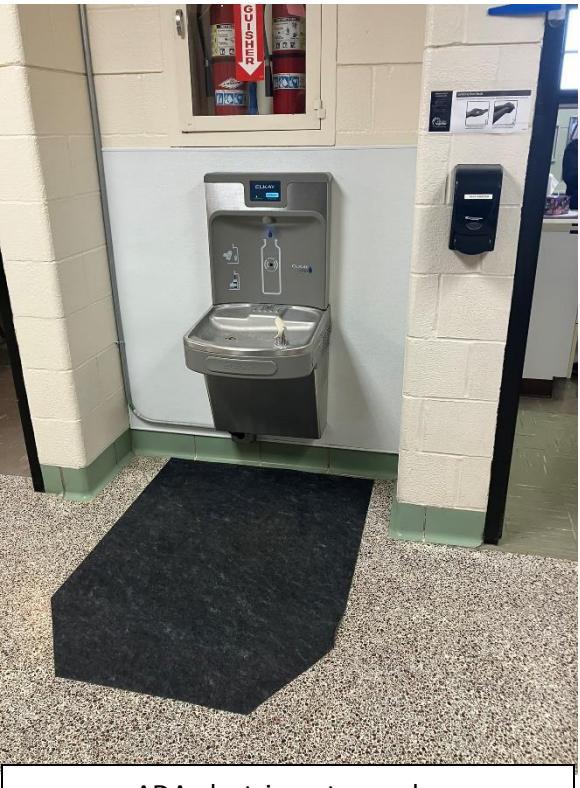
ADA electric water cooler

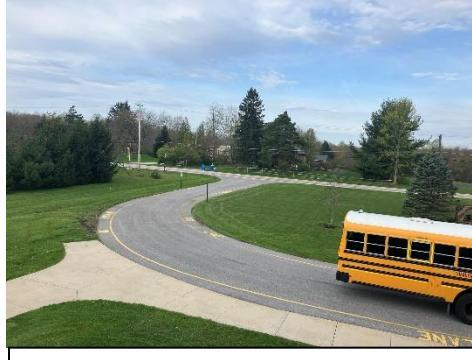
Bus loop in good condition

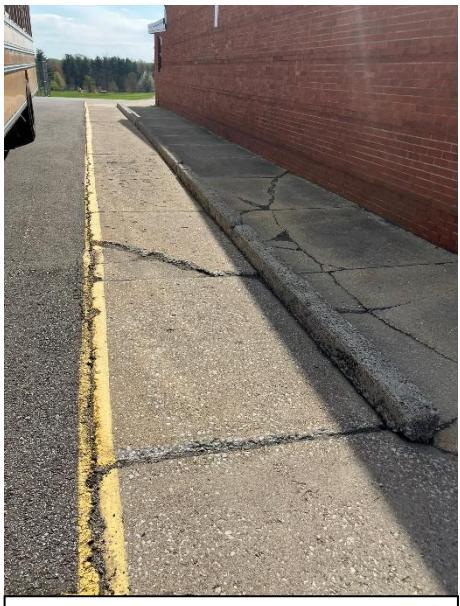
The sidewalks are a mix of ages and conditions from good to poor. The north sidewalk is in very poor condition, with large cracking and unevenness which is a tripping hazard.

North sidewalk in poor condition

The school district has slated that walk for replacement in the upcoming months. The trash

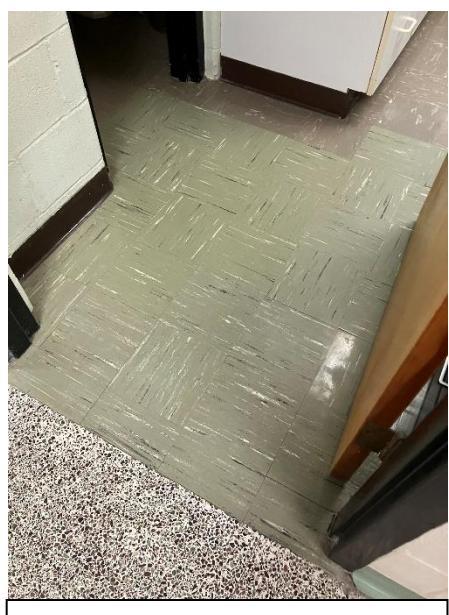
VAT flooring in clinic

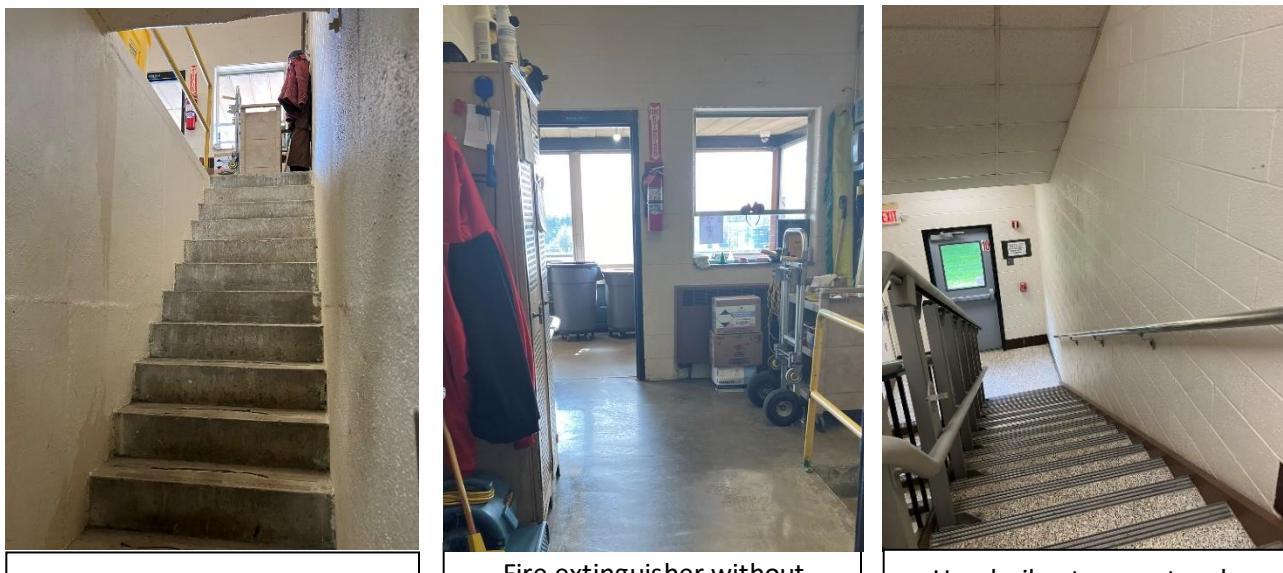
Stair lacks handrail

Fire extinguisher without cabinet and too high

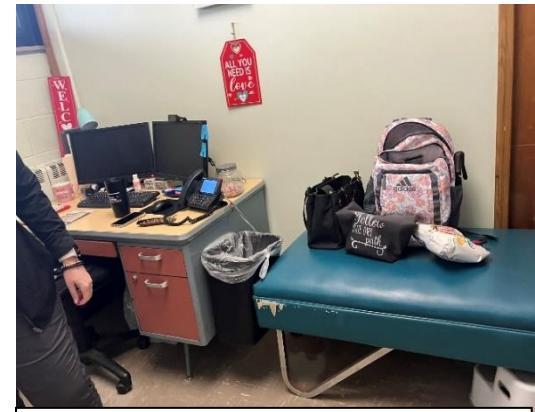
Clinic – dated furnishings

Replace outdated, worn furniture.

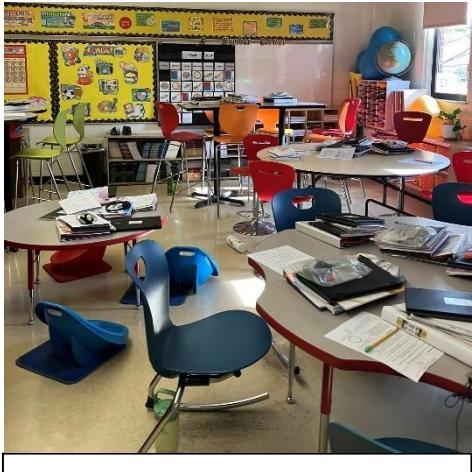
Newer furnishings

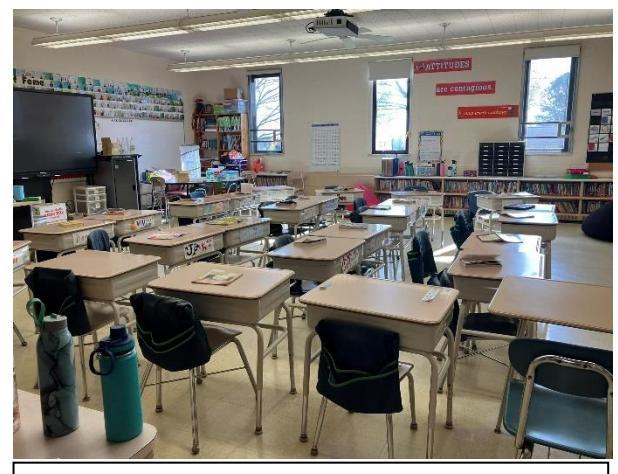
Older pieces
