Facility Assessment Update of Park Elementary School

Located at: 111 Goodrich Court, Chardon, Ohio 44024

May 2024

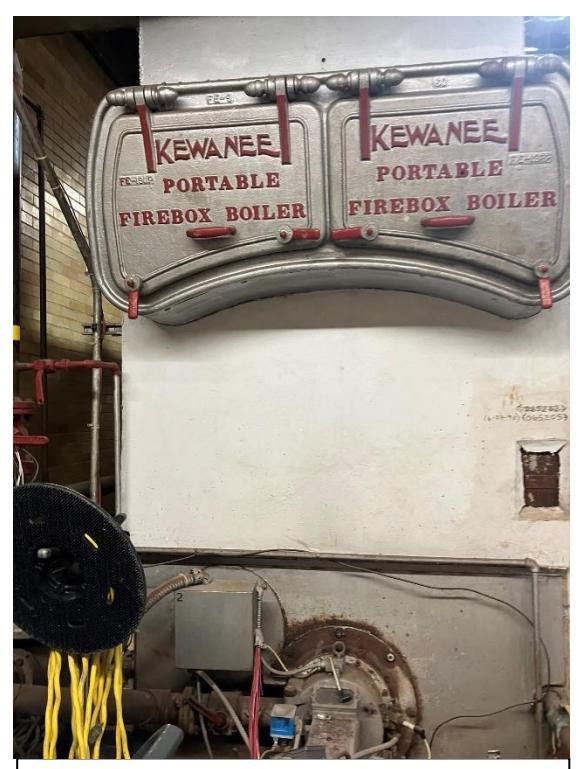
The existing system for the overall facility consists of a 1938 Kewanee steam boiler in fair condition and two 2013 Burnham boilers located in the gymnasium/auditorium building. The steam boiler is now offline. A newly replaced mechanical tunnel connects the HVAC piping from the gymnasium/auditorium West building to the East classroom building. All utility piping in the tunnel was also replaced at the time of tunnel replacement.

Steam boiler (offline)

Provide a new overall heating ventilating and air conditioning system to achieve compliance with OBC and OSDM standards. The two Burnham boilers can remain and be incorporated into the new system. The new ducted system will likely require architectural soffits to accommodate the installation of the ductwork. This work is outlined as Priority 3.

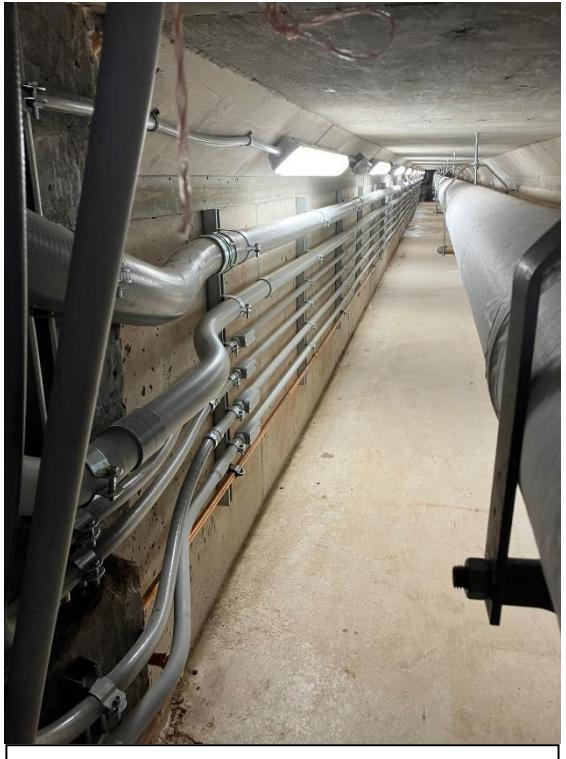
Newly installed pipe tunnel & piping

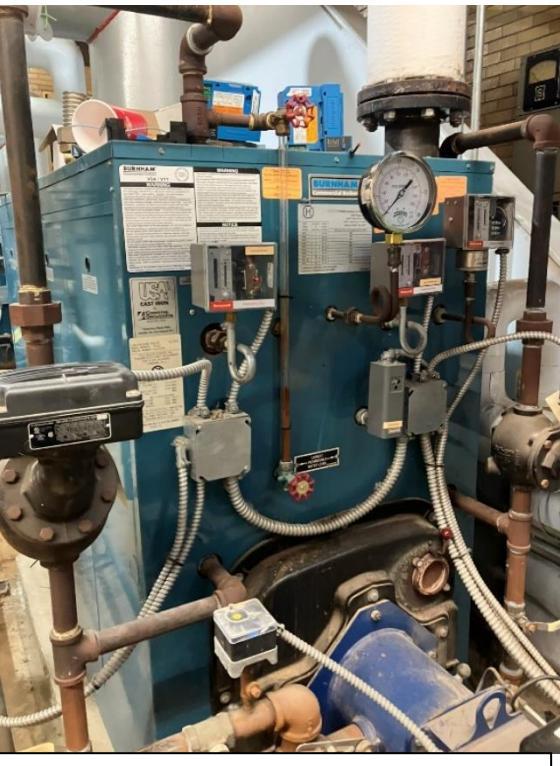
2013 Burnham Boiler

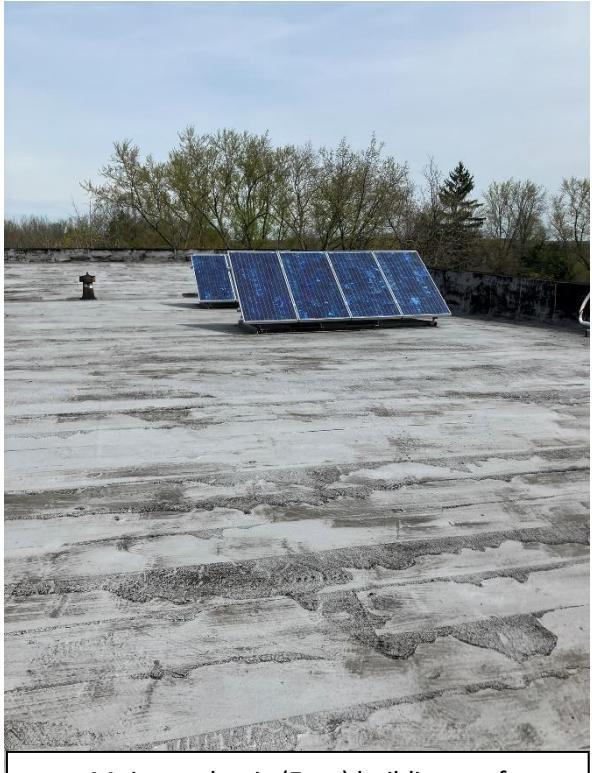
Main academic (East) building roof

portable ladder must be used to gain access to the bottom rungs of the ship ladder. The ladder and access hatch are dated but in functional condition. A fall safety protection cage is not provided.

There were no observations of standing water on the roof. Stone copings are in fair condition, having appeared to have been recently patched. Roof storm drainage is addressed through a system of internal roof drains. The roofs are not equipped with overflow roof drains though they are needed on these buildings. No problems requiring attention were encountered with any roof penetrations. There are not any covered walkways attached to this structure.

As a Priority 1, provide for replacement of both roofs due to age and condition. Additional cost is provided for multiple roof layers requiring tear-off. Provide for repairs to cap flashings and copings, new roof drains, and overflow drainage, as well as roof insulation. It is uncertain at this time if roof deck replacement will be required, as it could not be observed.

Provide for roof replacement.

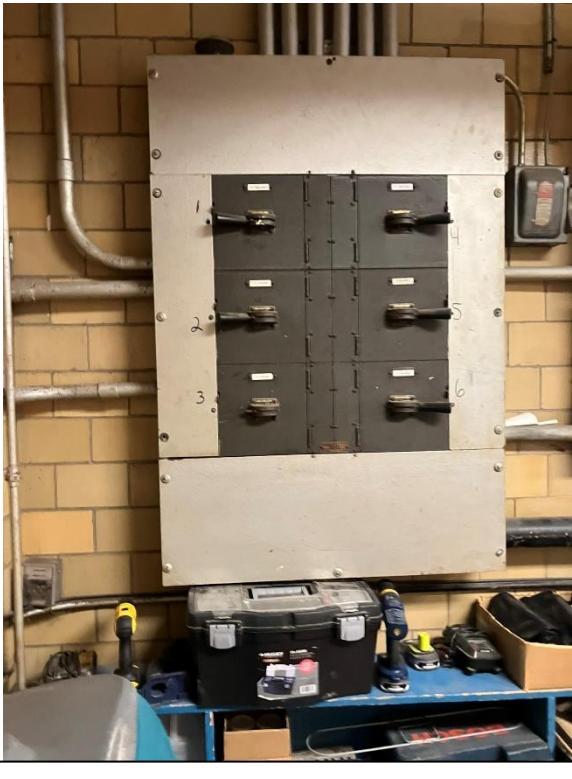
The electrical system in the overall facility is a 240/120 volt, 1 phase, 3 wire, 800-amp electric service with a 240 volt, 3 phase, 3 wire, 100-amp additional service. An upgrade occurred in 1999 to support the new computers at the school with no increase in the electric service. The service originates in the auditorium building and connects to the classroom building through the mechanical tunnel. The electrical conduits going through the mechanical tunnel were installed during the tunnel replacement last year. The existing system is not capable of supporting the new HVAC system. There is no lightning protection. The overall electrical system does not meet OSDM requirements in supporting the needs of the school.

Antiquated electric equipment

The entire electrical system requires replacement to meet OSDM guidelines for overall capacity due to age. Upgrade service to a 208/120 volt, 3 phase, 2000 amps minimum service per OSDM guidelines. Work outlined as a Priority 3.

Priority 3 Recommendation: Provide complete electrical system replacement.

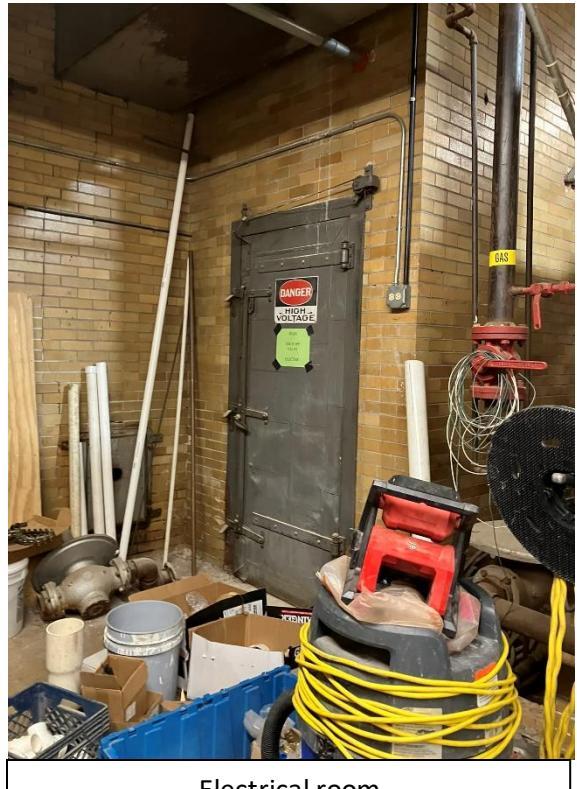
Electrical room

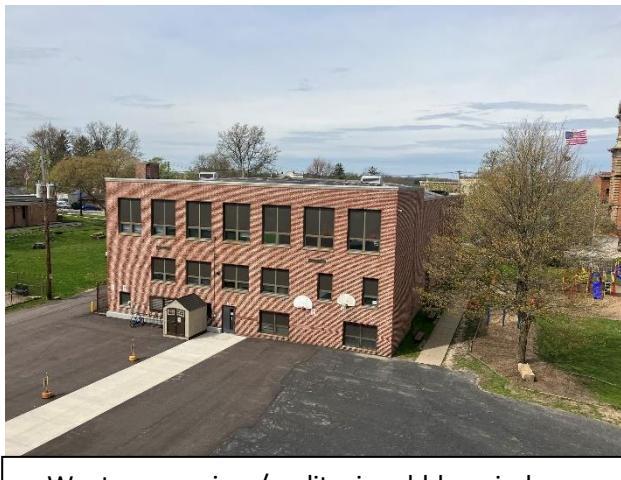
In 1985, the district replaced the lower portions of the window openings with double insulated pane, aluminum frame windows. Most of the openings were filled in with panels, many of which are rusting. The windows are reported to be in poor condition and some units were observed with condensation in between the panes. The seals have failed in these units, and they are a source of water and air infiltration. The windows are a source of energy loss to the building. The window system is an operable, awning-type window system and is equipped with insect screens.

West gymnasium/auditorium bldg. windows

Provide for replacement of all window systems throughout the facility due to age and failing condition. All work is recommended as a Priority 1 to ensure the building being warm, safe, and dry as a priority.

Provide for replacement of window system.

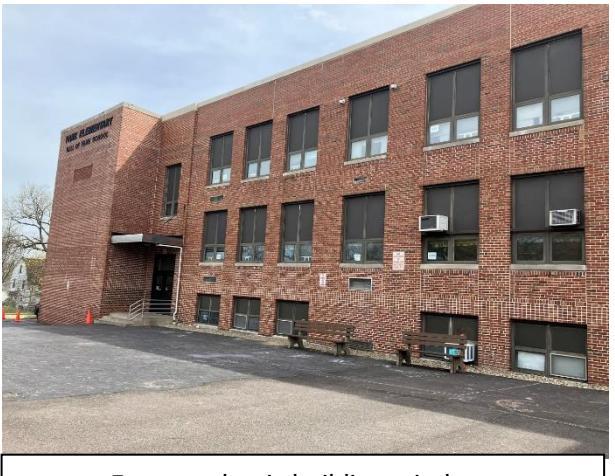
East academic building windows

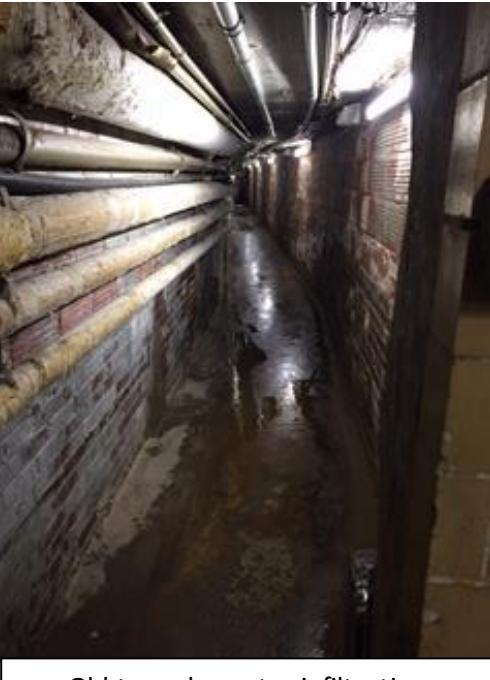
Before the tunnel replacement, it was observed to have significant water infiltration. Students and staff used this tunnel regularly as a connector between the two buildings. Efflorescence was observed throughout the tunnel walls. This issue has been resolved with the existing tunnel being demolished and the construction of the new tunnel. No significant site drainage issues were visible that could contribute to foundation wall deterioration. Please see Item H & I for issues related to spalling/deteriorating concrete structure in the West gymnasium/auditorium building.

Old tunnel – water infiltration

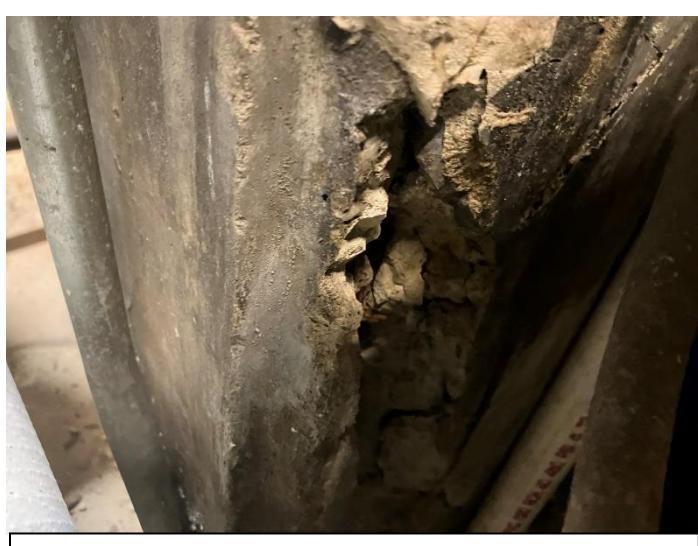
In the basement area of the West gymnasium/auditorium building, many locations of spalling and deteriorated concrete columns and intermediate concrete floor structures was observed. The deterioration was significant enough in some locations to expose the rebar/steel within, and it is beginning to rust. It is recommended that the district retain the services of a structural engineer to investigate the deterioration and provide a solution for repairs and restoration.

Spalling & cracking in concrete structure – exposed steel

As a Priority I, the district should retain the services of a professional structural engineer to provide analysis of the existing concrete condition and deterioration. Recommendations and anticipated costs can be amended in this report upon completion of that analysis. Additionally, provide for lintel replacement as a Priority 1 – lintel replacement should ideally happen when window replacement occurs (which is also a Priority 1 item). As a Priority 2, provide for masonry cleaning and sealing of the entire masonry façade. Provide tuckpointing as needed. Both of these items will protect the integrity of the exterior façade. As a Priority 3, provide expansion joints around the building's envelope, install control joints as needed, infill brick at unit vent openings, provide for window sill repairs, and replace overhangs.

Retain the services of a professional structure engineer to evaluate current existing conditions and renovation/restoration solution. This cost will be amended in the report once obtained. Provide for lintel replacement.

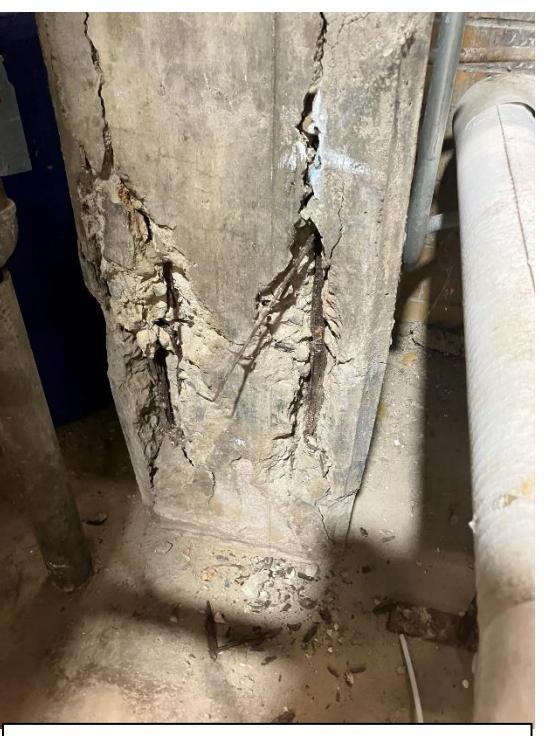
Spalling & cracking in concrete column – exposed steel

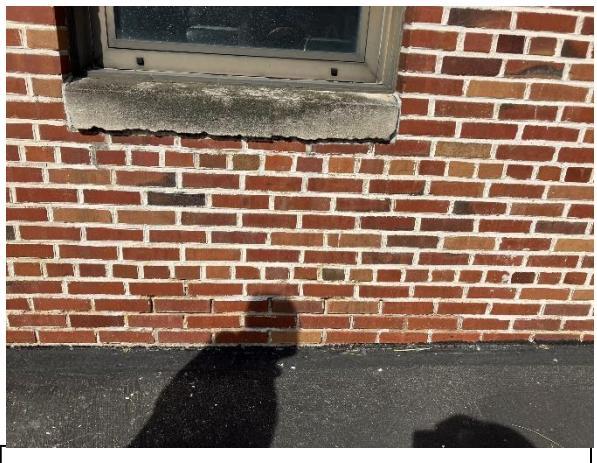
Tuckpointing needed (see lower brick courses)

Priority 2 Recommendation: Provide for masonry cleaning and sealing of the entire masonry façade tuckpointing as needed.	e. Provide for
Priority 2 Costs:	¢5710250
Masonry sealing: 29,330 SF x \$1.30/SF =	\$37,193.50 \$38,129.00
Masonrytuckpointing: approx.7,500SF x \$9.72/SF = Subtotal =	<u>\$72,900.00</u> \$168,222.50
Priority 3 Recommendation: Provide infill of brick @ unit vent voids when HVAC system is replaced. Replace	
Priority 3 Costs:	
Control joints: 978 LF x \$77.73/LF = Infill brick @ unit vent voids: 100 SF x \$73.90/SF =	\$76,019.94 \$7.390.00
Replace overhang: lump sum = Subtotal =	<u>\$14,500.00</u> \$97,909.94

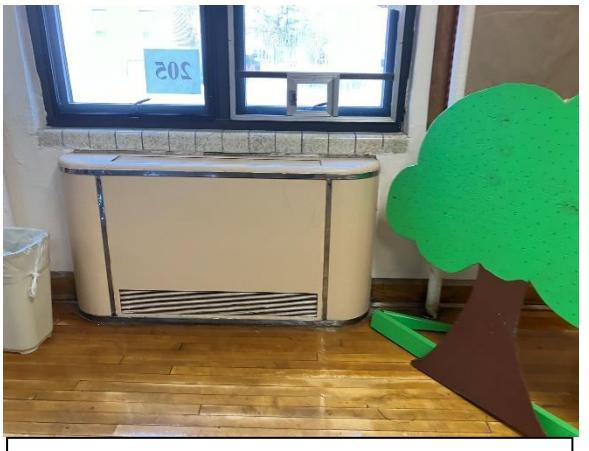
Wall voids will be present when unit vents removed at time of new HVAC installation

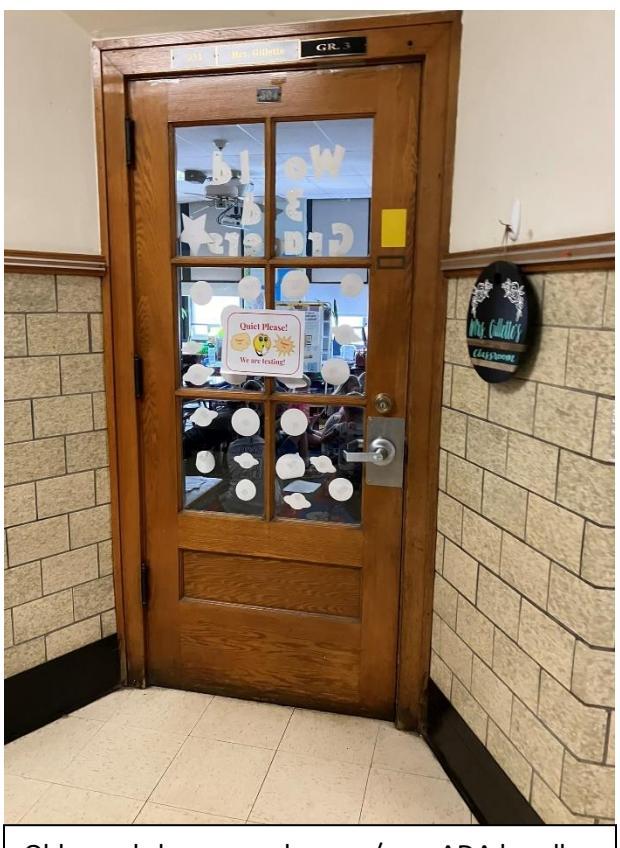
Old wood classroom doors w/new ADA handles

Provide complete replacement of finishes, new toilet partitions and accessories, select plaster repairs, wood flooring replacement, new gym seating, basketball backboard replacement, add wall padding, and replacement of select kitchen equipment. See Item O for ADA requirements of ADA toilet partitions and interior door replacement.

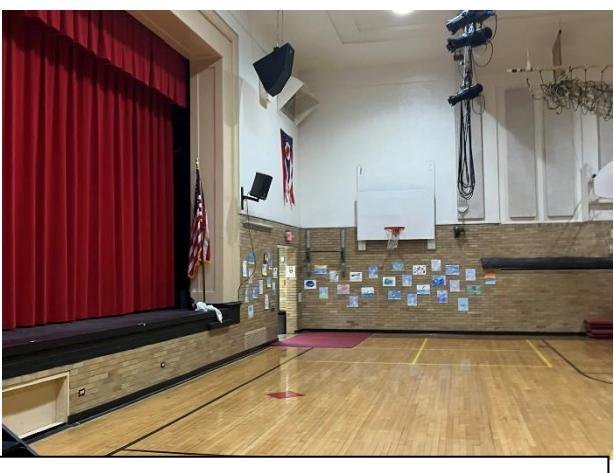
The gymnasium/auditorium is equipped with wood flooring on the gymnasium court, brick walls with plaster wainscot walls, and plaster ceilings in dated condition. The gymnasium doubles as an auditorium and fixed concrete riser seating with what appears to be the original wood seats that are in poor condition. The seating quantity provided is slightly over 300 seats. No ADA-compliant seating is provided. The space has some acoustical treatment provided on the walls as well as hanging from the ceilings. Four fixed basketball backboards/hoops are provided that are also in dated condition. There is no wall padding provided. There is a wood stage provided and the district reports that they have 2 new backstage curtains being ordered.

Gym finishes

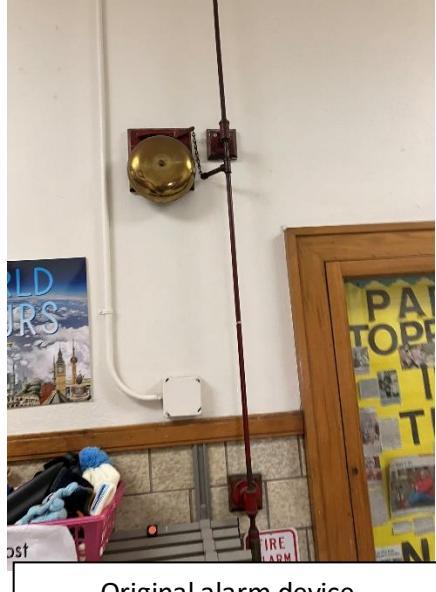
Original alarm device

Replacement of the system will be required when the work in A and C- upgrading the ventilation and air conditioning is completed. At that time, the devices would be replaced and added to with addressable devices.

<u>Priority 3 Recommendation:</u> Provide for replacement of fire alarm system.

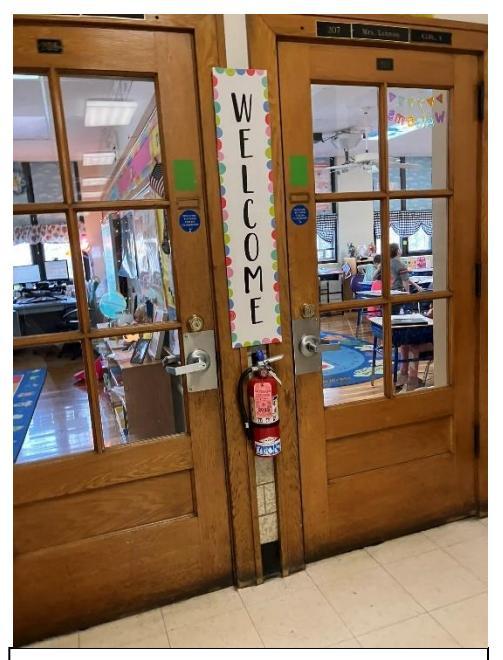
Non-recessed doors retrofitted with ADA hardware

Provide for ADA compliant large group restrooms on each floor of the two buildings. Provide a 3 stop elevator in each building for ADA accessibility, as well as a power door assist on each main entrance point. Although the academic building has doors that are retrofitted with ADA hardware, the doors themselves are very dated and should be replaced. Provide ADA signage in the buildings. Provide a lift for the stage.

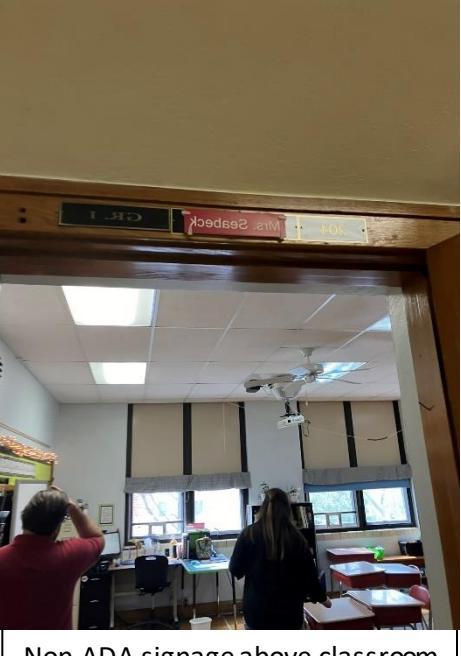
Non-ADA signage above classroom doors

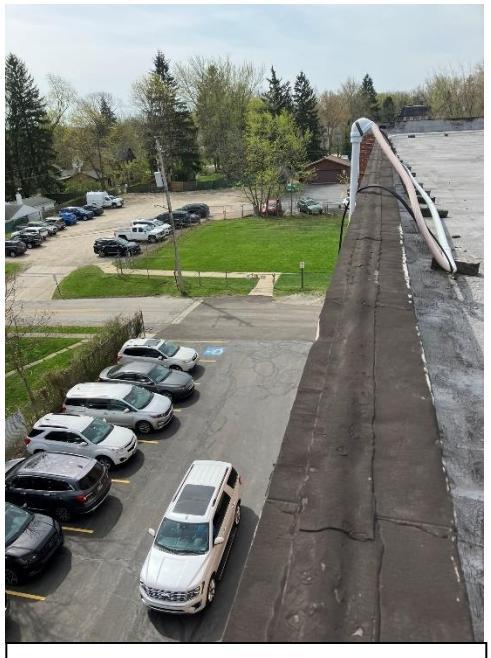
1 ADA parking space provided on the east side of the academic bldg.
