Facility Assessment of Chardon Schools Board of Education Facility

Located at: 428 North Street Chardon, Ohio 44024

May 2024

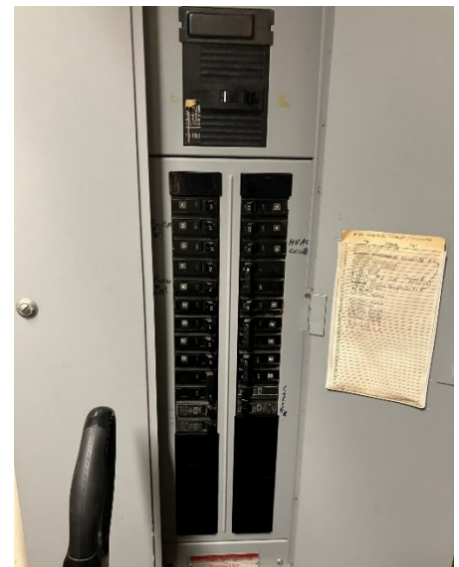
Breaker Panel

The overall electrical system is in good condition and meets the current needs of the facility and will be adequate to meet the facility's future needs.

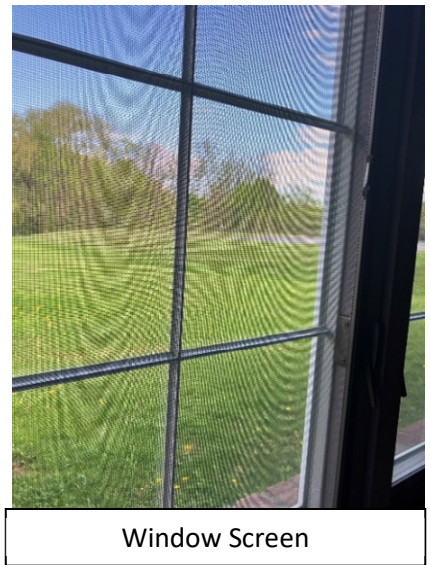
Window Screen

The majority of the windows are double insulated pane casement windows that are original to the building. The window system features both operable and inoperable windows and is not equipped with opening limiters but is equipped with insect screens in good condition. Window system seals are in good condition, and although no active leaks or condensation were present or reported, there was evidence that the window jambs were beginning to rot. Most of the window systems feature surface-mounted blinds which are in good condition. This facility is not equipped with a curtain wall system. This facility does not feature any glass block windows.

Provide for replacement of all original windows.

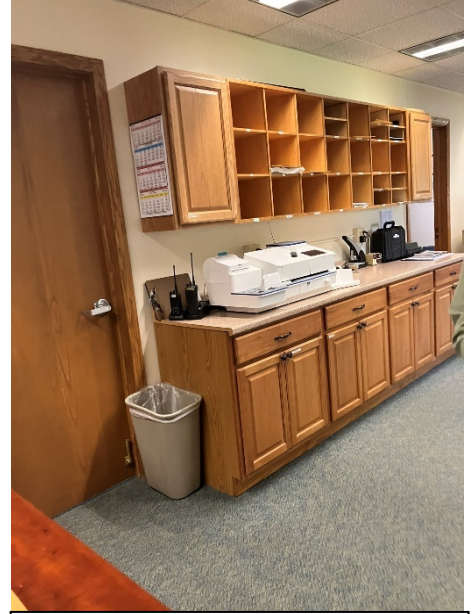
Casework not Original to Building

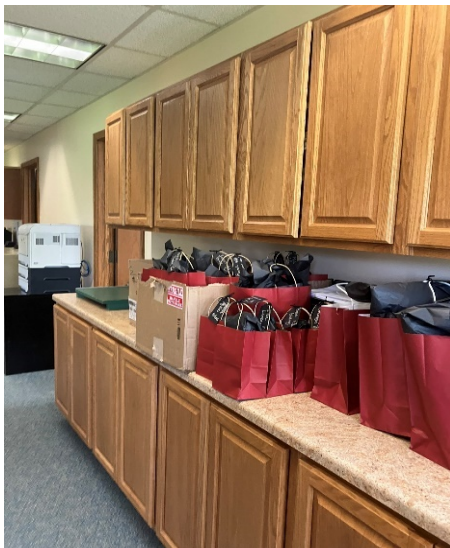
Casework not Original to Building

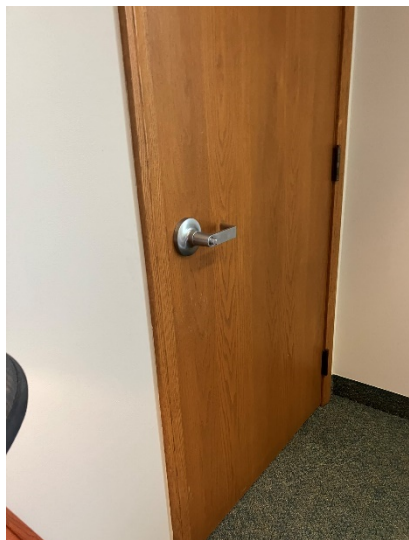
Interior Door and Hardware

The facility is equipped with wood non-louvered interior doors that are flush mounted with proper ADA hardware. The interior doors are in good condition.

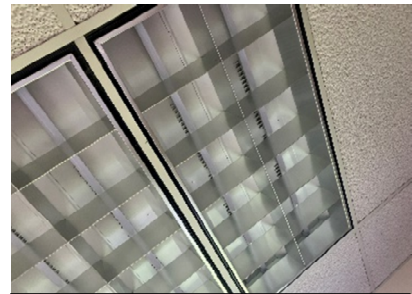
New LED Fixture

The Board of Education facility is equipped with all-new 2x4 LED lights with multi-level switching. The overall lighting systems of the facility are adequate and in good condition.

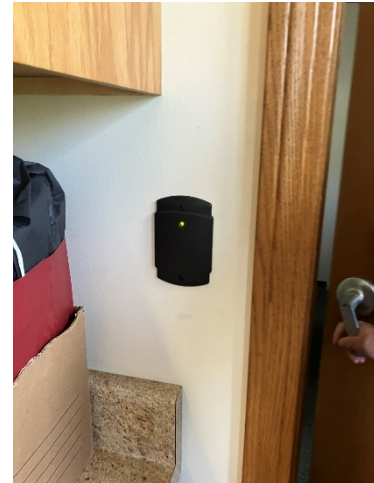
Keri Door Readers

The overall facility contains a Honeywell security system, monitored by Vector Security, in good condition. All exterior doors are equipped with a Keri Access Control reader.

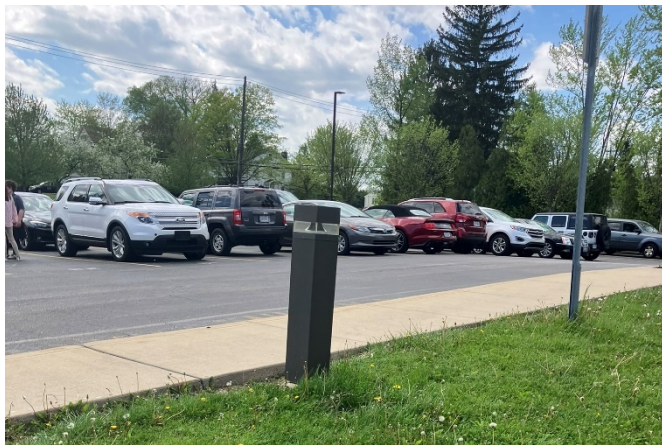
Pedestrian and Parking Lighting

The exterior site lighting system is equipped with surface mounted HID entry lights in good condition. Pedestrian walkways are illuminated with light bollards. Parking areas are illuminated by pole-mounted HID fixtures in good condition. The exterior site lighting system provides adequate illumination.
