## Facility Assessment Update of Chardon High School

Located at: 151 Chardon Ave., Chardon, Ohio 44024

May 2024

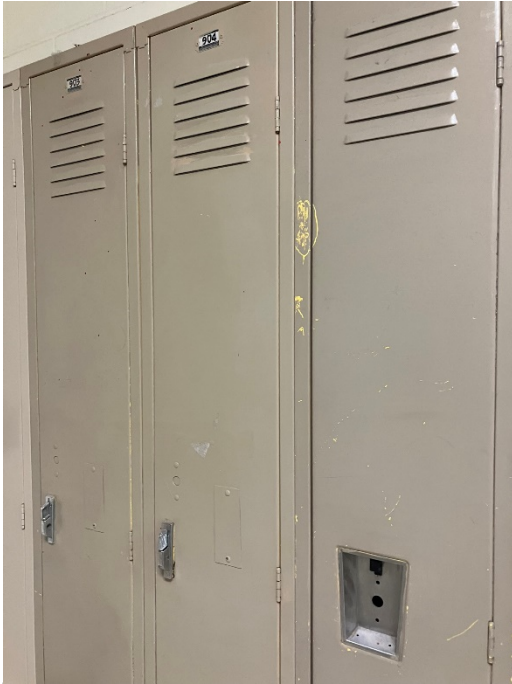
Metal lockers

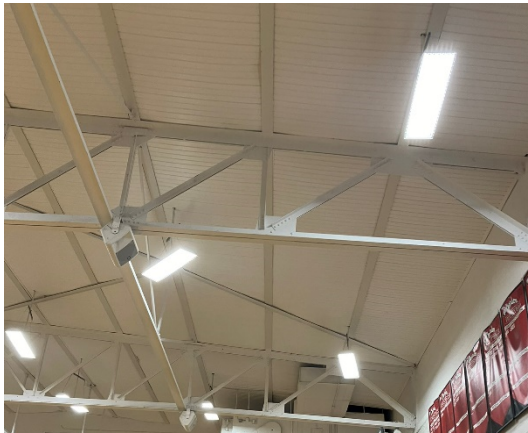
New LED lighting

Although all new LED lighting is provided, complete replacement of lighting system in areas with dropped ceilings will be required due to the installation of mechanical systems and fire suppression systems outlined in Items A & U.

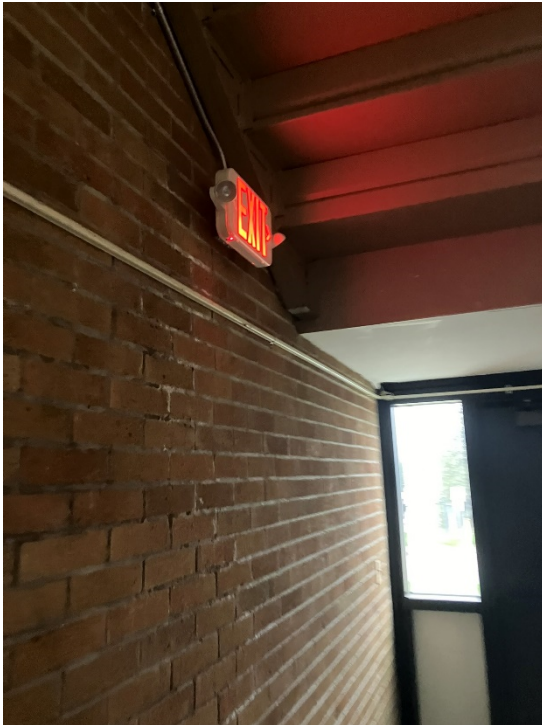
The overall facility is equipped with an emergency egress lighting system consisting of compact fluorescent and LED exit signs, and emergency lighting with battery packs. The system is not adequately provided throughout and is not compliant with OSFC design manual guidelines. The only upgrades in recent years include putting in a few new LED signs when existing ones need replacement. There is no emergency generator.

Exit sign

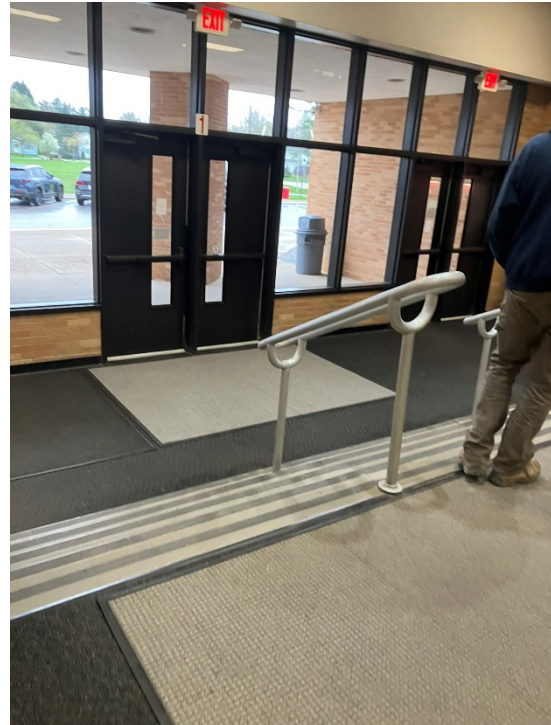
Exit signs

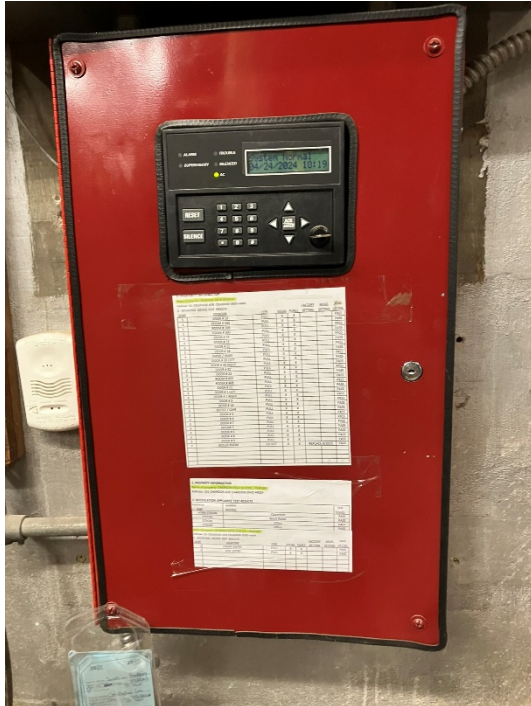
The fire alarm system is a zoned type system (non-addressable) and is annually tested and remotely monitored by Vector Security. The district recently replaced the fire alarm panel in the boiler room 2 years ago. There is not an adequate number of horn/strobe units. The existing system does not have enough capacity to add additional horn strobes or duct fire suppression system detectors for the shutdown of air handling equipment to meet NFPA and OFCC standards. It is not likely that the current system would accommodate the addition of a fire suppression system.

New Fire Alarm Control Panel

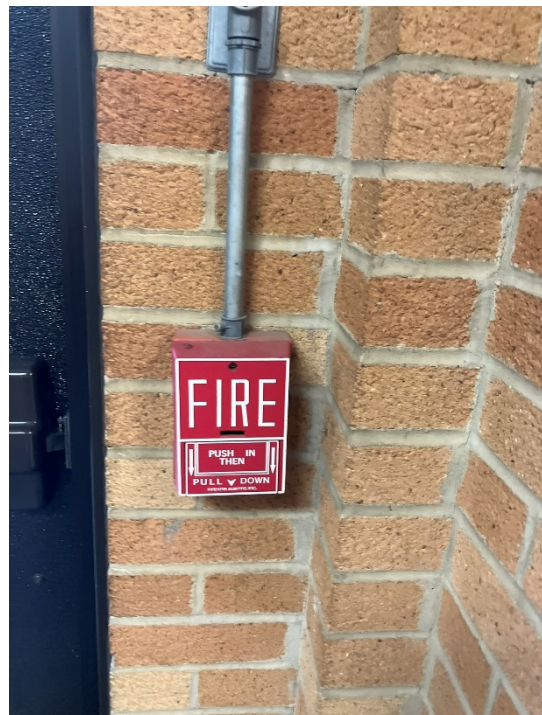
Fire pull

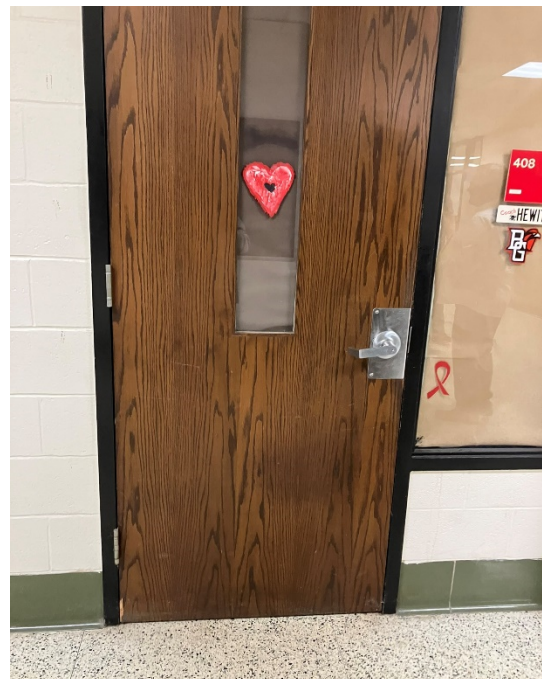
Interior doors are generally the original door leafs and most have been retrofitted with ADA hardware in recent years. Interior doors are primarily wood and metal, some feature louvers, and are not recessed.

ADA hardware on classroom door

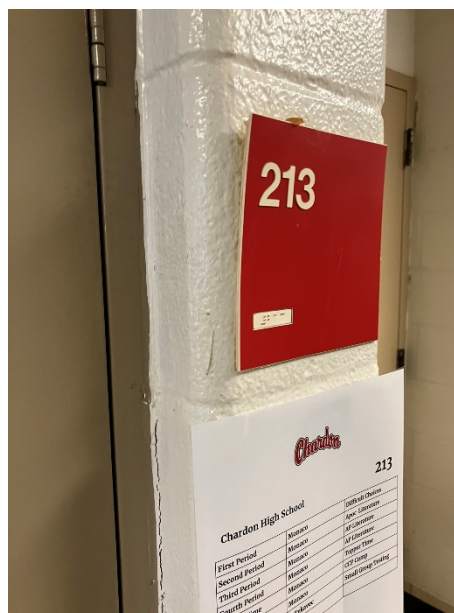
ADA signage is present in some areas, but not fully throughout the facility and varies in age and condition. Several locations are not at proper ADA mounting heights. There is an elevator in the building but due to the multiple half levels of various additions, there are still spaces that are not ADA accessible. The existing elevator recently had new controls installed, is provided with a smoke alarm and a telephone, and also has a card reader. The car itself and its hydraulics were not replaced.

ADA signage

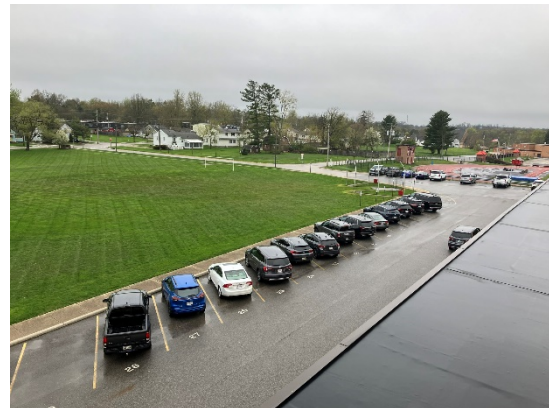
Drop off and parking in good condition

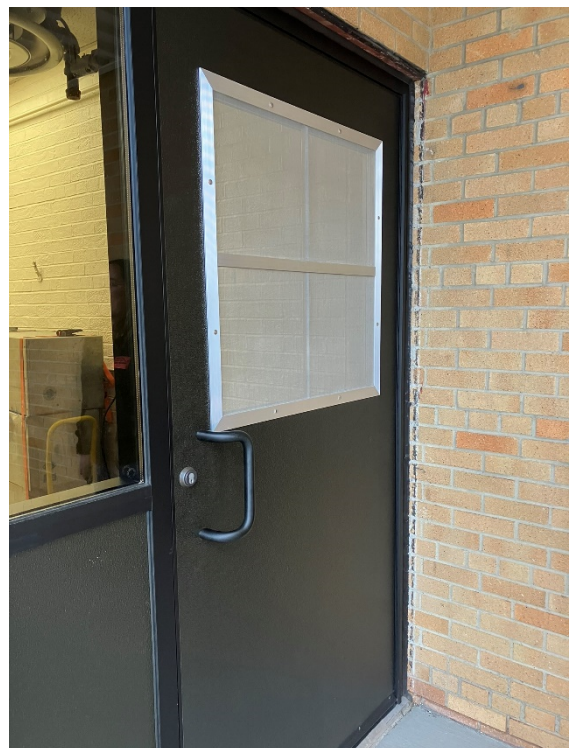
New FRP door

Provide for replacement of all old exterior doors. Due to condition and age, work is recommended as a Priority 2.

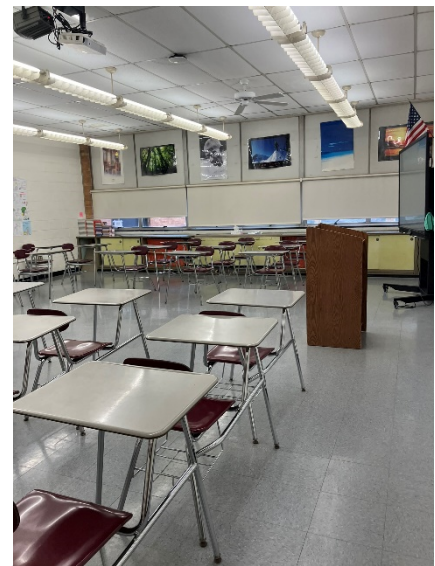
The facility's furniture and loose equipment were evaluated in the original assessment and on a scale of 1-10 the overall facility received a rating 3 out of 10 due to age, condition, and because it lacks some of the design manual required elements.

**Classroom furniture**
