Facility Assessment Update of Chardon Early Learning Center (formally Maple Elementary School)

Located at: 308 Maple Ave., Chardon, Ohio 44024

May 2024

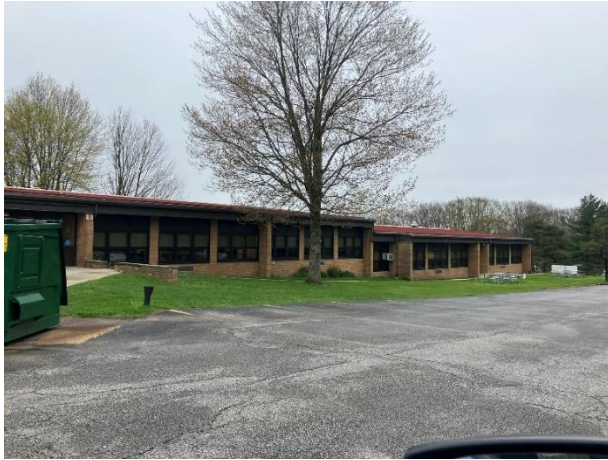
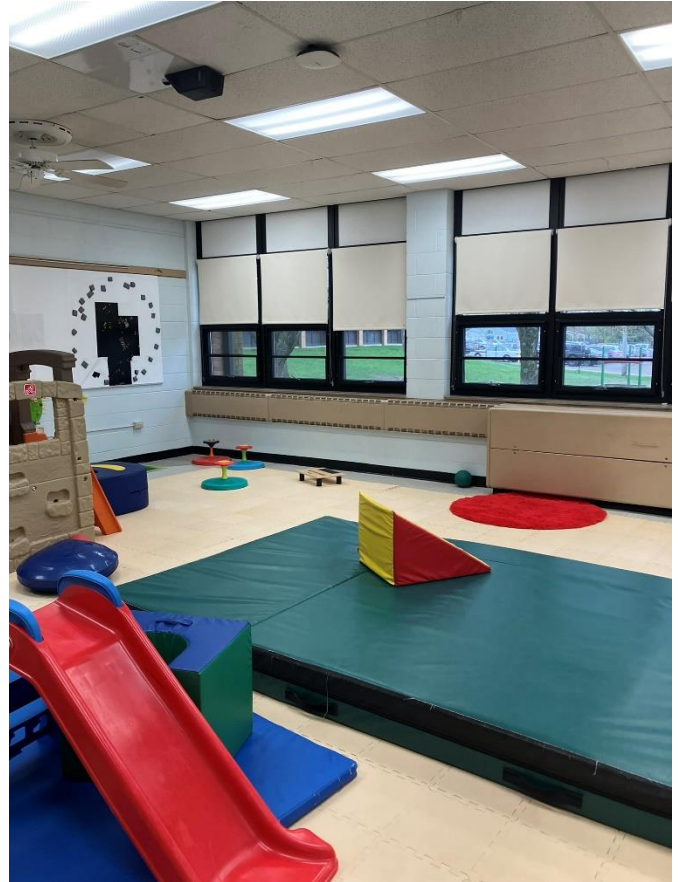
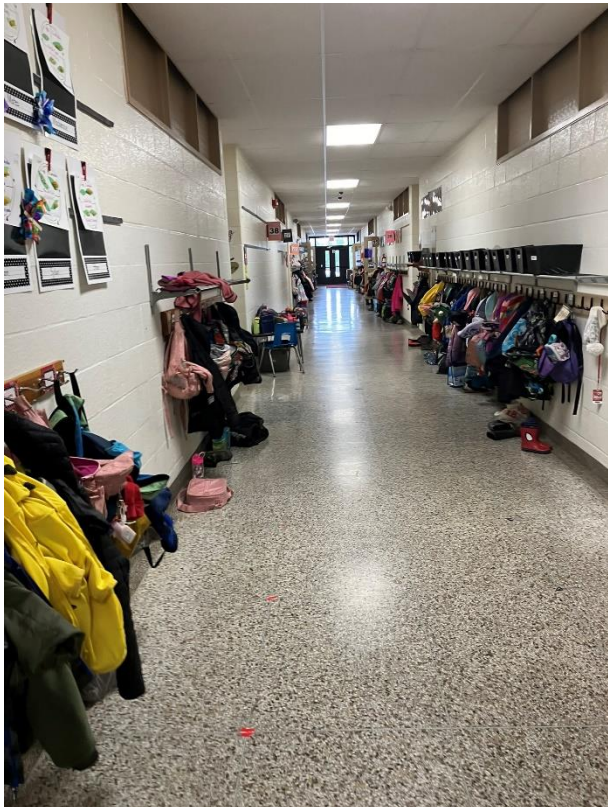
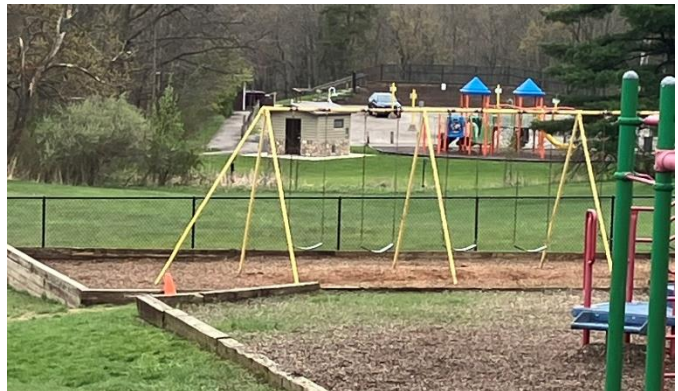
Chardon Early Learning Center is a brick school building originally constructed in 1958 (single story) with a subsequent addition constructed in 1964 (single story). The school was formerly known as Maple Elementary School but has recently changed grade configurations and now

serves the district's Pre-Kindergarten and Kindergarten grades only. The high school student parking lot flanks the building to the north. The school is small, with an overall square footage of 25,619 SF. The school has 15 traditional classrooms, a combined gym and cafeteria (now used as a multi-purpose room), and a small warming kitchen.
