Facility Assessment Update of Munson Elementary School

Located at: 12687 Bass Lake Rd. Chardon, Ohio 44024

May 2024

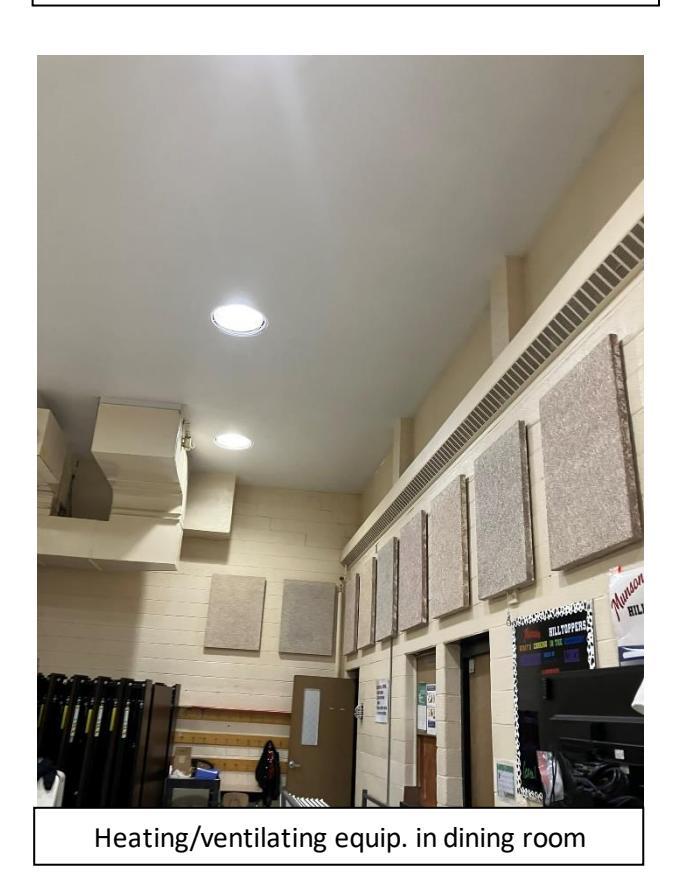
The existing system for the overall facility consists of two Burnham steam boilers replaced in May of 2021 (cost around \$282,500). The boilers are in good condition. They are, however, just one part/piece of an overall system which is outdated and does not provide the required outside air delivery to meet the Ohio Building Code mechanical code requirements. The boiler's steam is converted to hot water for some heat units via a heat exchanger. The system utilizes unit ventilators

New boilers

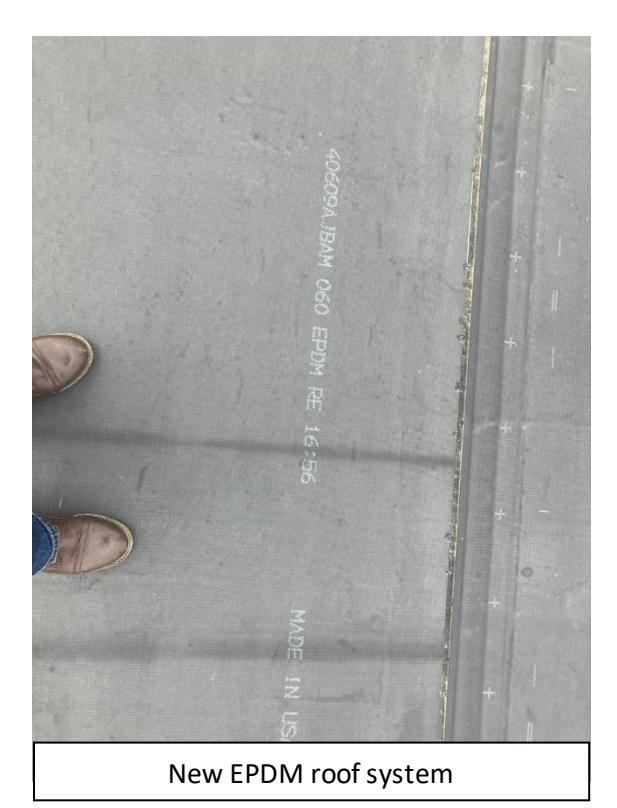
There were no observations of significant areas of standing water on the roof during the physical assessment. There are no overflow drains or scuppers on the roof. Roof access was gained via a roof hatch that is in fair condition and operating properly. Fall safety protection

cages are not provided nor required. No problems requiring attention were encountered with any roof penetrations.

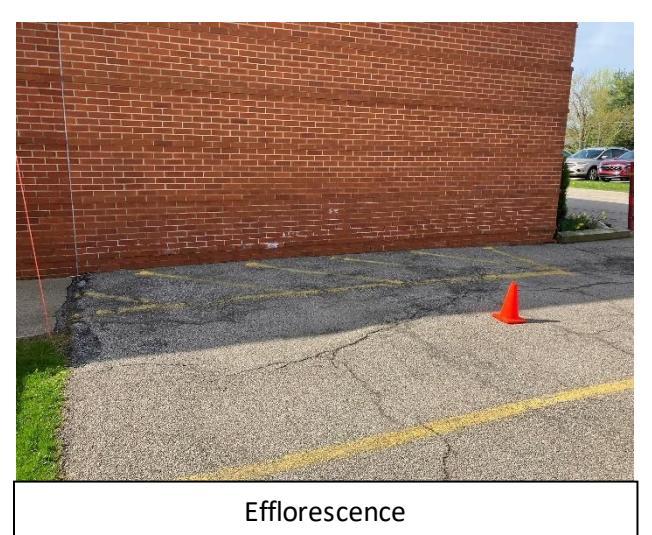
Brick veneer masonry walls are assumed not to be cavity walls given the construction dates. The exterior masonry shows evidence of some mortar deterioration and needs repair, cleaning, and sealing. Efflorescence was observed in several locations; however, no mold was observed. There are no major elements of exterior accent materials on the exterior. Installation of the new HVAC systems recommended in Item A will result in the removal of existing unit ventilators, necessitating the exterior masonry infill of associated exterior wall voids. The chimney stack is present just outside the mechanical room and needs brick replacement and tuckpointing. Lintels are in fair condition.

Spalling brick & previous repairs

As a Priority 2, provide for replacement of brick as needed, tuckpointing, masonry cleaning, and sealing of the entire masonry façade (including chimney as applicable). This work will protect the integrity of the exterior façade. As a Priority 3, install control joints as needed, and infill brick at unit vent openings in coordination with HVAC replacement outlined in Item A.

Provide masonry tuckpointing, chimney & masonry repairs, cleaning, and sealing of the entire masonry façade.

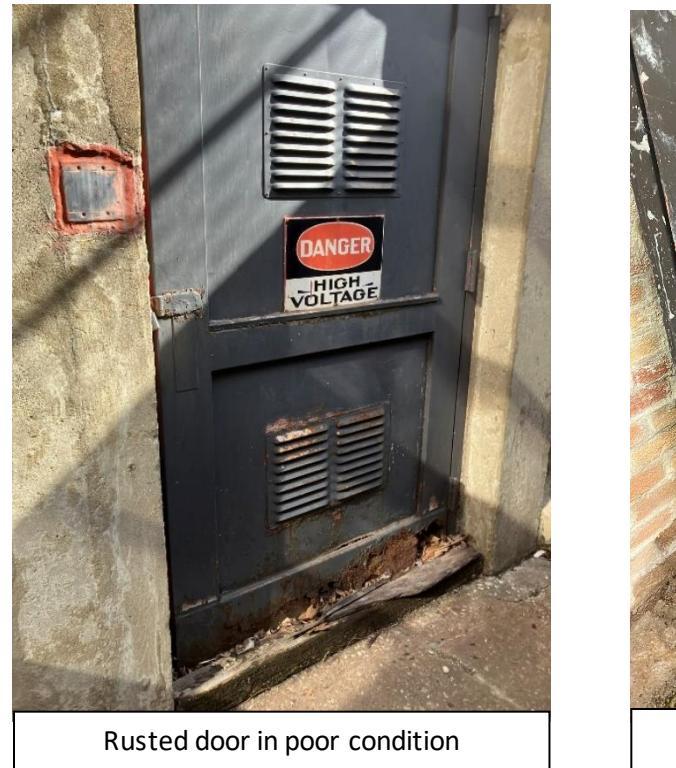
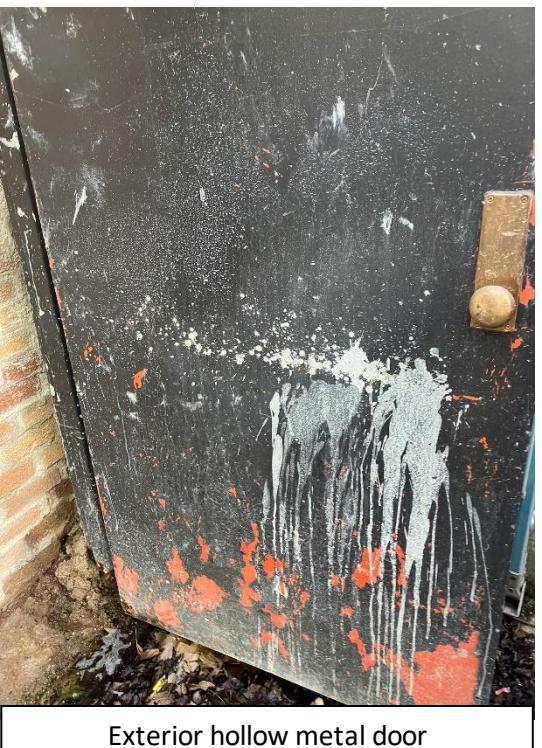
The exterior doors throughout the building are a mix of materials, age, and condition. They include both hollow metal doors which are generally in dated/poor condition, and some newer FRP doors in fair to good condition. Some of the metal doors were observed to be rusting and in very poor condition. The doors feature panic exit hardware, and many are equipped with single pane and/or wired glass.

Provide for replacement of all old exterior doors. Due to many being in a rusted, poor state, all are being recommended as a priority 1.

Replace dated deteriorating exterior doors.
